# RECALL CAMPAIGN BULLETIN

NTB11-106b

## VOLUNTARY SAFETY RECALL CAMPAIGN 2011 JUKE; AIR INLET TUBE

**APPLIED VEHICLE:** 2011 Juke (F15)

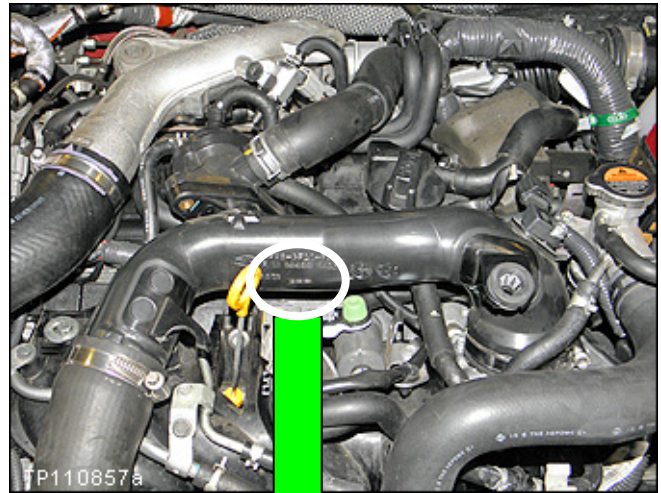
Figure 1

2. Check the date on the air inlet tube.

**NOTE:** If the date is not painted on the inlet tube in this location, go to the secondary location on the next page.

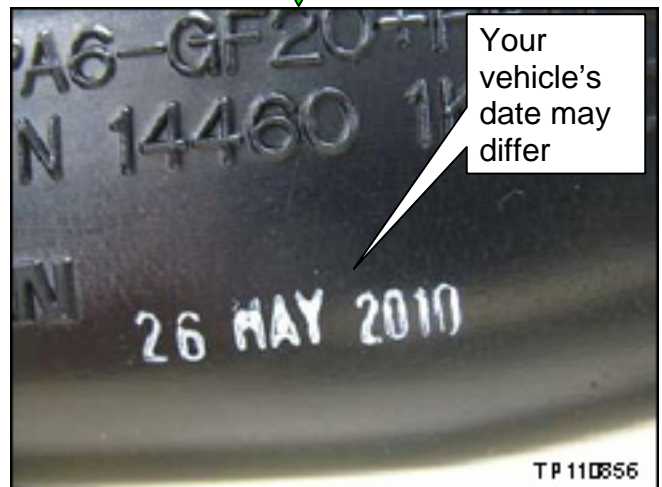
Figure 2

- Date of 01 Dec 2010 or after
- No repair needed.

- Date of 30 Nov 2010 or before
- Replace air inlet tube 1 – continue with the procedure on page 5.

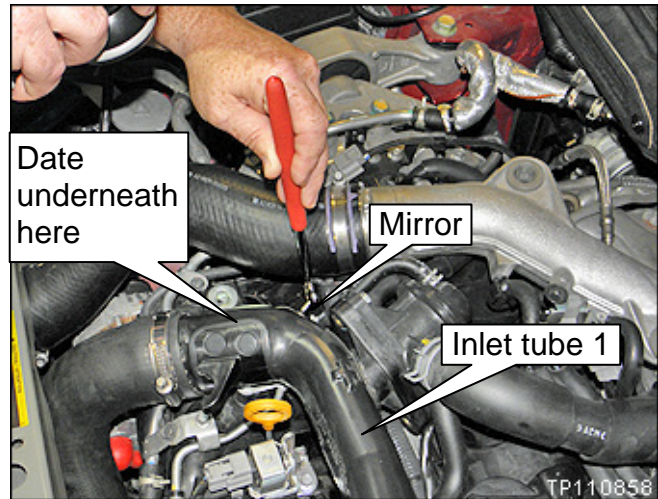
Figure 3

Secondary location for date

- Date is printed directly underneath the intake side of the air inlet tube.
- Use a light and a mirror to locate and read the date.

**NOTE:** The date will appear backwards in the mirror.

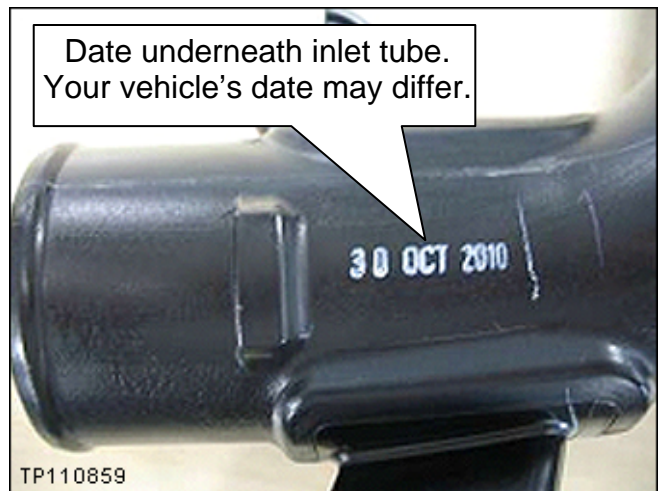
Figure 4

- Date of 01 Dec 2010 or after.
- No repair needed.

- Date of 30 Nov 2010 or before.
- Replace air inlet tube 1 – continue with the procedure on page 5.
