RECALL CAMPAIGN BULLETIN

NTB11-106a

VOLUNTARY SAFETY RECALL CAMPAIGN 2011 JUKE; AIR INLET TUBE

APPLIED VEHICLE: 2011 Juke (F15)

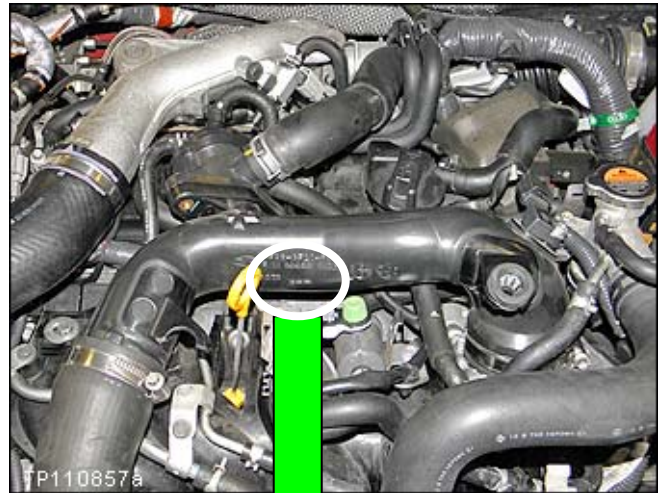
Figure 1

2. Check the date on the air inlet tube.

NOTE: If the date is not painted on the inlet tube in this location, go to the secondary location on the next page.

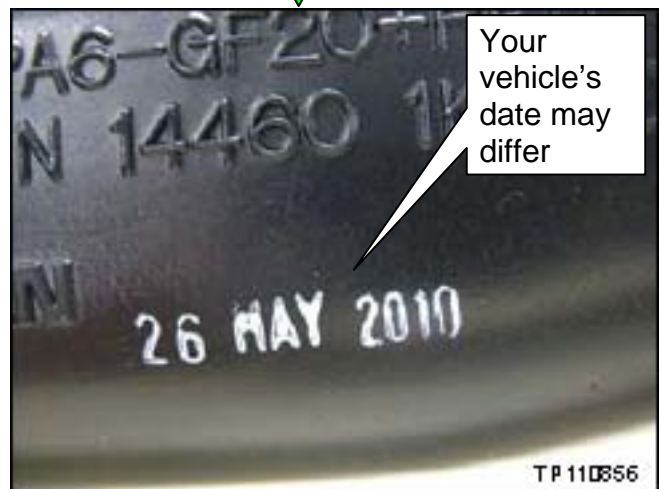
Figure 2

OK:

- Date of 01 Dec 2010 or after
- No repair needed.

NG:

- Date of 30 Nov 2010 or before
- Replace air inlet tube 1 – continue with the procedure on page 4.

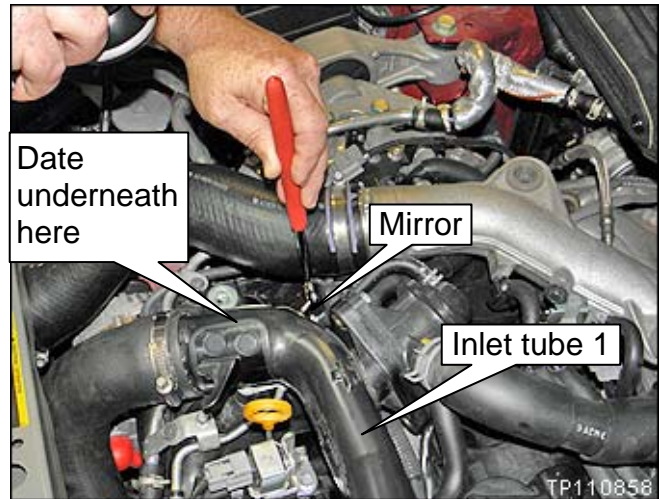
Figure 3

Secondary location for date

- Date is printed directly underneath the intake side of the air inlet tube.
- Use a light and a mirror to locate and read the date.

NOTE: The date will appear backwards in the mirror.

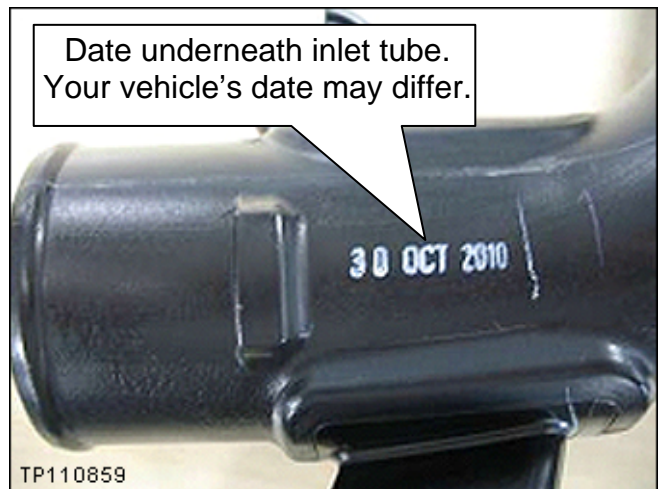
Figure 4

OK:

- Date of 01 Dec 2010 or after.
- No repair needed.

NG:

- Date of 30 Nov 2010 or before.
- Replace air inlet tube 1 – continue with the procedure on page 4.

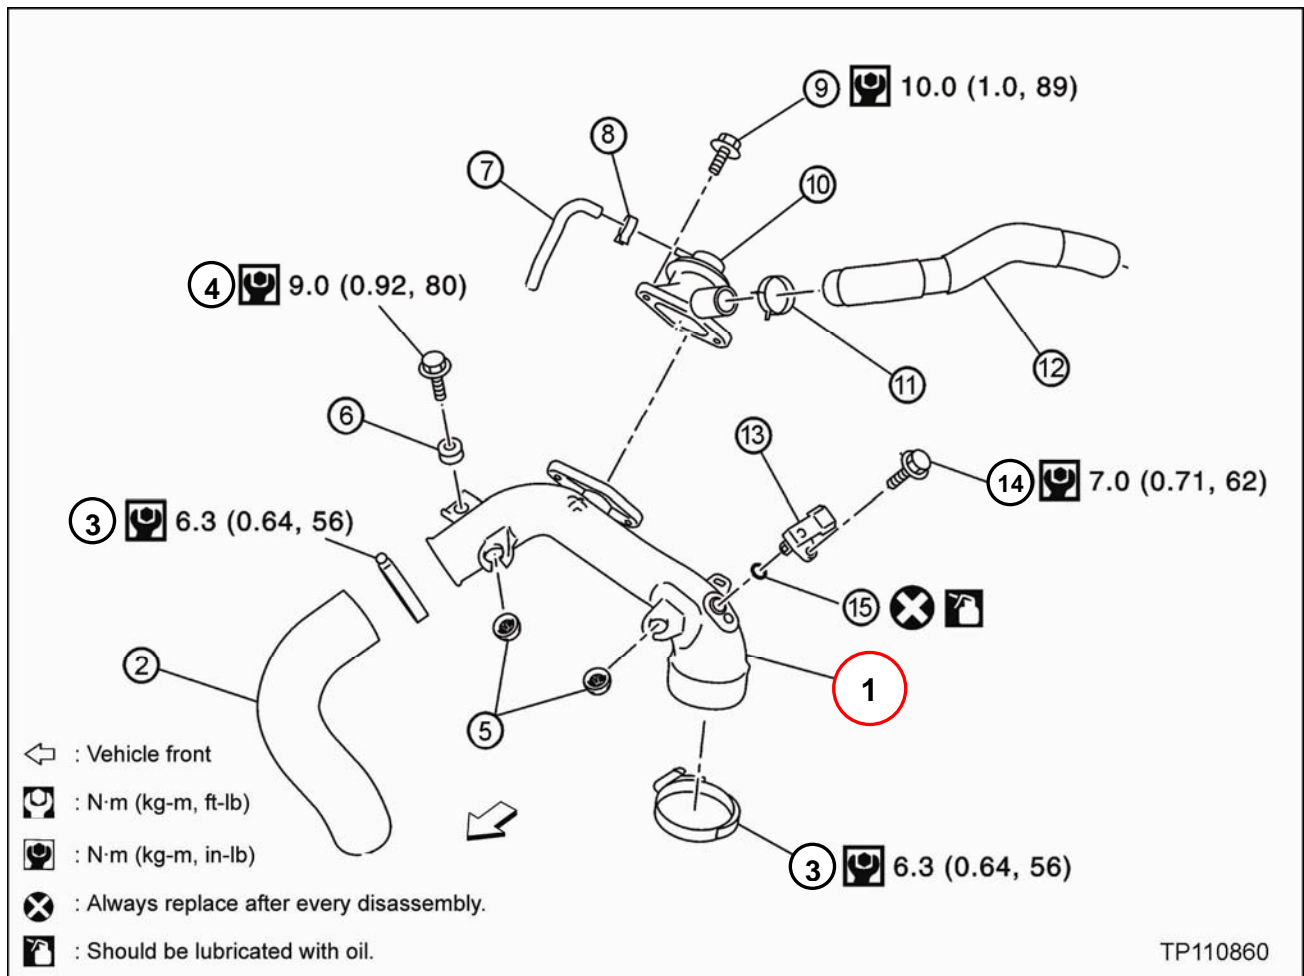
Replace Air Inlet Tube 1 (#1 in Figure 5)

NOTE: Use Figure 5 as a reference while performing steps 1-8 for air inlet tube replacement.

1. Loosen both clamps (#3), one at each end of inlet tube 1.
2. Disconnect the vacuum hose (#7):
 - a. Disengage the clamp (#8).
 - b. Disconnect the vacuum hose (#7).

3. Disconnect the air inlet hose (#12):
 - a. Disengage the clamp (#11).
 - b. Disconnect the air inlet hose (#12).
4. Disconnect the electrical connector from the turbocharger boost sensor (#13).
5. Remove the air inlet tube 1 mounting bolt (# 4).
6. Remove the air inlet tube 1 (#1) and place it on a work bench.

7. Swap the following parts from the old air inlet tube 1 to the new air inlet tube 1:
 - Turbocharger boost sensor (#13)
 - Make sure to use a new O-ring (#15).
 - Make sure to apply a suitable lubricant to the new O-ring.
 - Recirculation valve (#10)
 - Remove two bolts (#9).
 - Make sure to use a new gasket.
 - Make sure to use the correct torque when installing the bolts.
 - Mounting rubber (#5)
 - Grommet (#6)
8. Install the new air inlet tube 1 in reverse order of removing the old air inlet tube 1.
 - Make sure to use the correct torque for bolts and clamps (see Figure 5).
9. Render the old air inlet tube unusable by drilling a hole in the middle of the tube.
