RECALL CAMPAIGN BULLETIN

NTB11-094a

VOLUNTARY SAFETY RECALL CAMPAIGN 2011 370Z POWER WINDOW SWITCH

CAMPAIGN ID #: P1247
NHTSA#: 11V-583
APPLIED VEHICLES: 2011 370Z (Z34)

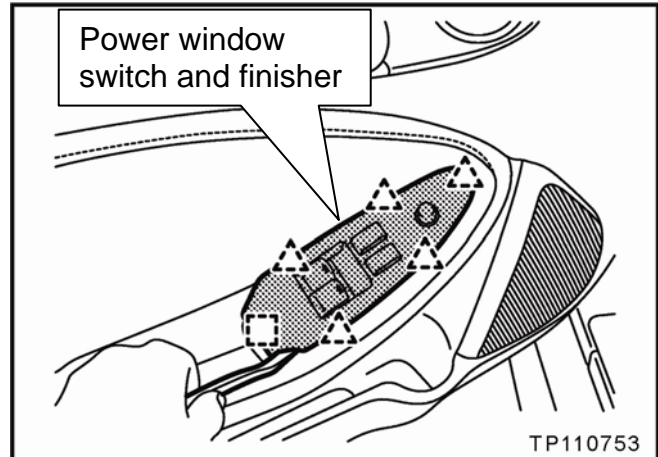
Figure 1

1. Remove (snap loose) the power window switch with finisher from the door panel.

- Use a plastic trim tool.
- Start at the rear of the finisher.

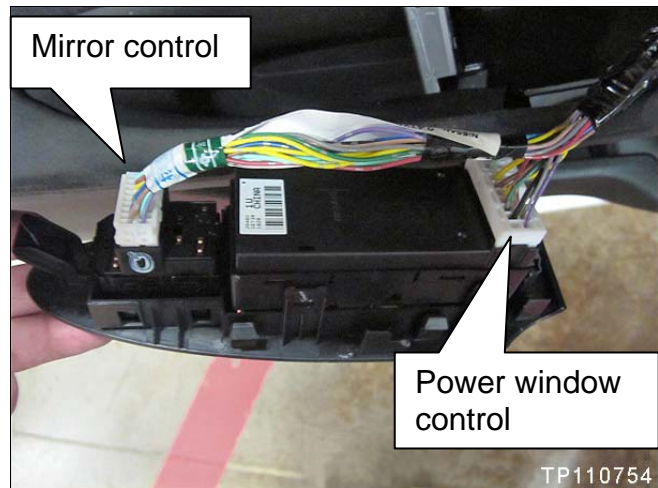
Figure 2

2. Disconnect the harness connectors.

- Mirror control – driver side only.
- Power window control.

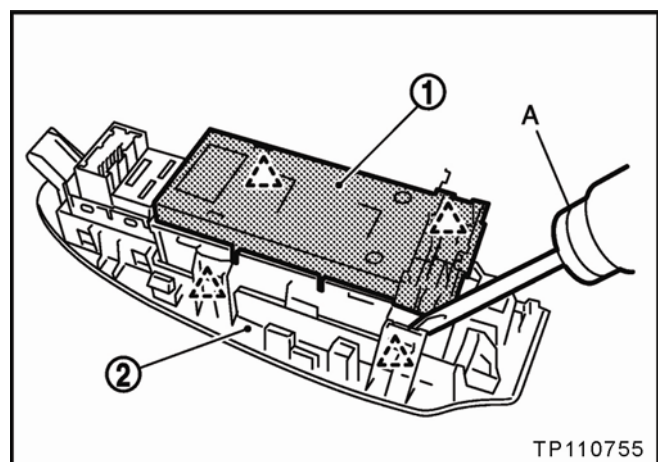
Figure 3

3. Remove the power window switch (1) from the finisher (2).

- Use a small flat blade screwdriver.
- Release the 4 pawls.
