Recall Bulletin

F/CMVSS NONCOMPLIANCE RECALL

SUBJECT: Transmission Shift Cable Not Installed Properly - Inspect Routing

MODELS: 2010-2011 Cadillac SRX

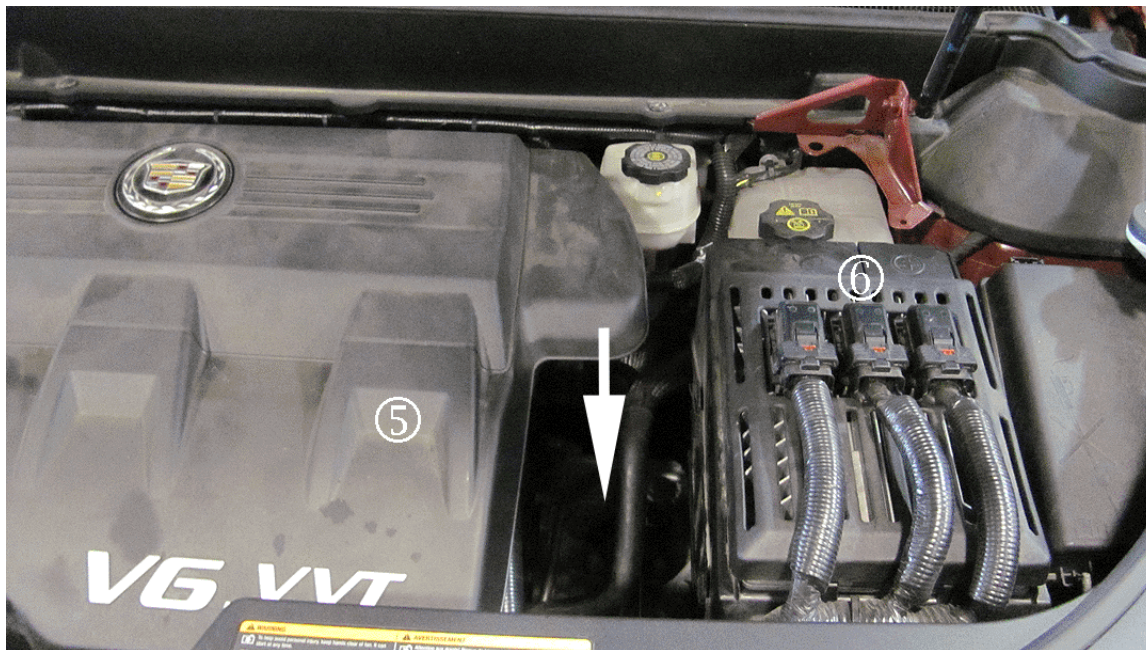
3. Locate the transmission shift cable. The transmission shift cable is located between the intake manifold cover (5) and battery cover/engine control module (ECM) (6). Refer to illustration.
4. Inspect the transmission shift cable.

Note: Removal of the battery tray support is required to inspect or adjust the shift cable if the vehicle is equipped with turbocharger. Refer to *Battery Tray Support Replacement* in SI if the vehicle is equipped with a turbocharger.

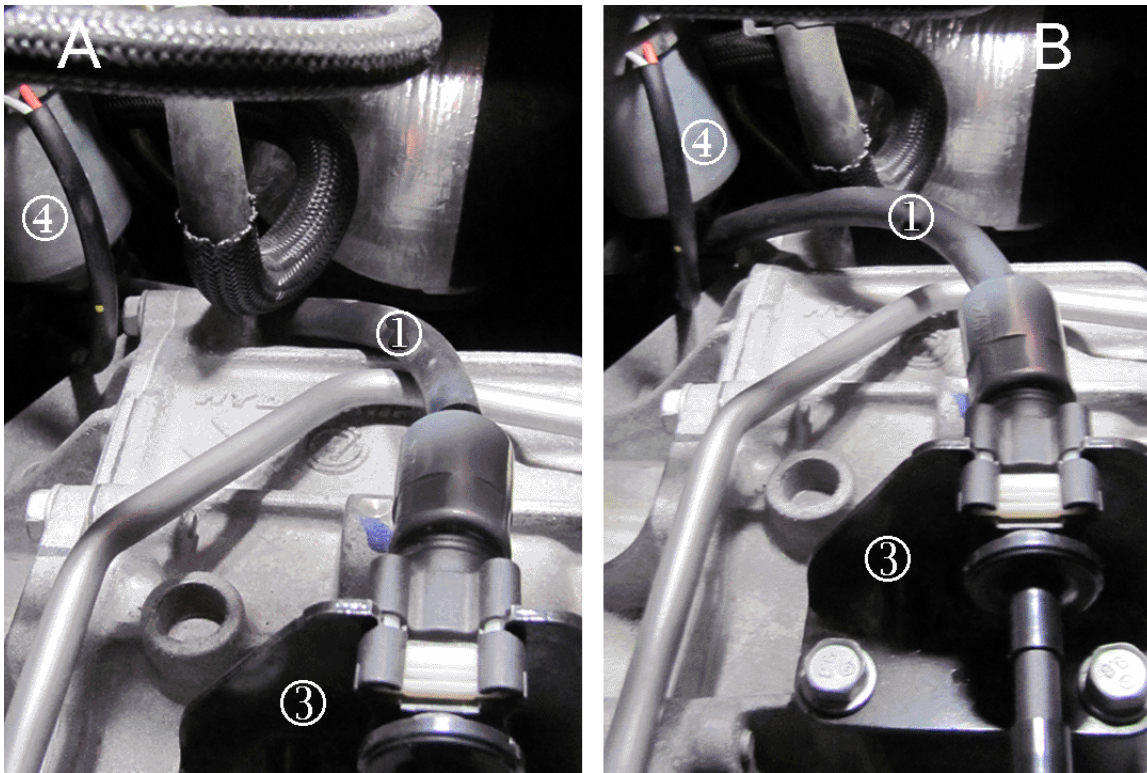
Note: Ensure that the transmission shift cable (1) is routed along the backside of the transmission and away from the power brake booster auxiliary pump (4). Refer to illustration. The “A” portion of the illustration shows a correctly routed transmission shift cable. The “B” portion of the illustration shows an incorrectly routed transmission shift cable.

- 4.1 Ensure the transmission shift cable (1) is routed correctly in the area of the transmission.
- If the transmission shift cable is routed correctly, proceed to step 4.2.
 - If the transmission shift cable is NOT routed correctly, disconnect the transmission shift cable terminal from the manual shift lever pin location and transmission bracket location. Route the cable correctly and re-install the transmission shift cable to the manual shift lever pin and bracket locations.

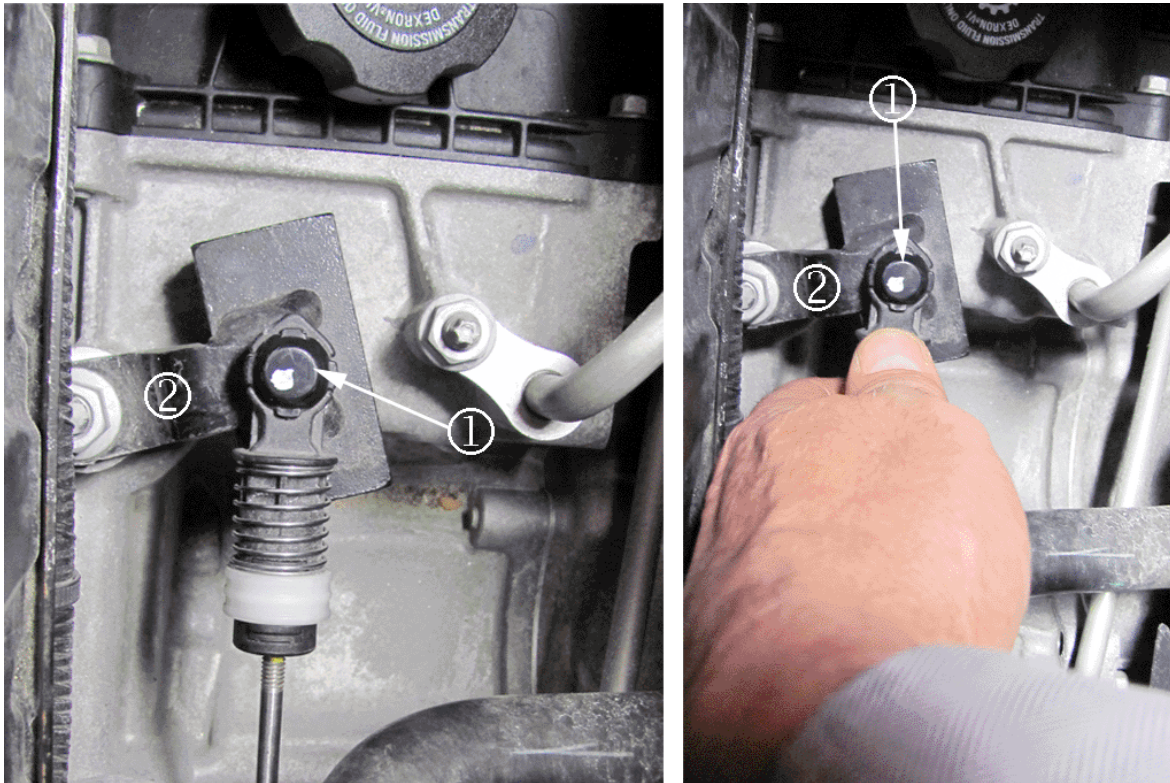
4.2 Ensure that the transmission range selector lever cable terminal (1) is connected to the manual shift lever pin (2). Pull up on the transmission range selector lever cable terminal (1) to determine if the transmission range selector lever cable terminal is connected to the manual shift lever pin (2).

- If the transmission range selector lever cable terminal is connected to the manual shift lever pin, proceed to Step 4.3.
- If the transmission range selector lever cable terminal is NOT connected to the manual shift lever pin, connect the transmission range selector lever cable terminal to the manual shift lever. Proceed to Step 4.3.

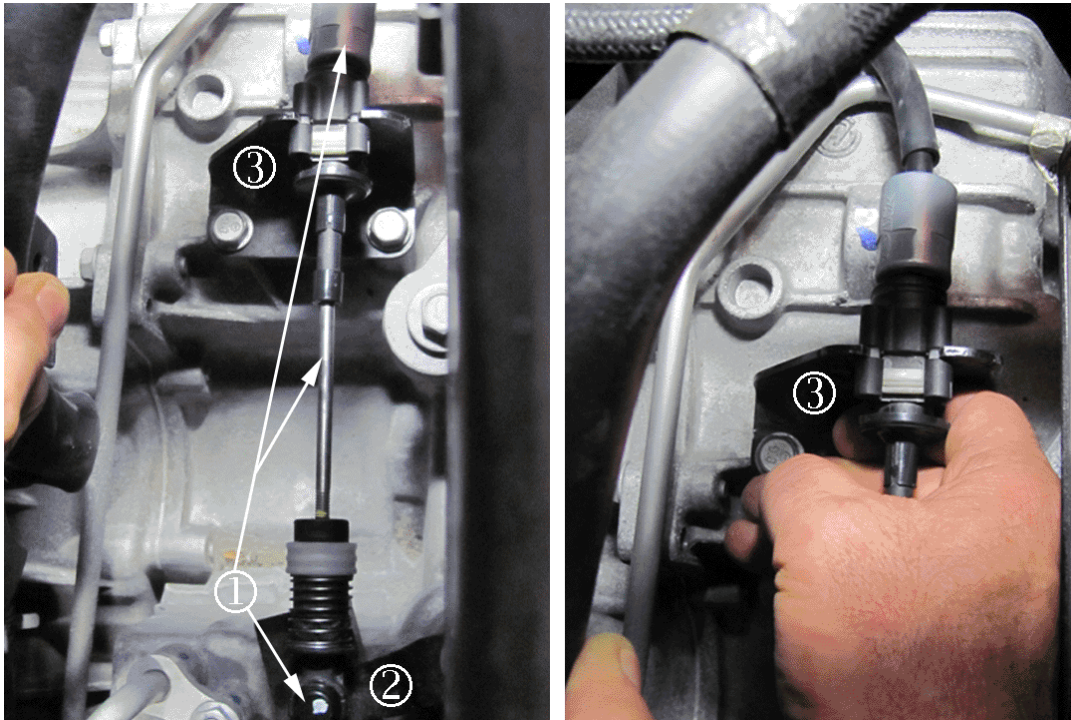
4.3 Ensure that the transmission shift cable (1) is fully seated in the transmission shift cable bracket (3). Pull up on the transmission shift cable (1) at the transmission shift cable bracket (3) location to determine if the transmission shift cable is fully seated in the transmission shift cable bracket.

- If the transmission shift cable is fully seated in the transmission shift cable bracket, proceed to Step 5.
