File In Section: Product Recalls  
Bulletin No.: 11348  
Date: December 2011

# Recall Bulletin

**SUBJECT:** Transmission Shift Cable Not Installed Properly - Inspect Routing

**MODELS:** 2010-2011 Cadillac SRX

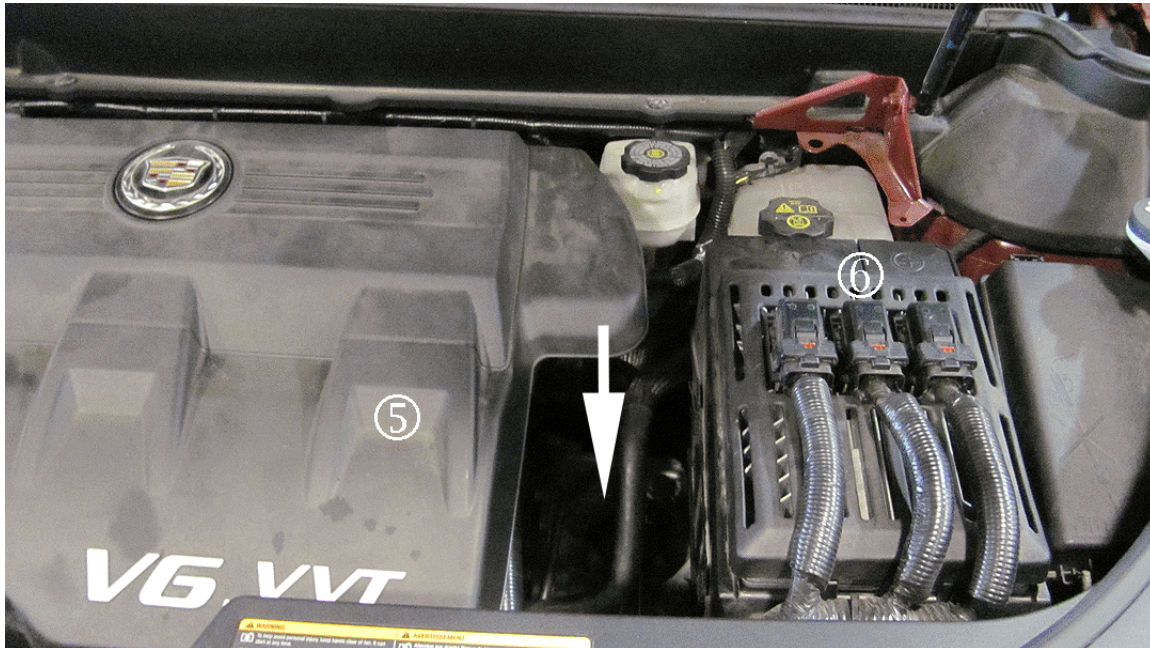
3. Locate the transmission shift cable. The transmission shift cable is located between the intake manifold cover (5) and battery cover/engine control module (ECM) (6). Refer to illustration.
4. Inspect the transmission shift cable.

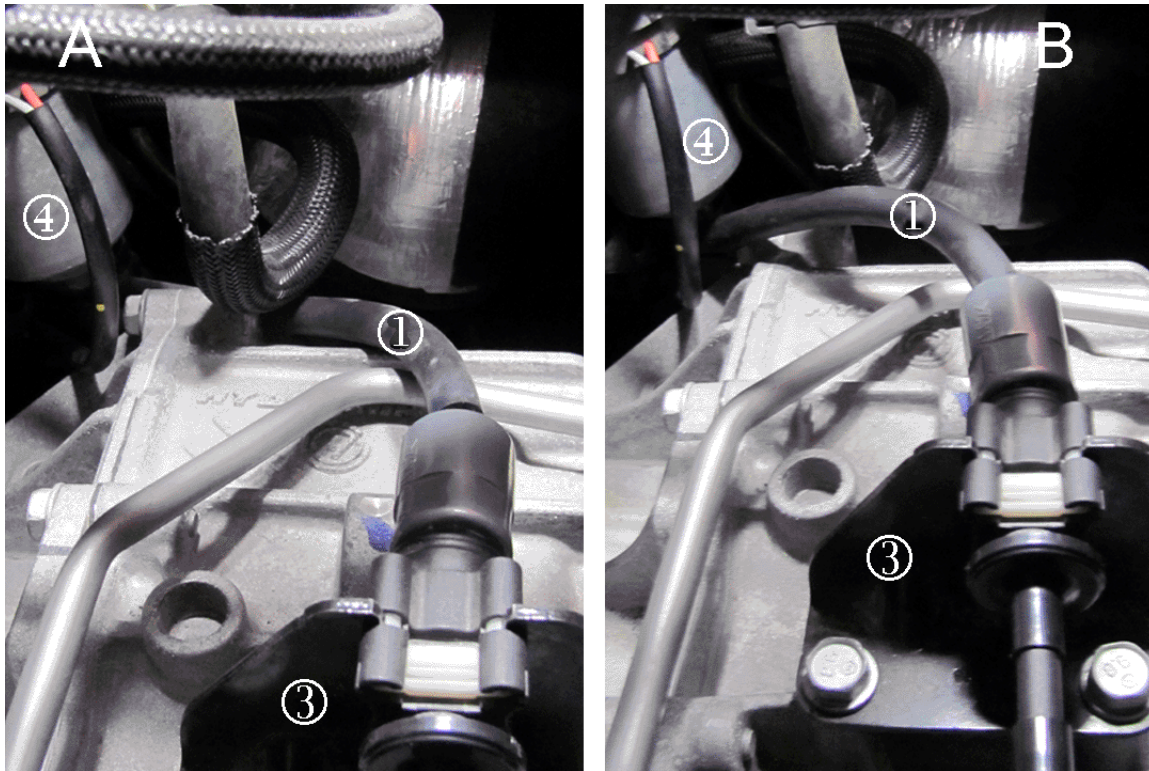
**Note:** Ensure that the transmission shift cable (1) is routed along the backside of the transmission and away from the power brake booster auxiliary pump (4). Refer to illustration. The “A” portion of the illustration shows a correctly routed transmission shift cable. The “B” portion of the illustration shows an incorrectly routed transmission shift cable.

4.1 Ensure the transmission shift cable (1) is routed correctly in the area of the transmission.

- If the transmission shift cable is routed correctly, proceed to step 4.2.
- If the transmission shift cable is NOT routed correctly, disconnect the transmission shift cable terminal from the manual shift lever pin location and transmission bracket location. Route the cable correctly and re-install the transmission shift cable to the manual shift lever pin and bracket locations.
