File In Section: Product Recalls
Bulletin No.: 11348B
Date: January 2012

Recall Bulletin

SUBJECT: Transmission Shift Cable Not Installed Properly - Inspect Routing

MODELS: 2010-2011 Cadillac SRX

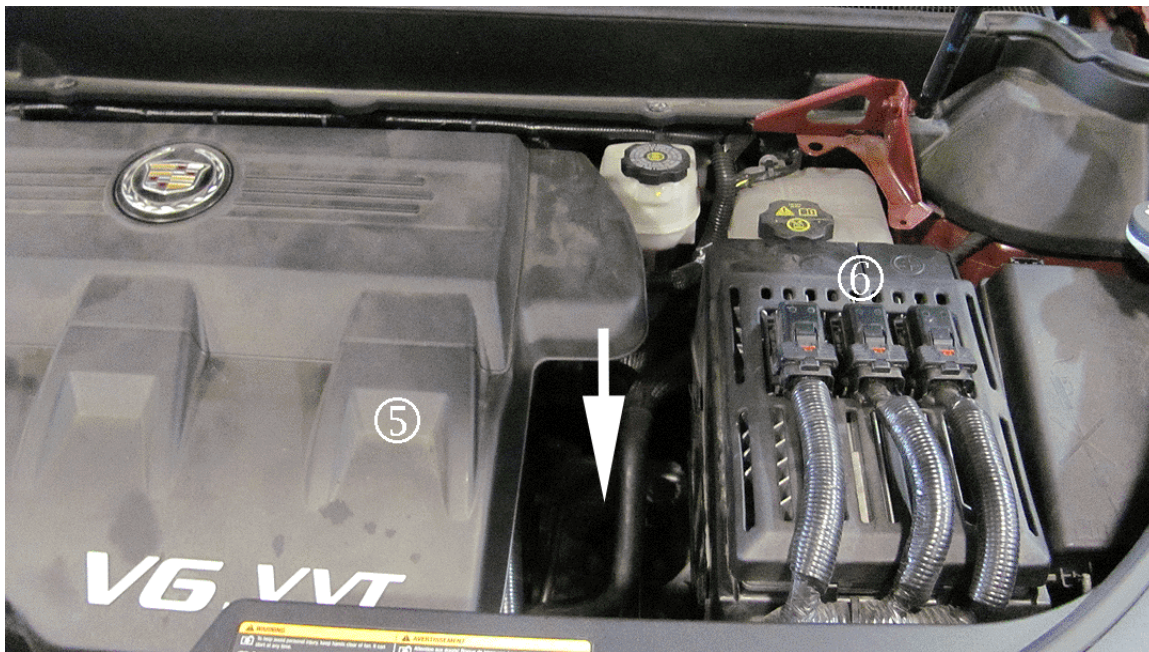
3. Locate the transmission shift cable. The transmission shift cable is located between the intake manifold cover (5) and battery cover/engine control module (ECM) (6). Refer to illustration.
4. Inspect the transmission shift cable.

Note: Removal of the battery tray support is required to inspect or adjust the shift cable if the vehicle is equipped with turbocharger. Refer to *Battery Tray Support Replacement* in SI if the vehicle is equipped with a turbocharger.

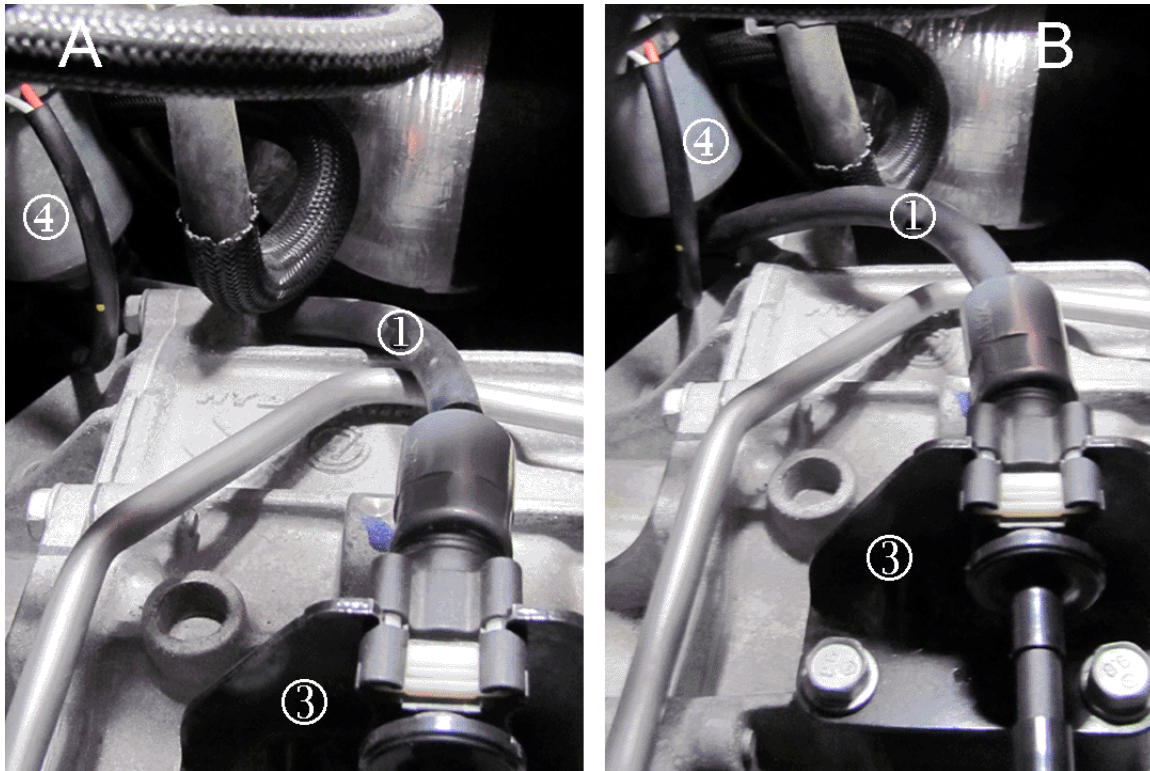
Note: Ensure that the transmission shift cable (1) is routed along the backside of the transmission and away from the power brake booster auxiliary pump (4). Refer to illustration. The “A” portion of the illustration shows a correctly routed transmission shift cable. The “B” portion of the illustration shows an incorrectly routed transmission shift cable.

4.1 Ensure the transmission shift cable (1) is routed correctly in the area of the transmission.

- If the transmission shift cable is routed correctly, proceed to step 4.2.
- If the transmission shift cable is NOT routed correctly, disconnect the transmission shift cable terminal from the manual shift lever pin location and transmission bracket location. Route the cable correctly and re-install the transmission shift cable to the manual shift lever pin and bracket locations.

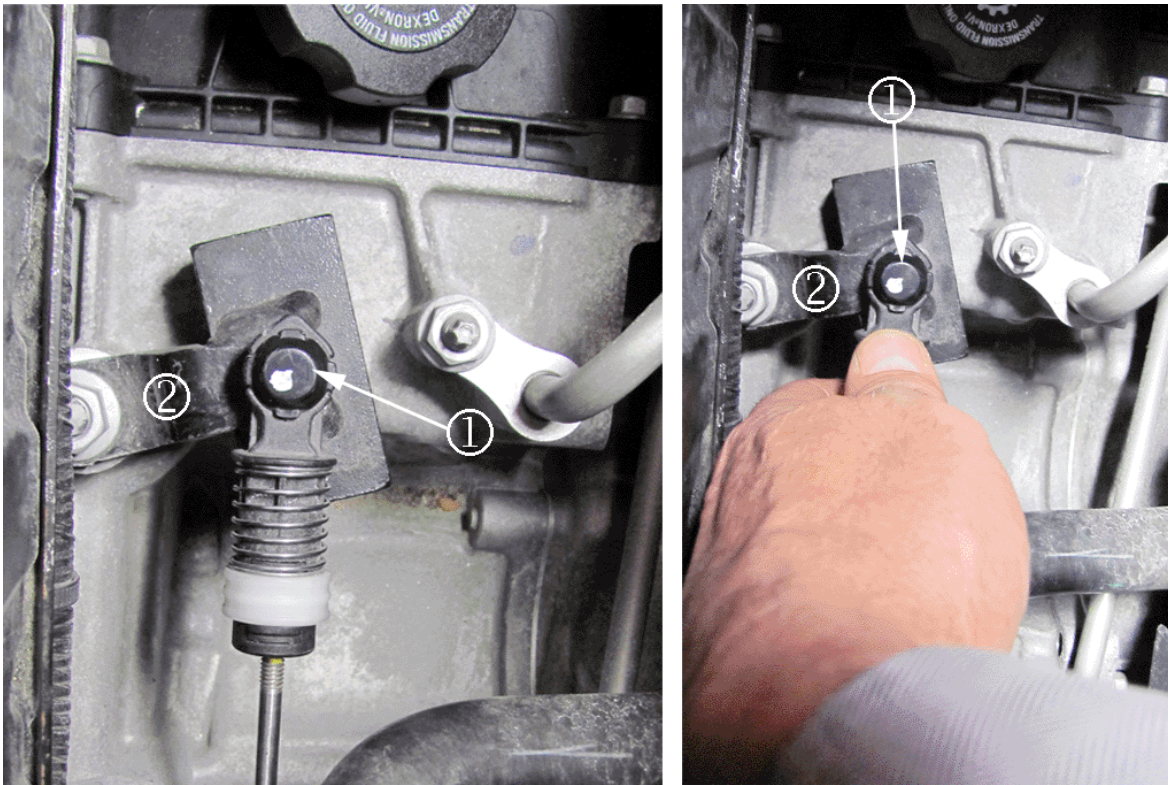
- 4.2 Ensure that the transmission range selector lever cable terminal (1) is connected to the manual shift lever pin (2). Pull up on the transmission range selector lever cable terminal (1) to determine if the transmission range selector lever cable terminal is connected to the manual shift lever pin (2).
- If the transmission range selector lever cable terminal is connected to the manual shift lever pin, proceed to Step 4.3.
 - If the transmission range selector lever cable terminal is NOT connected to the manual shift lever pin, connect the transmission range selector lever cable terminal to the manual shift lever. Proceed to Step 4.3.

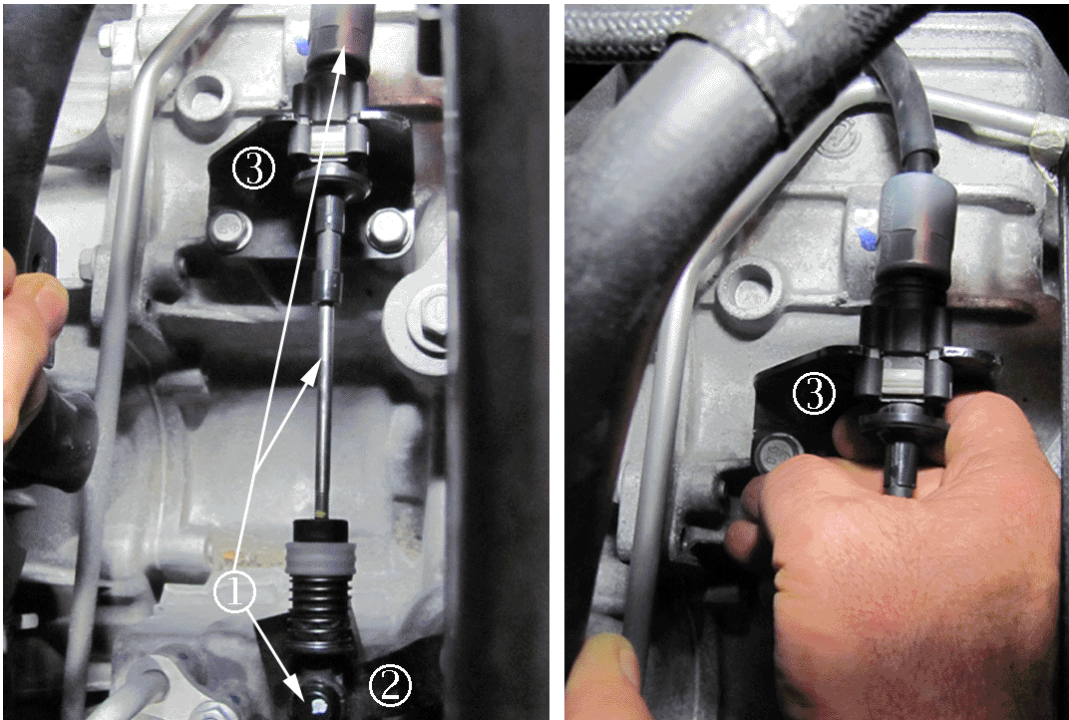
4.3 Ensure that the transmission shift cable (1) is fully seated in the transmission shift cable bracket (3). Pull up on the transmission shift cable (1) at the transmission shift cable bracket (3) location to determine if the transmission shift cable is fully seated in the transmission shift cable bracket.

- If the transmission shift cable is fully seated in the transmission shift cable bracket, proceed to Step 5.
