# Service Bulletin No. 356

<b>MODEL</b> E / J Series Coaches	<b>TYPE</b> Field Change Program	<b>SECTION/GROUP</b> 7 – Electrical	<b>DATE</b>
<b>SUBJECT</b> DOGA WINDSHIELD WIPER MOTOR WIRES			
<b>CONDITIONS</b>

Ref. NHTSA Recall No.: 11V-XXX

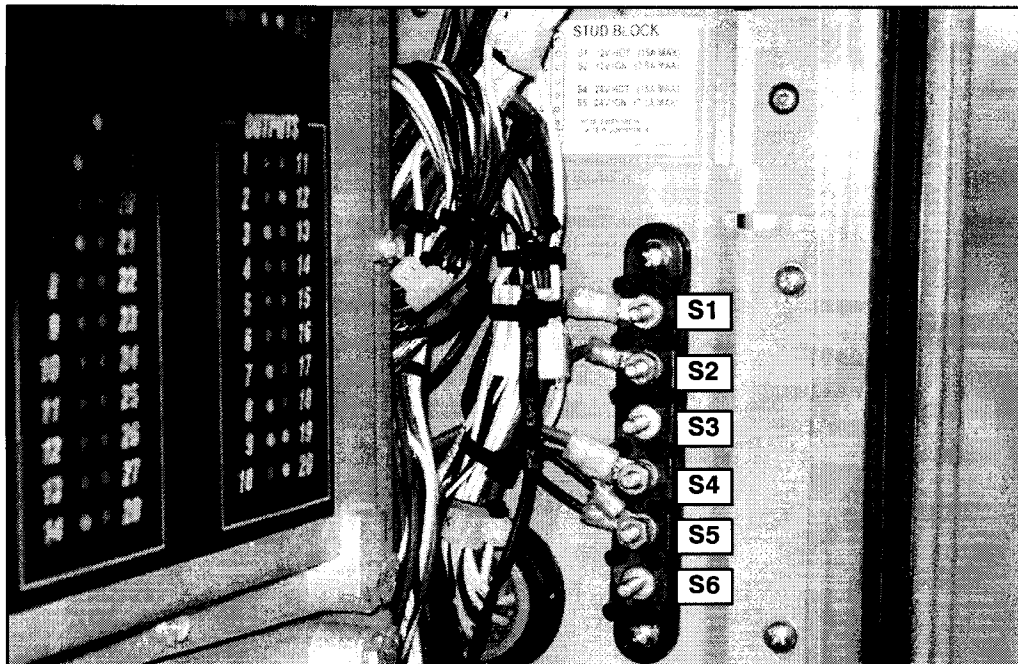
Figure 1.

The wiring connections in the front junction box for the circuit powering the wiper system may be incorrect.

4. Locate the stud block on the compartment wall ( refer to Figure 1 ).
5. Visually inspect to verify that the red wire, 1285A, is connected to stud block S4.
6. Visually inspect to verify that the black wire, 1244A, is connected to stud block S5.

*If the wires are not installed properly, using a nut driver remove the red and black wires and re-connect them per Steps 5. and 6. Close the front service compartment door. Procedure complete.*
