File In Section: Product Recalls
Bulletin No.: 11224
Date: August 2011

PRODUCT SAFETY RECALL

SUBJECT: Power Steering Hose Routed Incorrectly

MODELS: 2012 Chevrolet Impala

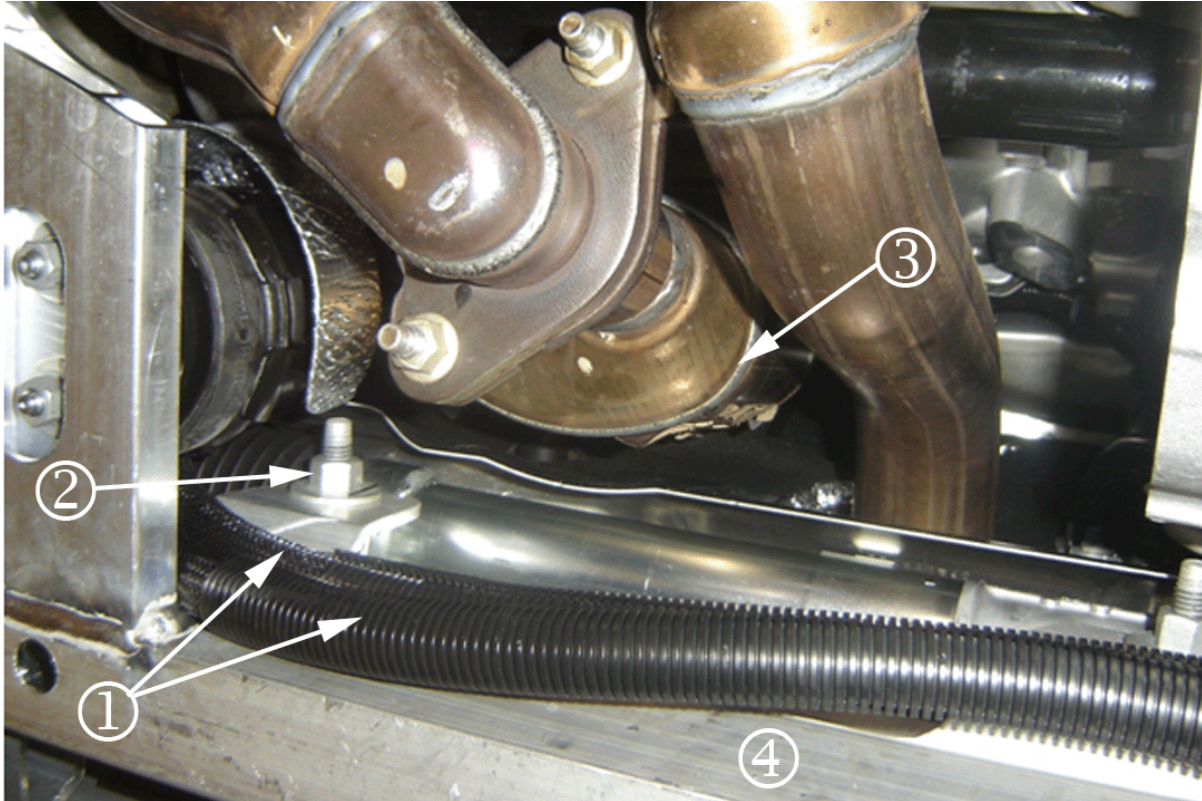
Correctly Routed Power Steering Gear Inlet Pipe/Hoses are Routed Below the Steering Gear Mount Bolt: (1) Power Steering Gear Inlet Pipe/Hose (2) Steering Gear Mount Bolt (3) Catalytic Converter (4) Cradle

- If the power steering gear inlet pipe/hoses are routed correctly, proceed to *Protective Sleeve Installation* in this bulletin.

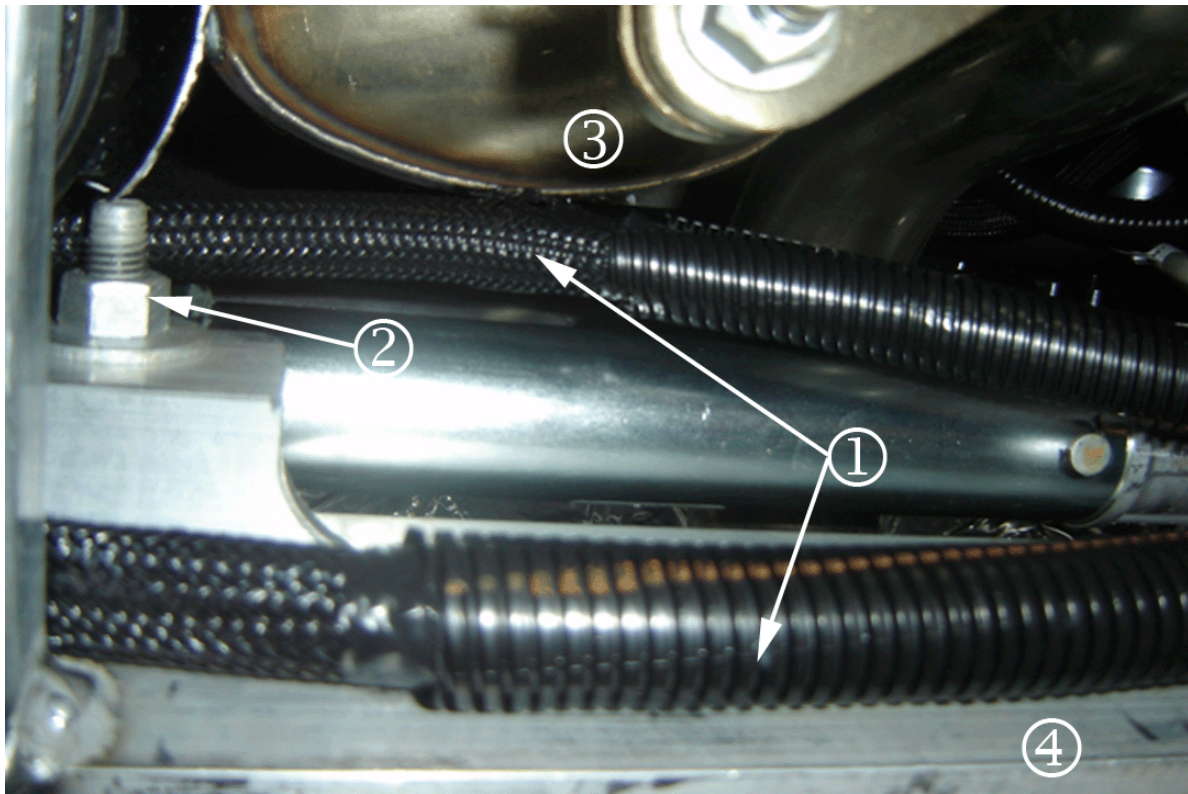
2696265

Incorrectly Routed Power Steering Gear Inlet Pipe/Hoses are Routed Above the Steering Gear Mount Bolt: (1) Power Steering Gear Inlet Pipe/Hose (2) Steering Gear Mount Bolt (3) Catalytic Converter (4) Cradle

Note: Incorrectly routed power steering gear inlet pipe/hoses include one or both hoses routed above the steering gear bolt. The hoses may contact the steering gear bolt and/or the catalytic converter. **REPLACE** the power steering gear inlet pipe/hoses if the hoses are incorrectly routed.

- If the power steering gear inlet pipe/hoses are NOT routed correctly, remove and replace the power steering gear inlet/pipe hoses. Refer to *Power Steering Gear Inlet Pipe/Hose Replacement* in SI. After installing the power steering gear inlet pipe/hoses, ensure that the hoses are routed below the steering gear mount bolt. Refer to *Correctly Routed Power Steering Gear Inlet Pipe/Hose* illustration. Proceed to *Protective Sleeve Installation* in this bulletin after installing the power steering gear inlet pipe/hoses.
