This Service Information bulletin supersedes SI B63 06 11 dated **December 2011**.

**Recall Campaign 11V-438: Repair Ground Cable for Rear Light Lamps (Side Panel)**

E46/4 (3 Series Sedan) produced from **NEW** 9/1/01 to 02/01/05

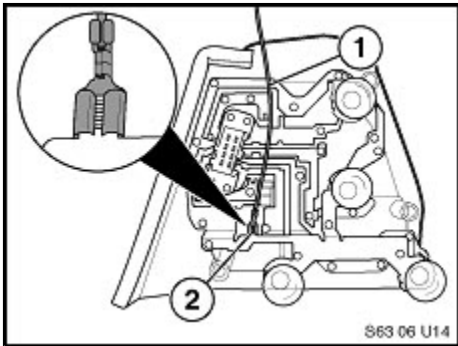
**If both rear lamp assemblies already have an additional ground cable (1) on the bulb holder (2) (see diagram – bulb holder is removed), no further repair is necessary.**

1. **NEW** Check the operation and function of all the lamps (park light, turn signal, and brake light) for both rear lamp assemblies.

If additional ground cables are **not** present on both sides, proceed to the next step.

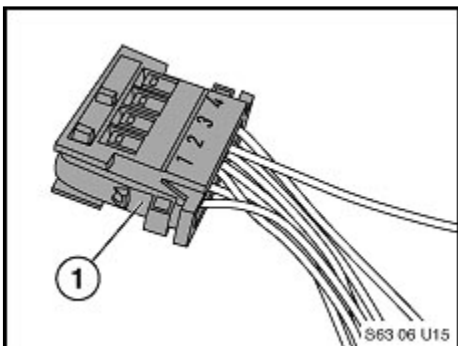
If the lights within either tail lamp assembly **are not** functioning:

Repair the thermal damage caused by poor connection at the 8-pin connector, only for the defective side(s).

Remove the socket housing (1) (X338 and/or X339): Refer to ISTA (Integrated Service Technical Application) Repair Instructions **REP 63 21 055** "Replace the socket housing for the left-hand or right-hand rear light (side panel)".

Make note of the pin assignments and wire colors. Remove the harness tape about 150 mm from the 8-pin connector. Cut the cables off directly flush with the 8-pin connector. Replace the socket housing and all the connector terminals only for the defective side. Proceed to the next step, # 3.
