AMERICAN SUZUKI MOTOR CORPORATION

February 2, 2012

Affected vehicles are 2012 model year Suzuki AN400, AN650, and DL650 motorcycles produced prior to December 17, 2011.

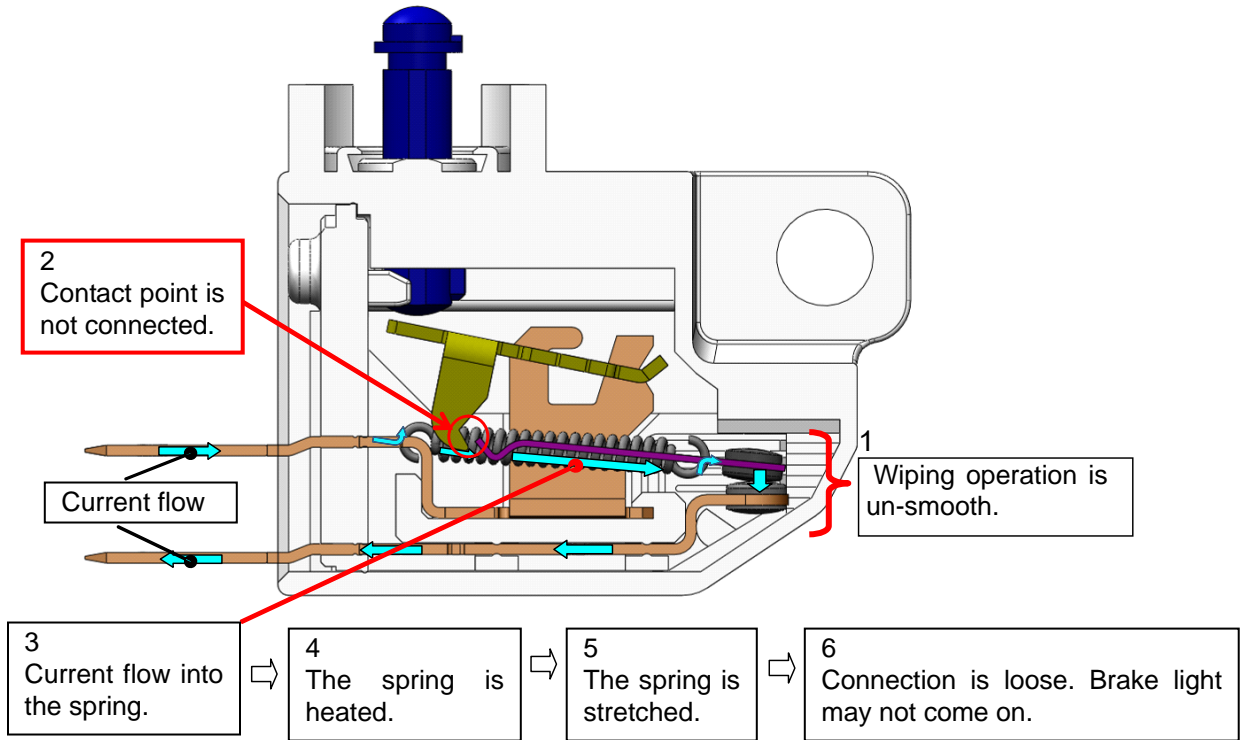
For affected models, when the wiping action of the brake light switch is slow, light welding caused by tiny electrical arcs creates surface roughness of the contacts, resulting in un-smooth wiping movement (1). The un-smooth wiping movement can cause momentary separation of a contact point (2) along the normal path of current flow, which can allow current to take an alternate flow path through the spring (3) that controls the connection point of the contacts. After continued use, heat generated from current flow through the spring (4) can cause the spring to become stretched (5), resulting in failure of the brake light to illuminate, due to a loose connection (6) at the point of contact. In the case of AN400 and AN650 models, failure of both switches can also cause the motorcycle to be unable to be restarted.

Current flow (Abnormal condition)

ASMC and Montgomery Motors, Inc. will conduct a safety-related recall campaign to replace the brake light actuating switch(es) on affected vehicles with an improved part that has a modified inner structure and an insulated connection point for the spring hook.

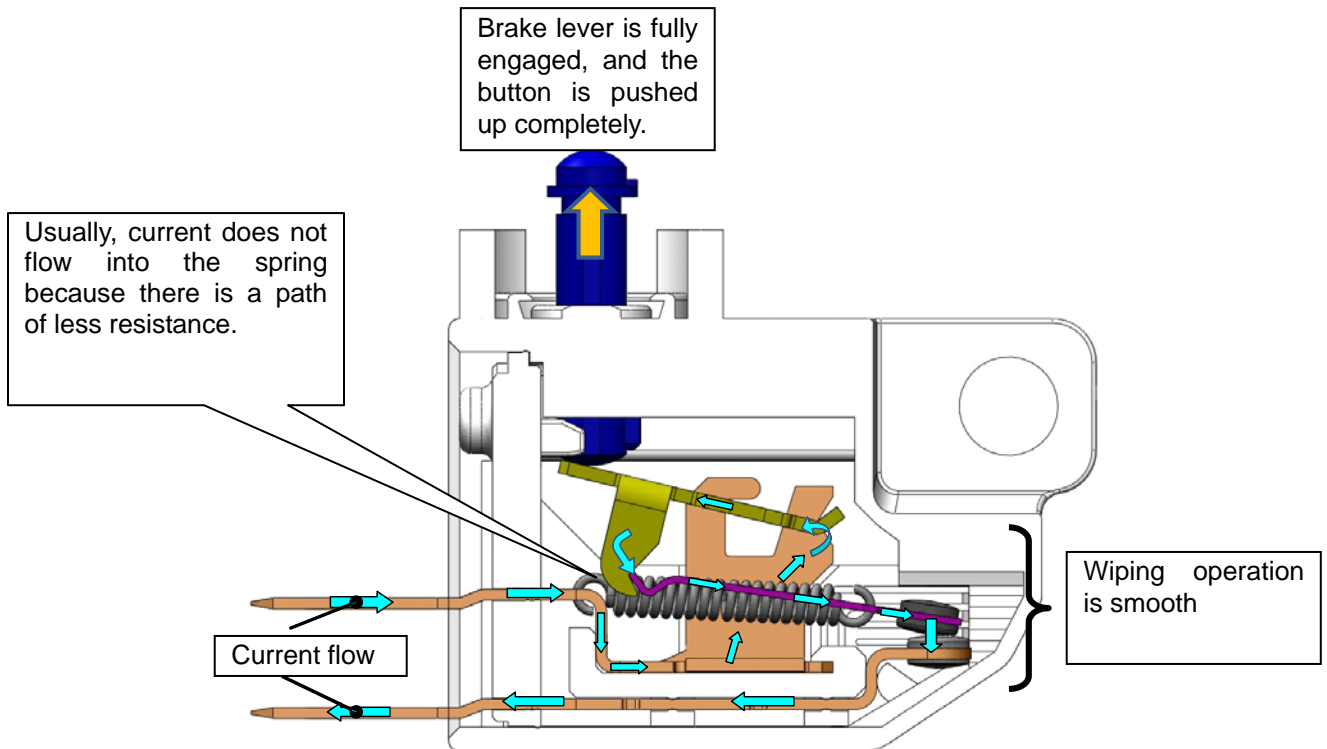
lever is operated to vary braking force, the surface of the movable contact is wiped along the surface of the fixed contact, maintaining an electrical connection and allowing the brake light to remain illuminated.

Current flow (Normal condition)
