12V-047  
(4 Pages)

February 9, 2012  
Ref. No.: GR12-009

**RE: Part 573 Defect Information Report –Side Curtain Air Bag Inflator on certain 2012 Subaru Legacy and Outback Vehicles**

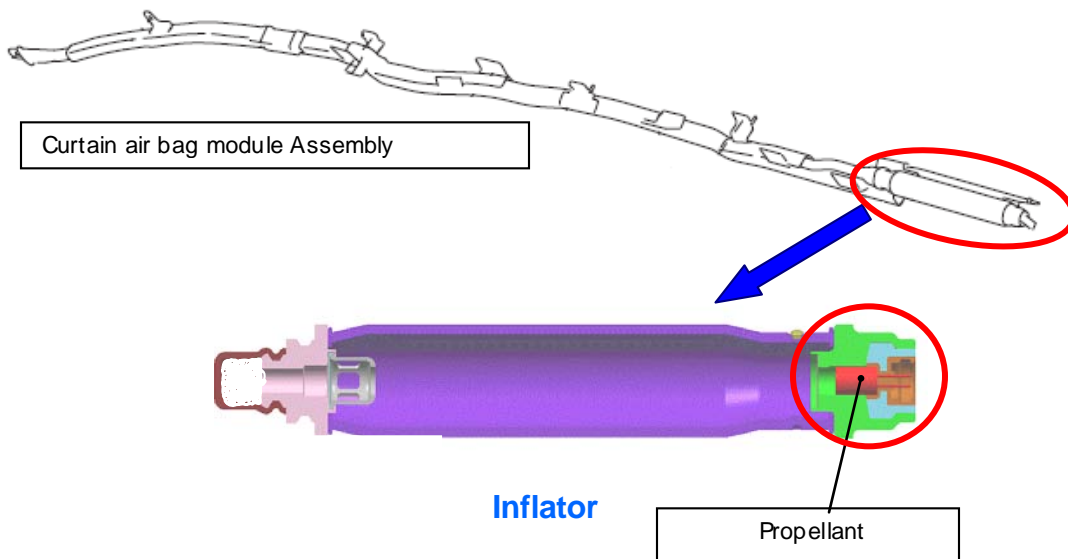
For those side curtain air bags with the defect, an incorrect propellant mixture for the initiator component was used, resulting in insufficient output of compressed gas. In this condition, the side curtain air bags will attempt to deploy; however they may not inflate, and therefore, fail to provide the intended protection.

(i) The remedy plan calls for dealers to replace one or both side curtain air bag module(s) with a new one.
