12V-256

June 1, 2012

**Re: Recall Notification**  
**2012 Model Year Honda Civic**  
**Left (driver's side) Driveshaft**

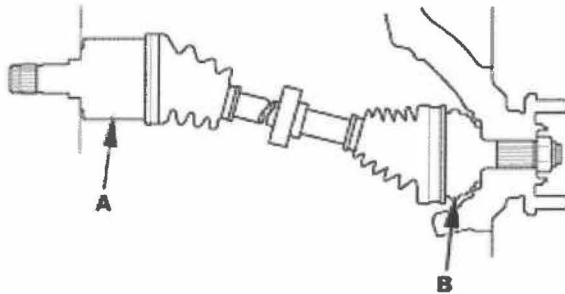
As shown in the illustration shown below, the complete driveshaft assemblies for 2012 Honda Civic vehicles consist of an inboard constant velocity (CV) joint (A below) connected to a driveshaft, connected to an outboard CV joint (B below), which is inserted into the wheel hub.

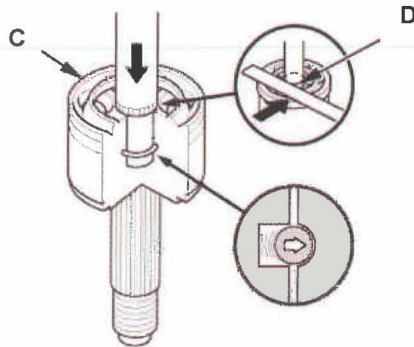
The driveshaft is attached to the outboard CV joint by inserting the driveshaft into the outboard CV joint (C below) to a specified depth (D below) where it is held in place by a retaining clip (circlip) when fully inserted. The insertion process is performed by a machine that applies a specified force to the driveshaft to assure proper insertion and retention in the CV joint.

During assembly of the affected driveshafts, the push stroke required to fully seat the driveshaft into the joint and set the retaining clip was not completed. After the assembly machine experienced a push stroke failure, operator-initiated procedures to disassemble the driveshaft from the CV joint were not consistently performed. Consequently, the retaining ring may not be engaged, and the driveshaft may separate from the outboard joint. If the driveshaft separates from the outboard joint, the engine will no longer propel the vehicle in any gear, and the vehicle may roll away if the parking brake has not been set when the gear selector has been placed in the Park position, increasing the risk of a crash or personal injury.

The owners of affected vehicles will be contacted by mail and asked to take their vehicle to a Honda automobile dealer. The dealer will inspect the driver's side driveshaft and, if necessary, replace the driveshaft, free of charge.
