Subject: Recall Campaign SR12-26
Power Cable Rubbing Protection
Some X3-45 coaches, XLII Entertainer Bus Shells and X3-45 VIP Bus Shells
Model Years 2011 up to 2013
Defect Report – revised July 20th 2012

Defect Report

Recall Campaign Number Prevost SR12-26
Subject: Power Cable Rubbing Protection

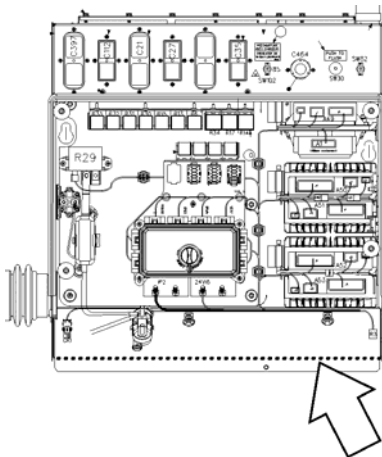
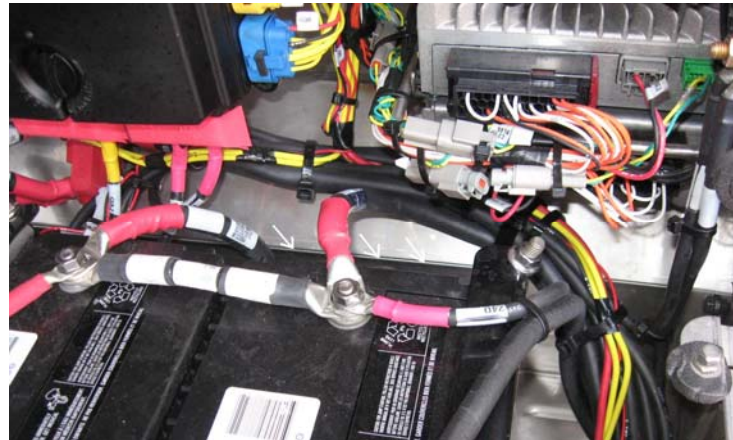
- **Description:** The vehicles involved in this recall need to have their rear electrical compartment's power cables inspected.
- **Cause of the defective condition:** Power Cables might be rubbing against the rear electrical compartment's panel lower edge (part number 068124).
- **Consequence:** possibility of short-circuit, or fire due to wear of power cables.
- **Warning that can precede:** May be noticed at routine inspection.

Location of the Rear electrical compartment's panel lower edge (see arrows) at risk of rubbing against power cables

Recalled vehicles might have their power cables rubbing against the rear electrical compartment's panel lower edge. The remedy will route cables away from this sharp edge, if needed.

Prevost has voluntarily decided that all suspected vehicles shall have their power cables (located in the rear electrical compartment) inspected, and repaired if needed, free of charge.
