NISSAN

12V-494
(4 pages)

DEFECT INFORMATION REPORT

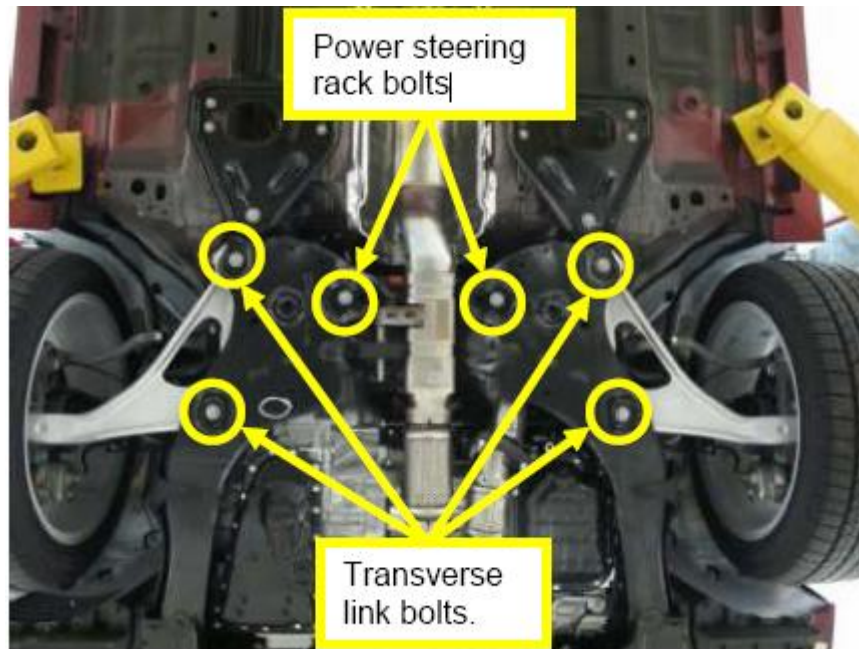
Some of the subject vehicles may have been manufactured with four (4) transverse link bolts and two (2) power steering rack bolts that were not torqued to the proper specification (see Figure 1).

Figure 1 – Bolt locations

On some of the affected vehicles, a multispindle tool that installs and torques the transverse link bolts and power steering rack bolts may not have torqued them to the proper specification during the assembly process. This condition could cause the bolts to become loose while the vehicle is being driven. A rattling noise and vibration would give the driver notice that one of the bolts may be loose. If the driver continues to drive the vehicle in this condition, the bolts may fall out completely and, in that extreme case, the driver may experience difficulty controlling the direction of the vehicle.

Owners of all potentially affected vehicles will be notified to take their vehicle to a Nissan dealer. The dealers will inspect and retighten the transverse link bolts and power steering rack bolts to the proper torque specification. If the dealer determines that any of the transverse link bolts and power steering rack bolts do not meet the proper torque specification, the loose bolts will be replaced and tightened to the proper torque specification.
