12V-555  
(9 pages)  
Amended

**PART 573 Defect and Noncompliance Report**

**On August 9, 2012, Hino Motors Sales U.S.A., Inc. decided that (a defect which relates to motor vehicle safety) exists in the motor vehicles listed below, and is furnishing notification to the National Highway Traffic Safety Administration in accordance with 49 CFR Part 573 Defect and Noncompliance Reports.**

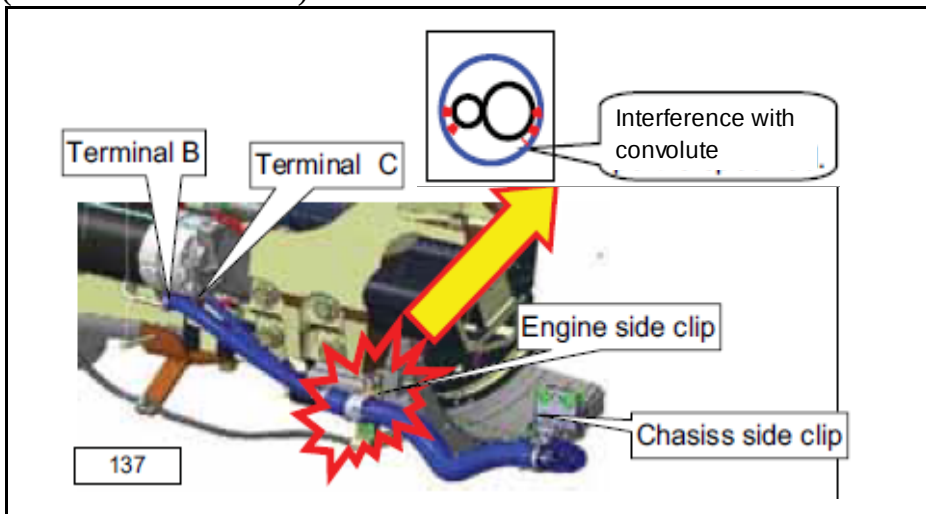
The main B+ (Battery Positive) circuit from the battery to the starter could potentially short to ground due to wear that accumulates over time. The wear is the result of interference between the B+ circuit and the convoluted tubing.

The wear is the result of interference between the B+ and the convoluted tubing.

Potential short to ground, which could potentially lead to a fire.

Visual inspection may indicate wear if signs of corrosion are present. The area where the wear occurs may smell of electrical overload or smoke.

The cable design has been modified to prevent this defect. (See illustration)

LH drawing depicts the recall condition. RH drawing depicts the remedied condition. Manufacturer will replace the original cables with newly designed cables in which each cable is enclosed in its own separate convolute tube.

The original component contained two separate wires within a single convoluted tube.

The remedy component contains two separate wires within two separate pieces of convoluted tube.
