Inspection, Repair and/or Replace Procedure Front ReadyMount™ Assembly

Ride Control, LLC has identified a defect that may affect the operation or safety of your vehicle. This defect may exist in two Gabriel® branded ReadyMount™ Assembly part numbers and two Parts Master branded Ready Mount Assembly part numbers. Therefore, Ride Control is voluntarily recalling the affected part numbers as described below. This notice is issued in accordance with National Highway and Transportation Safety Administration requirements.

Under certain assembly conditions, the strut rod may become detached from the upper mount assembly. This could potentially cause damage to vehicle, surroundings, and/or handling issues.

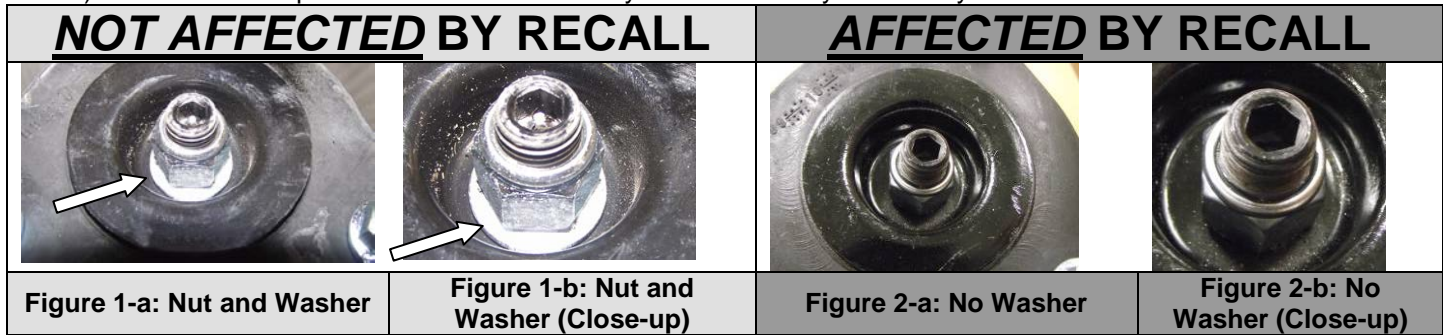
- 3) If a nut and washer is present as shown in Figure 1-a and 1-b, then the ReadyMount Assembly is not affected by this Recall.
- 4) If only a nut is present (no washer) as shown in Figure 2-a and 2-b, then the ReadyMount Assembly is affected by this Recall. Please continue below for instructions on how to determine repair procedure.
- 5) Please contact Gabriel Technical Services toll free at 1-800-999-3903 to receive repair kit consisting of one new flange nut per ReadyMount Assembly (as shown below). Maximum of 2 per vehicle. Repair kit with flanged nut will be overnight expressed.
