******* IMPORTANT VEHICLE RECALL NOTICE *******

RE: Volvo Recall 250
Certain Model Year 2012 S60, XC60, S80 and XC70 Vehicles

<h1 style="margin: 0;">VOLVO</h1> <h2 style="margin: 0;">Service Manager Bulletin</h2>				TITLE:		GROUP:	NO:
				Recall 250: Front Seat Wiring Inspection		85	250
				Model Year 2012 S60, XC60, S80, XC70		ISSUING DEPARTMENT:	
						Warranty	
				REFERENCE BULLETINS:		DATE:	
				TJ 26012, PB 85-250		YEAR	MONTH
Service Person- nel: read and initial.	SERVICE MANAGER	SERVICE WRITER	WARRANTY ADMINISTRATOR	2012		03	08
				Page 1 of 3

Volvo Car Customer Service	
	TJ Instruction
	No 26012
	Date March 2012 Issue 01
Title	Recall 250 Front Seat Wiring Inspection

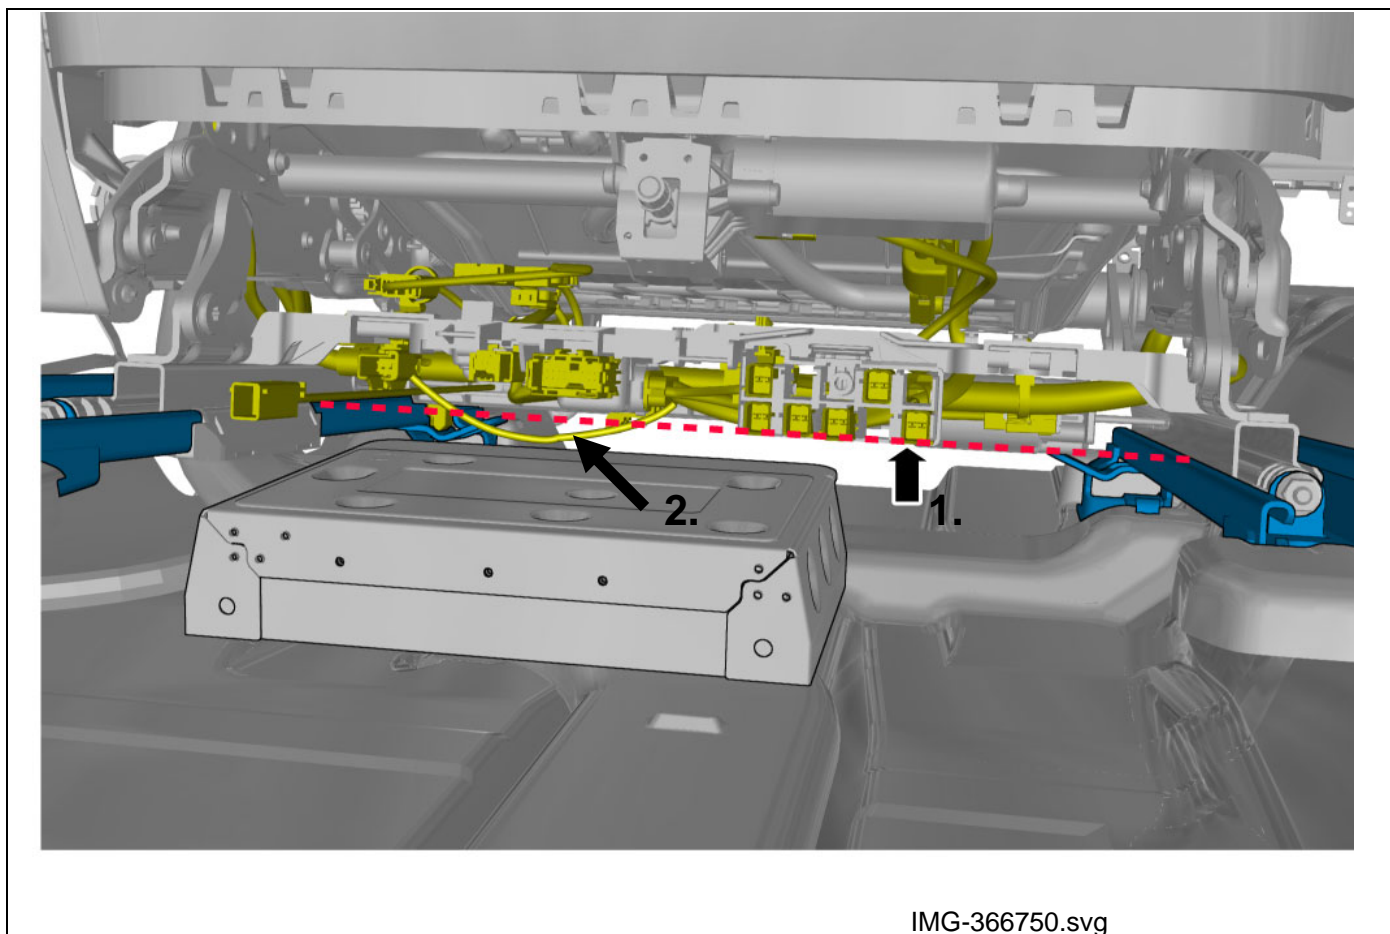
Inspection (facing rearward)

No wiring harness is to hang down below the dotted line (Arrow 1) with the exception of the wiring harness for the seat heater (Black Tube). The seat heater harness may hang down on some vehicles (Arrow 2), however the distance between the seat heater harness and the amplifier must be 5 mm (1/4") or more.

Note: Only the seat wiring harness is shown in the above illustration. The additional wiring harnesses from the vehicles main harness are not shown.

Only if the inspection identifies an issue, please remedy per the repair instructions.
