******* IMPORTANT VEHICLE RECALL NOTICE *******

RE: Volvo Recall 251
Certain Model Year 2012 S60 and XC60 Vehicles

VOLVO				TITLE:		GROUP:	NO:	
				Recall 251: Inspect Fuel Lines for Contact with Underbody Coating		80	251	
Service Manager Bulletin						Model Year 2012 S60, XC60		ISSUING DEPARTMENT:
				Warranty				
Service Personnel: read and initial.				REFERENCE BULLETINS: TJ 26058, PB 80-251		CARMARKET:		
						United States, Canada		
SERVICE MANAGER		SERVICE WRITER		WARRANTY ADMINISTRATOR		DATE:		
						YEAR	MONTH	DAY
						2012	05	08
						Page 1 of 3

Title Recall 251 Inspect Fuel lines for Contact with Underbody coating

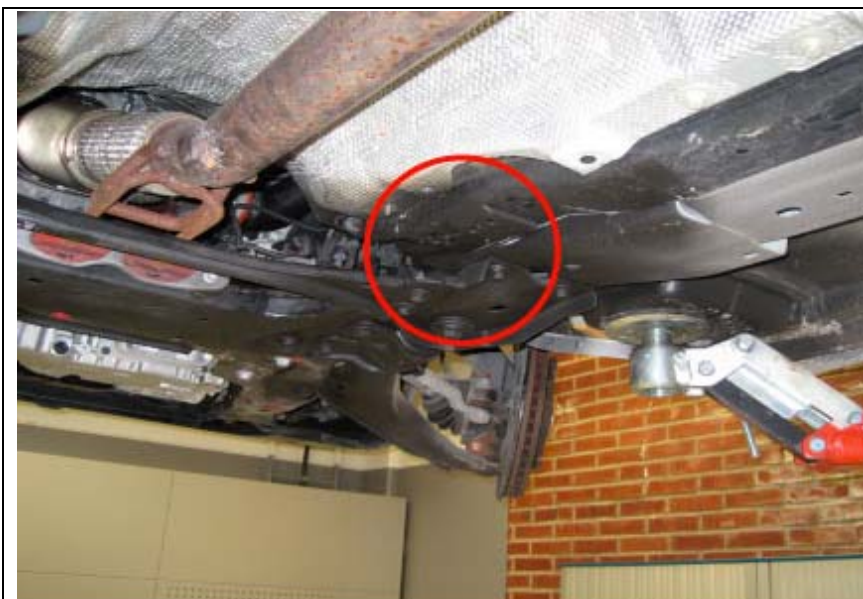
2.

Location of conflict area under fuel rail.

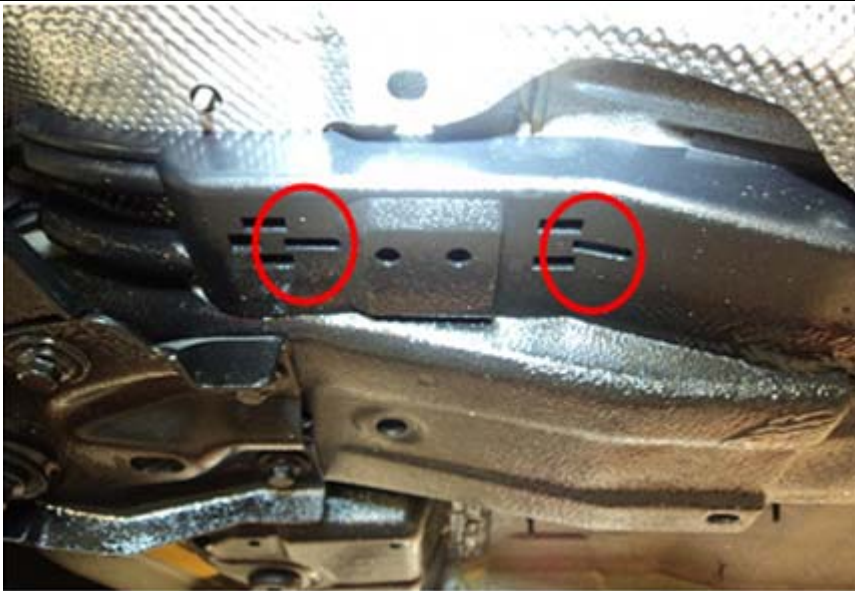
3.

Location of the two yellow clips in fuel rail.

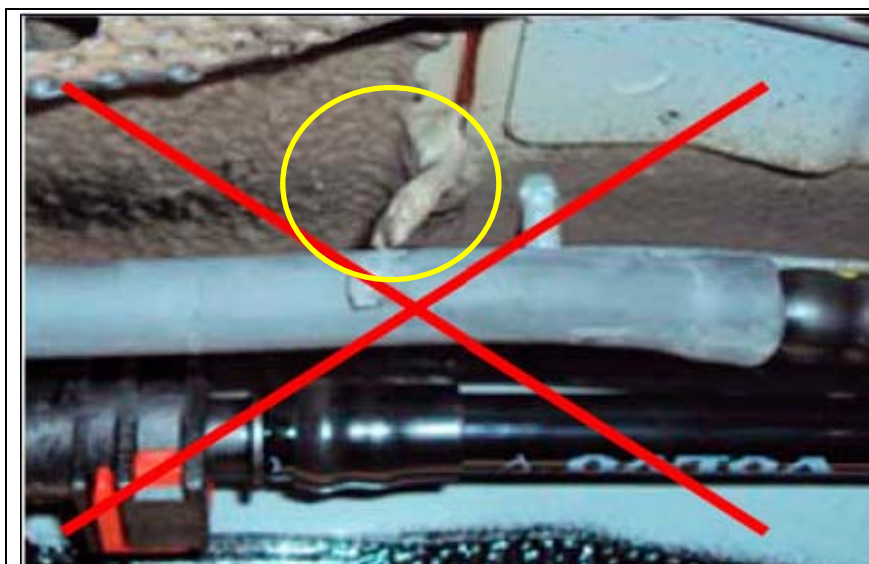
Check for excess body coating.
If the fuel pipes are in conflict with the stalactites, the fuel rail has to be replaced.

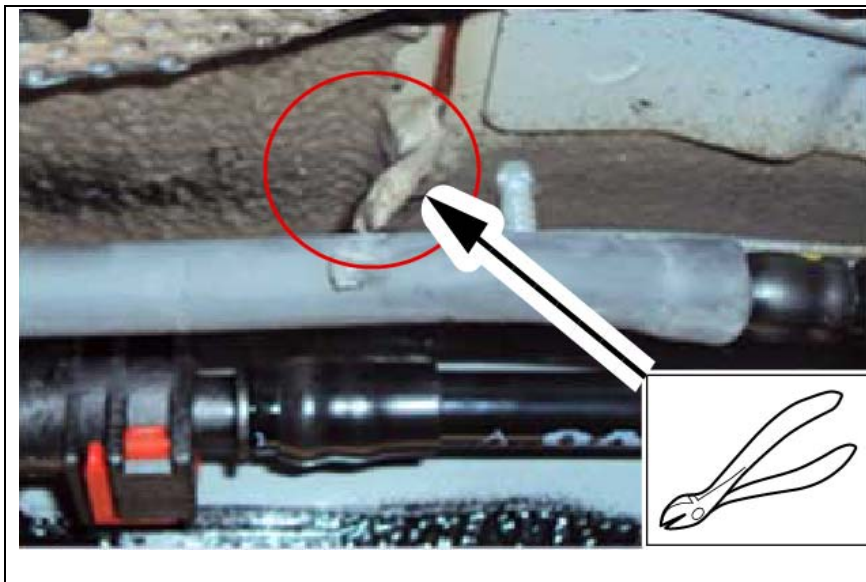
Not OK

Cut away any contact with fuel rail.
