<b>Title</b>	Recall 251 Inspect Fuel Lines for Contact with Underbody Coating	<b>Status</b>	Released
<b>Ref No</b>	US26058.1.2 en-GB	<b>Status Date</b>	2012-05-08
<b>Issuer</b>	-	<b>Issue Date</b>	2012-05-08
<b>Partner</b>	3 US 7510 Volvo Cars North America	<b>Reference</b>	VIDA
<b>Func Group</b>	8000		
<b>Func Desc</b>	body, cab and interior

TJ No26058

Recall 251 Inspect Fuel lines for Contact with Underbody coating

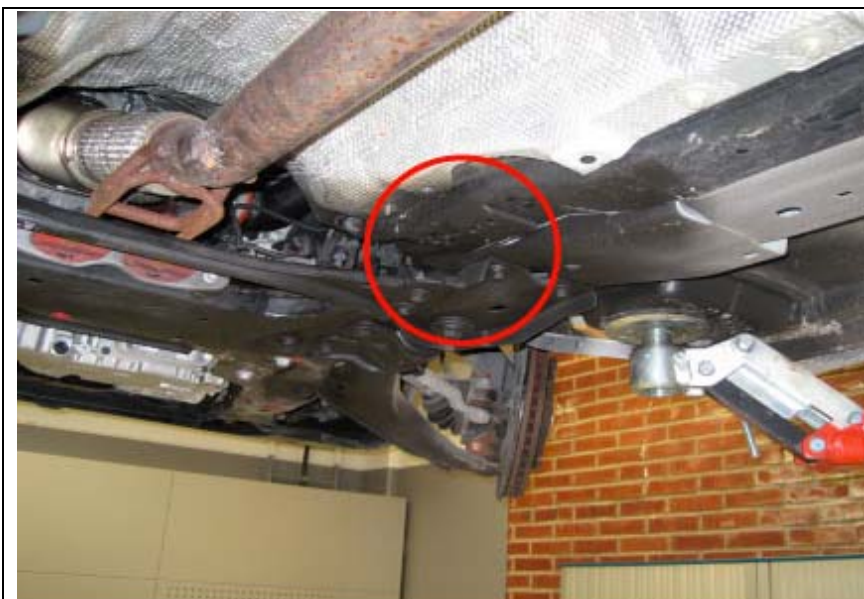
2.

Location of conflict area under fuel rail.

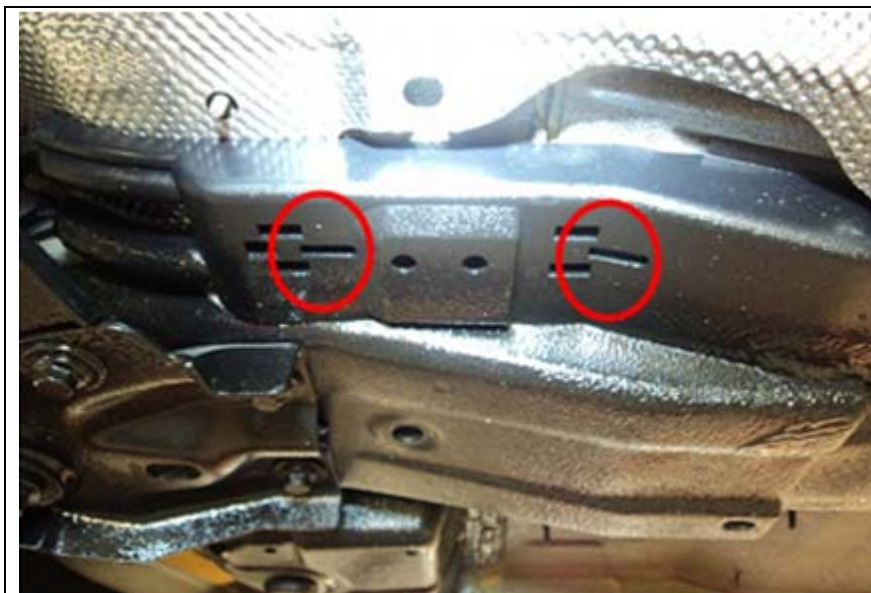
3.

Location of the two yellow clips in fuel rail.

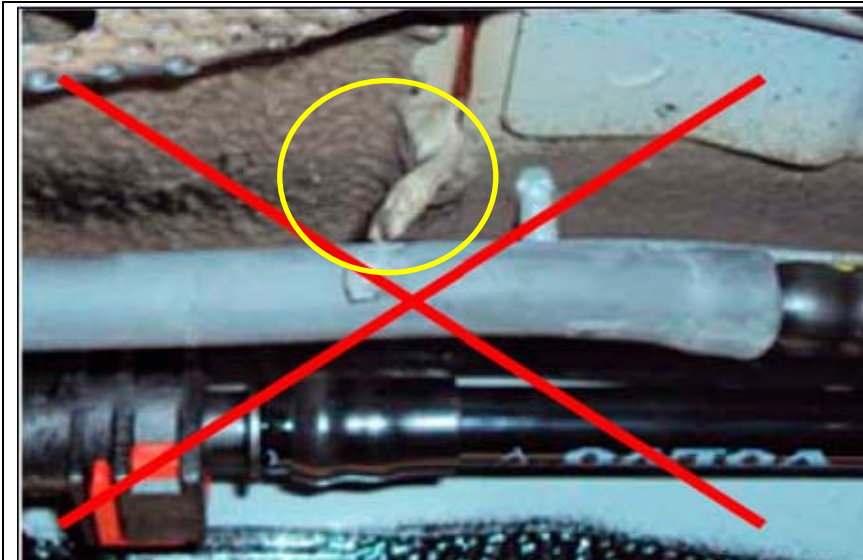
**Check for excess body coating.  
If the fuel pipes are in conflict with  
the stalactites, the fuel rail has to be  
replaced.**

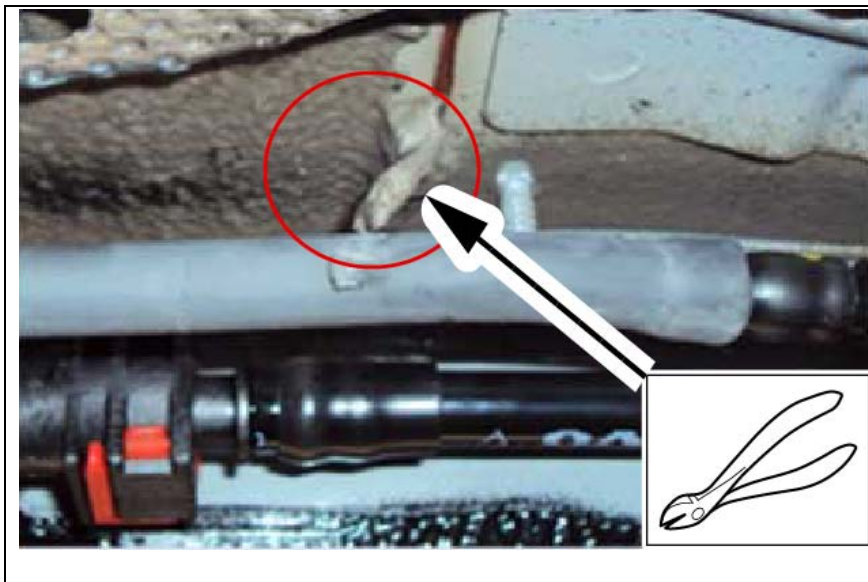
Not OK

Cut away any contact with fuel rail.
