**RE: Defect Information Report – Supplemental Report No. 1  
12V-137, FL-623, Steering Wheel Nuts  
Dealer Notice**

## Subject: Steering Wheel Nuts

May 2012  
FL623A  
NHTSA #12V-137  
Transport Canada #12-119

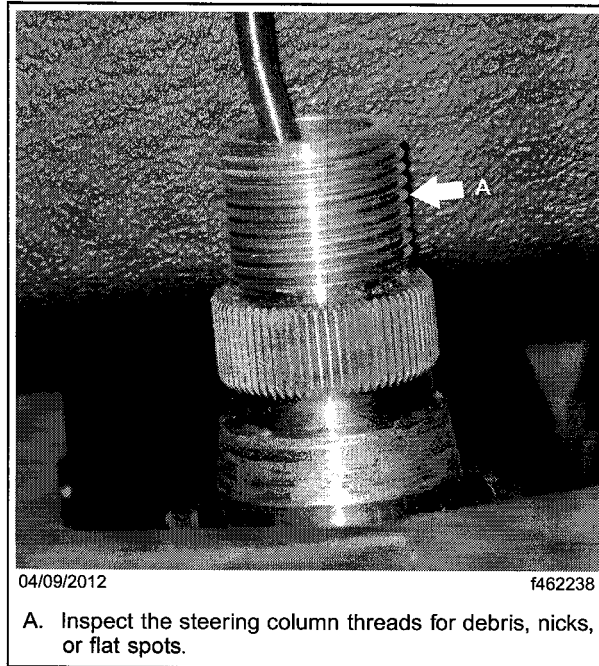
**Fig. 1, Acceptable Steering Column Threads**

7. Inspect the threads on the steering column for damage, nicks, flat spots, or metal shavings. See **Fig. 1** for acceptable steering column threads. If damage is found, replace the steering column. Refer to the **Steering Column Replacement** heading below for instructions.

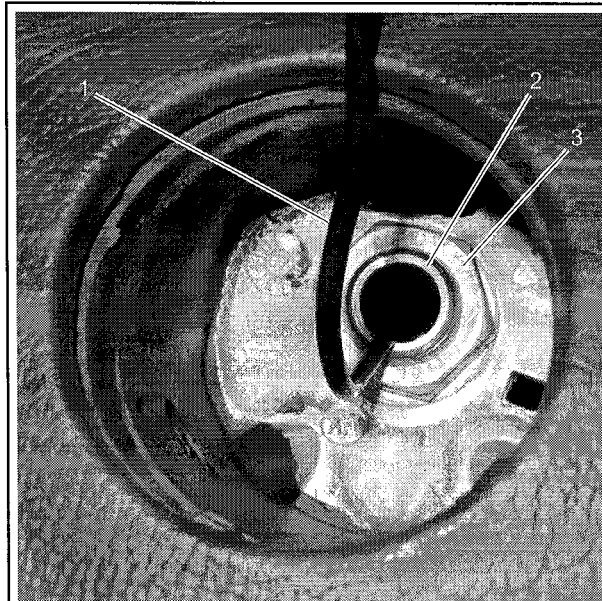
**Fig. 4, Steering Wheel Nut Seating**

Ensure the steering wheel nut is seated just below the top edge of the steering column threads.

9. If the nut tightened to less than 6 lbf-ft (8 N·m), remove it in order to install the steering wheel.
10. Thread the horn wiring harness through the steering wheel center hole and set the steering wheel on the steering column, see **Fig. 2**.
11. Make sure that the steering wheel is within  $\pm 10$  degrees of center as shown in **Fig. 3**.
12. Install the new steering wheel nut and tighten the nut 33 to 41 lbf-ft (45 to 56 N·m). Ensure the nut is seated correctly. See **Fig. 4**.
