Michael A. Berardi
 Director
 Service Engineering Operations
 Ford Customer Service Division

August 28, 2015

SUBJECT: **Safety Recall 11S16 – Supplement #9**
 Certain 1999-2003 Model Year Windstar Vehicles Operated in Corrosion States
 Subframe Front Lower Control Arm Rear Attaching Flanges and Rear Body Mount
 Attachments Inspection and Repair

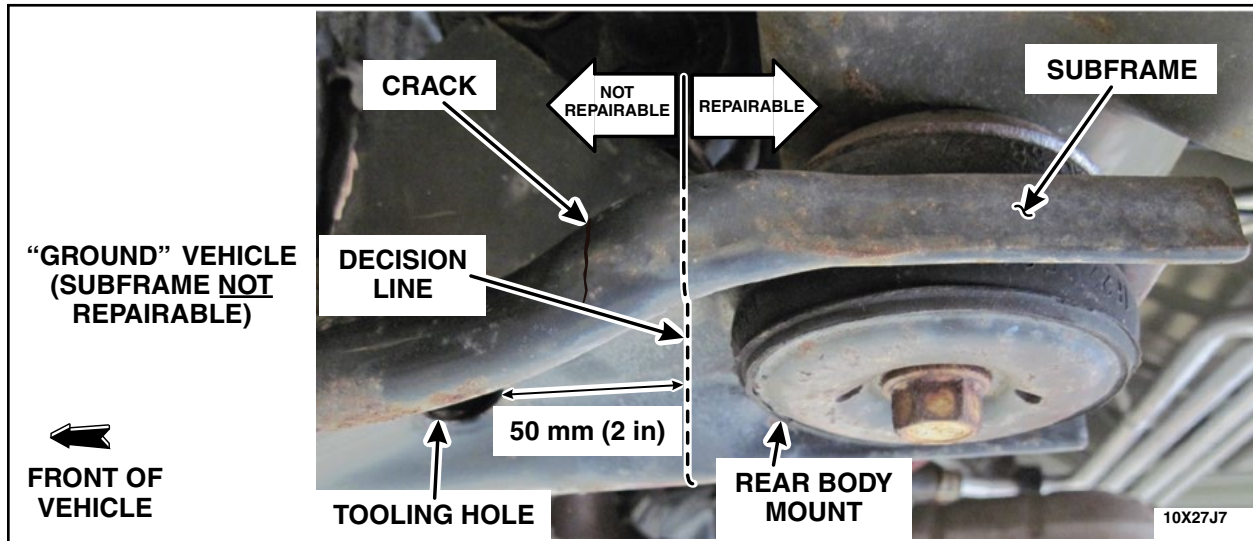
FIGURE 1

1. With the gear selector in NEUTRAL, position the vehicle on a hoist and lift the vehicle. For additional information, refer to the WSM, Section 100-02.
2. Inspect the driver and passenger side of the rear body mount area of the subframe for cracks, perforations, gaps and any non-factory welds or reinforcements. See Figures 1, 2, 3 and 4.

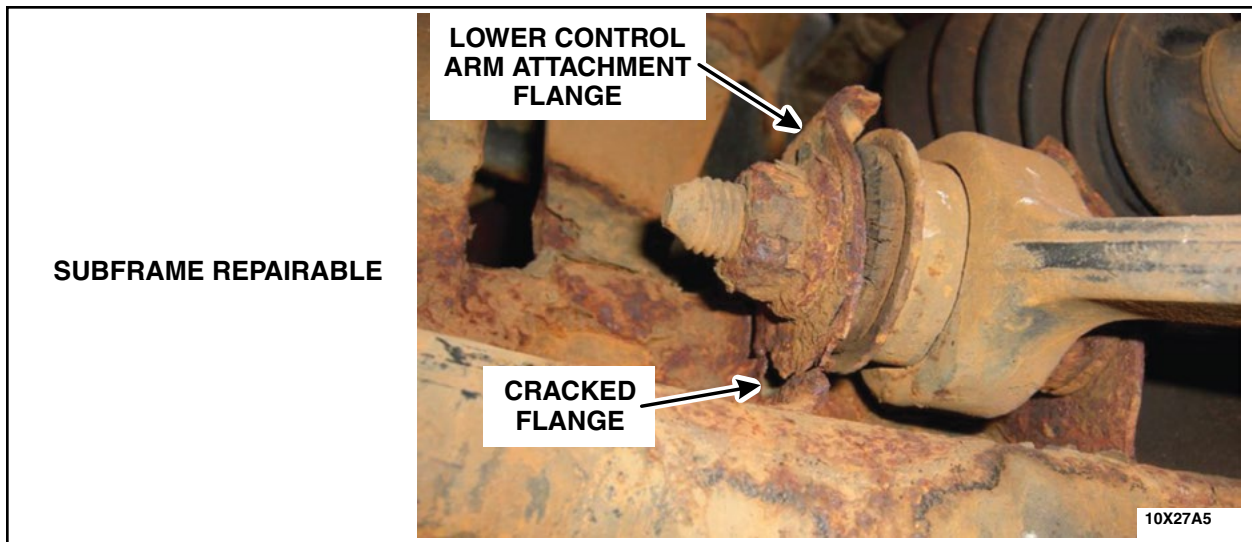
FIGURE 2

3. Inspect both surfaces of the LCA rear attachment flanges on the driver and passenger side of the subframe for cracks, perforations, excessive loss of metal, non-factory welded flanges or reinforcements. See Figures 2, 3, 4 and 5.

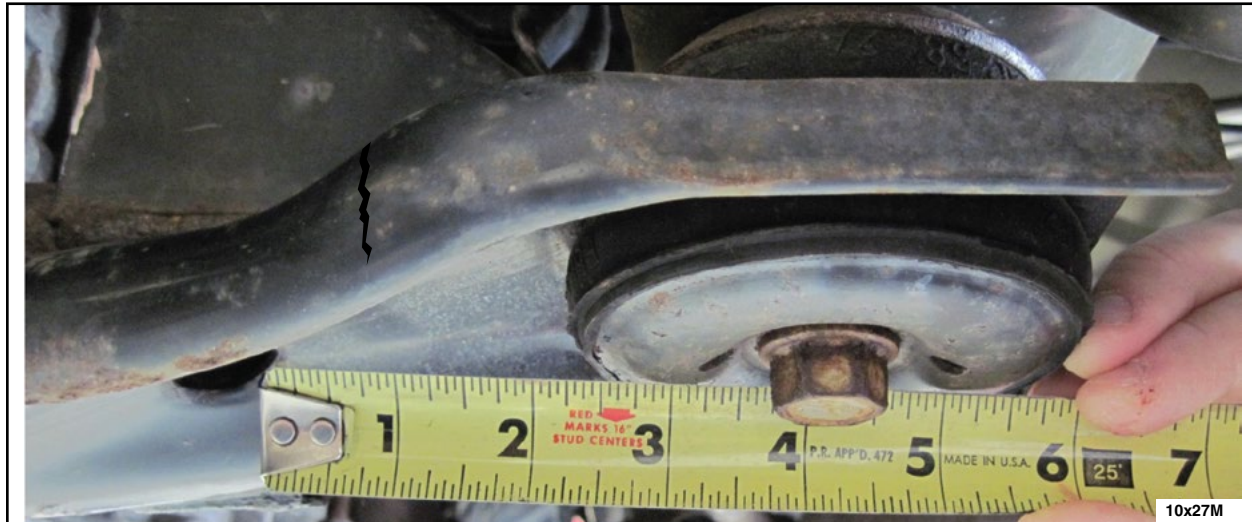
Take three close up pictures from the side of the subframe showing the crack and the tooling hole. In order to make a determination, the evaluator will need to be able to see the crack in relationship to the tooling hole. See Figure 3.

FIGURE 3 - Proper angle for a cracked subframe

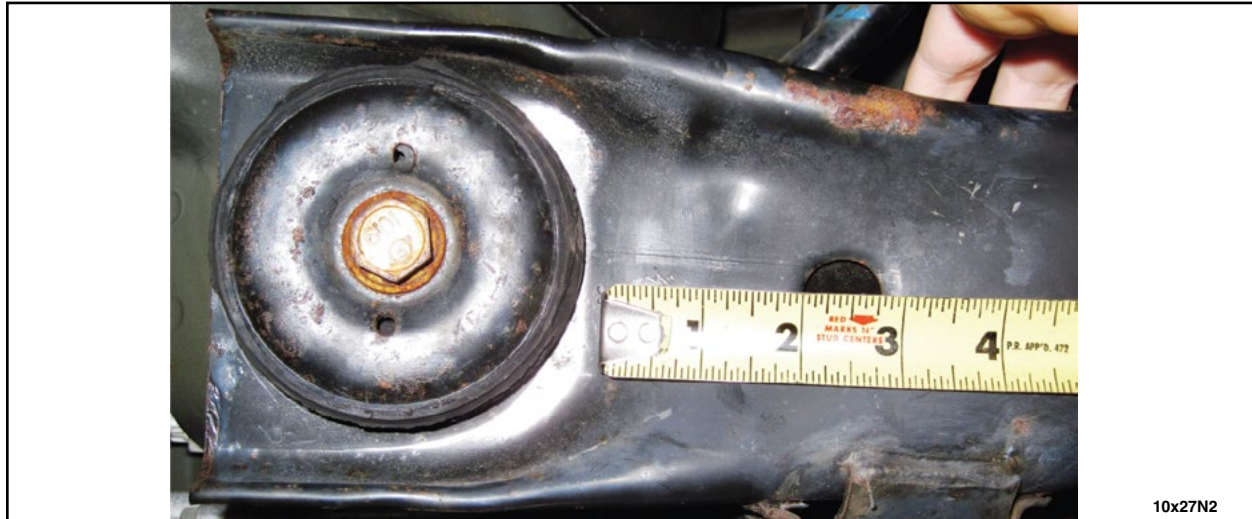
Take three close up pictures from the bottom of the subframe showing the perforation and the tooling hole. In order to make a determination, the evaluator will need to be able to see the perforation in relationship to the tooling hole. See Figure 4.

FIGURE 4 - Proper angle for a perforated subframe

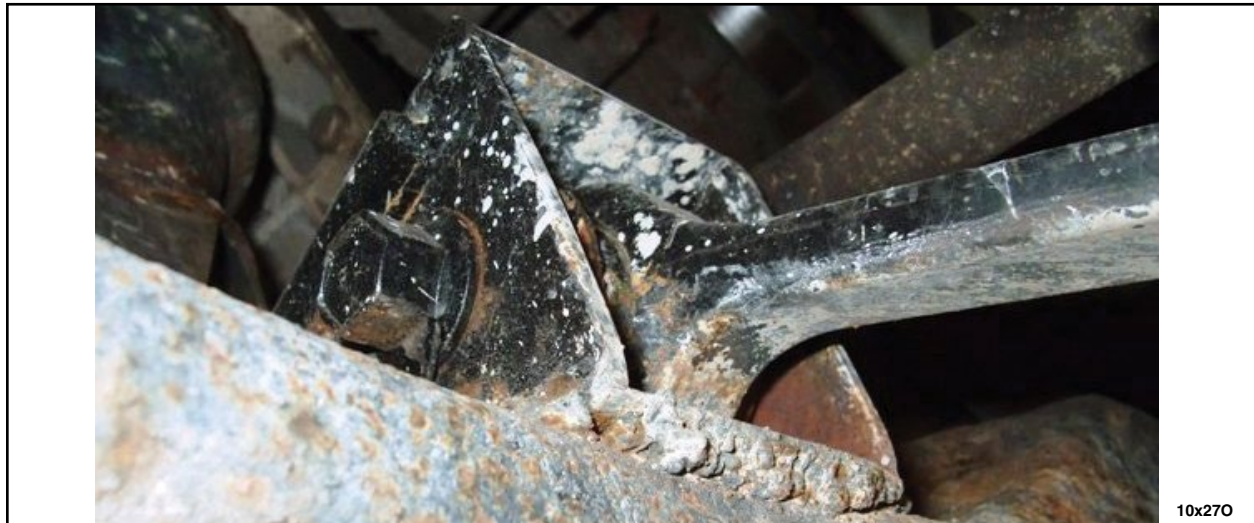
FIGURE 5

Take three close up pictures that clearly show the location and extent of the non-factory welds and/or reinforcements. See Figure 5.
