TMS-NTC-12172  
July 30, 2012

Re: Toyota Safety Recall 12V-305 – Dealer Notification Remedy

**Subject: Safety Recall 9LG (Interim 92G) - Phase 4 - Remedy Available**  
2010 Model Year RX350 and RX450h Vehicles  
Potential Floor Mat Interference with Accelerator Pedal

**TECHNICAL INSTRUCTIONS**  
**FOR**  
**SAFETY RECALL 9LG (PHASE 4)**  
**ACCELERATOR PEDAL MODIFICATION**  
**2010 MODEL YEAR RX350 AND RX450H**

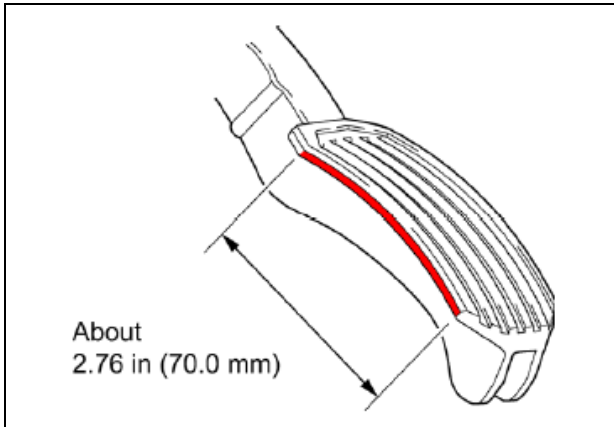
### 1. INSPECT THE ACCELERATOR PEDAL ASSEMBLY

The following inspection procedure is to determine if vehicle has had remedy (accelerator pedal) already applied.

- a) Inspect the accelerator pedal length, is it approximately 2.76 in. (70 mm)?
