SUBJECT: **DEMONSTRATION / DELIVERY HOLD - Safety Recall 12S34**
Certain 2013 Model Year Escape Vehicles
Console Trim Panel Clearance to Pedals

DEMONSTRATION / DELIVERY HOLD - Safety Recall 12S34

CERTAIN 2013 MODEL YEAR ESCAPE VEHICLES — CONSOLE TRIM PANEL CLEARANCE TO PEDALS

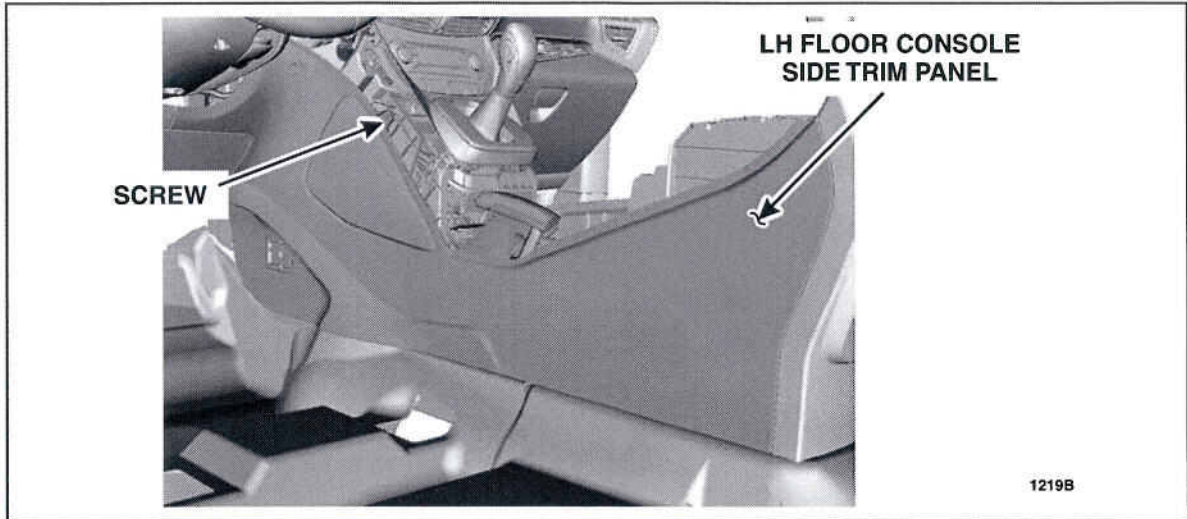
FIGURE 6

7. Remove and discard the LH floor console side trim panel. See Figure 6.
- a. Remove the screw.
 - b. Detach the clips and remove.

9. Install a *new* LH floor console side trim panel containing a revised surface contour. See Figure 6.
 - a. Install and attach the clips.
 - b. Install the screw.
10. Install the push pin and install the push pin cover. See Figure 5.
11. Position the floor console upper trim panel back. See Figure 4.
 - a. Position back and attach the clips.
 - b. Install the screw.
12. Install the parking brake handle trim and position the parking brake handle downward. See Figure 3.
13. Install the floor console latch trim panel. See Figure 2.
14. Close the floor console stowage bin door.
15. Install the lower IP trim panel. For additional information, refer to WSM, Section 501-12. See Figure 1.

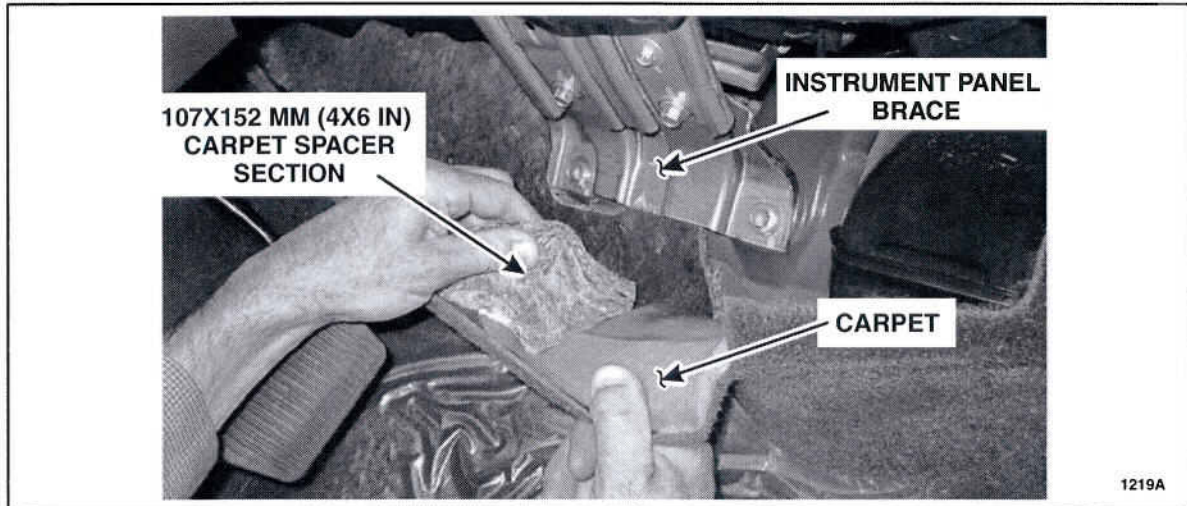
FIGURE 7

A spacer pad under the carpet may have been mispositioned during installation, reducing the clearance between the floor console trim panel and the brake pedal. Dealers are to remove the carpet spacer and install a new LH floor console side trim panel containing a revised surface contour. Note that both operations are required to complete this service action.

8. Position aside the carpet at the instrument panel brace. Remove and discard the 107x152 mm (4x6 in) carpet spacer section. See Figure 7.
