**TO:** All Mazda Dealership General Managers, Service Managers, and Parts Managers

**SUBJECT:** 2001 - 2008 Tribute Engine Cover Modification Voluntary Safety Recall 6812G

**2001-2008 TRIBUTE 3.0L - ENGINE COVER MODIFICATION [RECALL 6812G]**

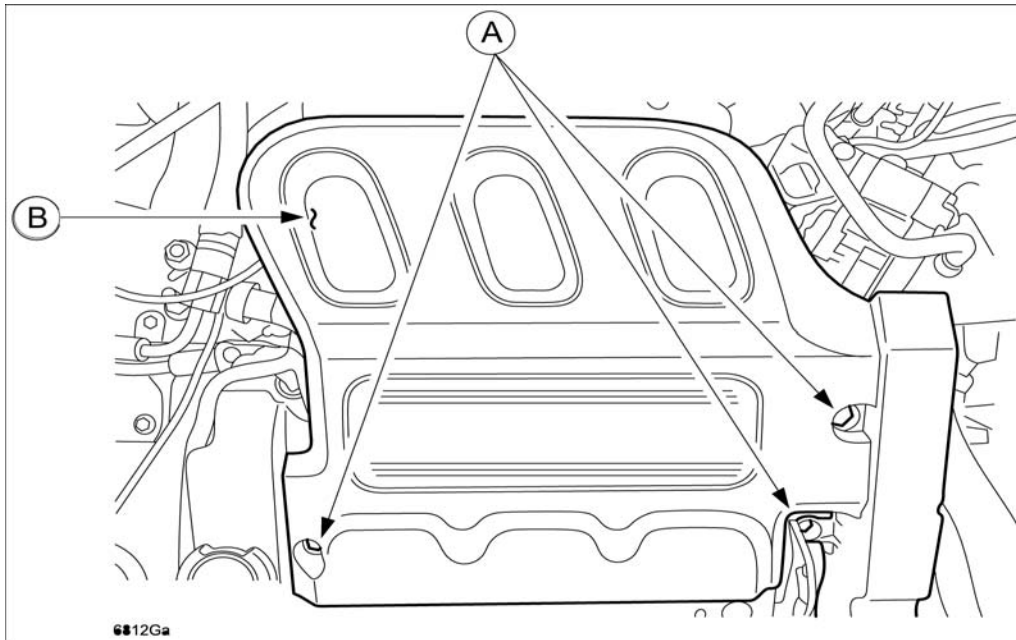
1. Remove the three nuts (A) and the engine cover (B).

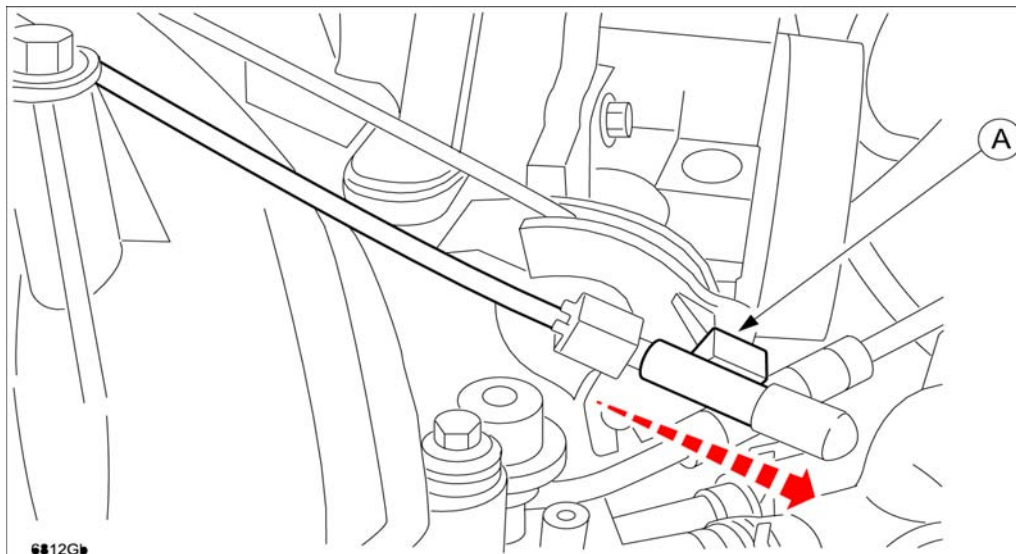
2. Slide the speed control cable off of the throttle body lever nail head (A).

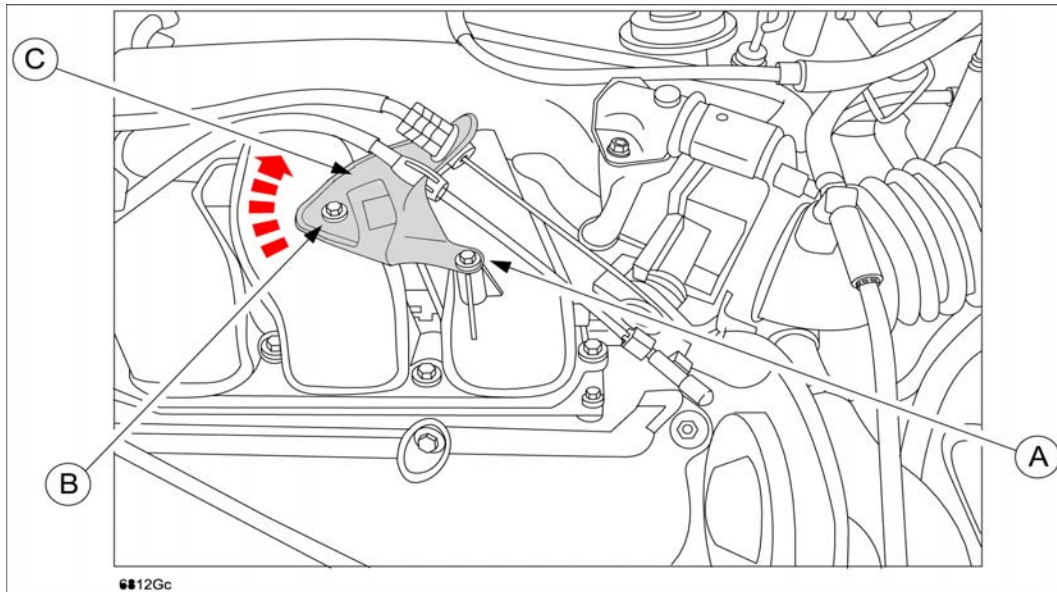
3. Loosen the RH throttle cable bracket bolt (A) and remove the LH throttle cable bracket bolt (B). Rotate the bracket (C) to allow enough clearance for the speed control cable to be positioned under the bracket.

**NOTE:** Do not bend the speed control cable (A) in order to route it under the throttle cable bracket. The throttle cable bracket must be positioned aside or damage to the speed control cable may occur.

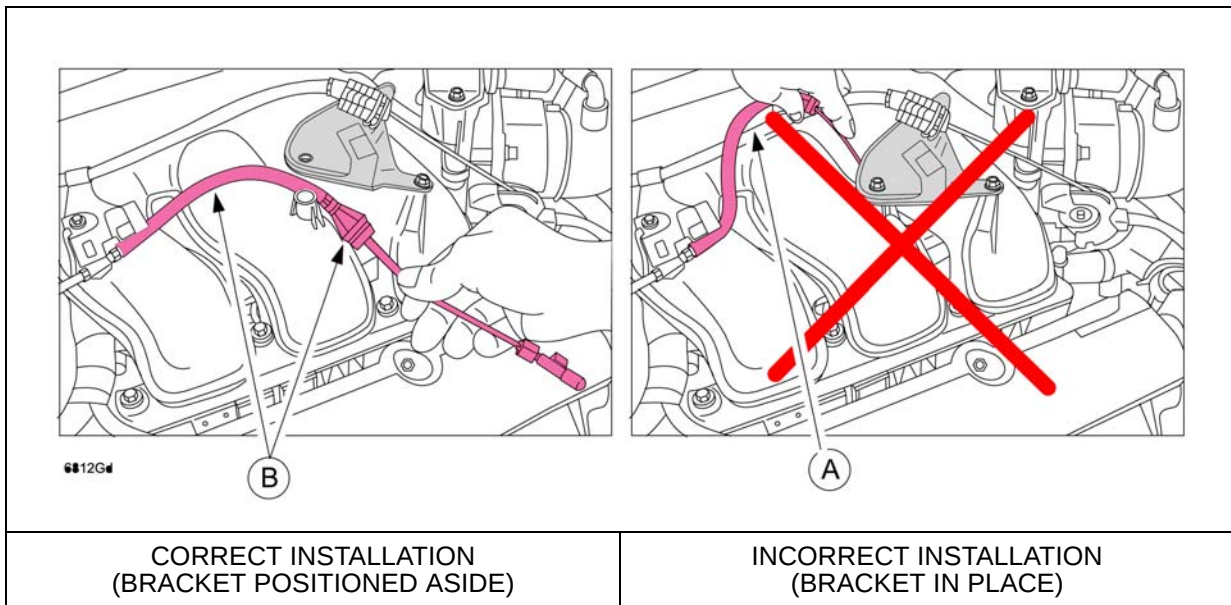
4. Route the speed control cable (B) under the bracket as shown in "correct installation" below.

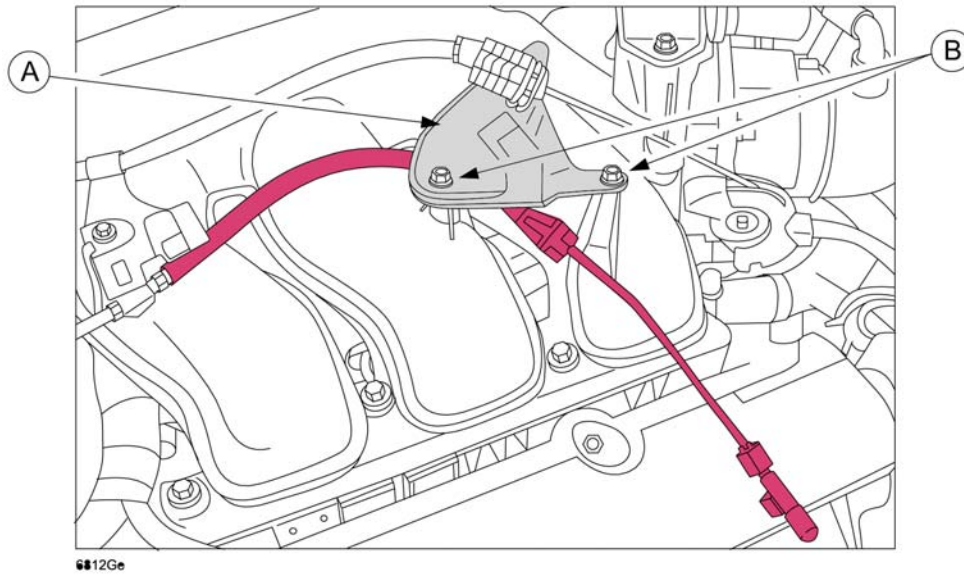
5. Reposition the throttle cable bracket (A) and tighten both bolts (B).  
Tighten the throttle cable bracket bolts (B) to 89 in-lbf (10 Nm).

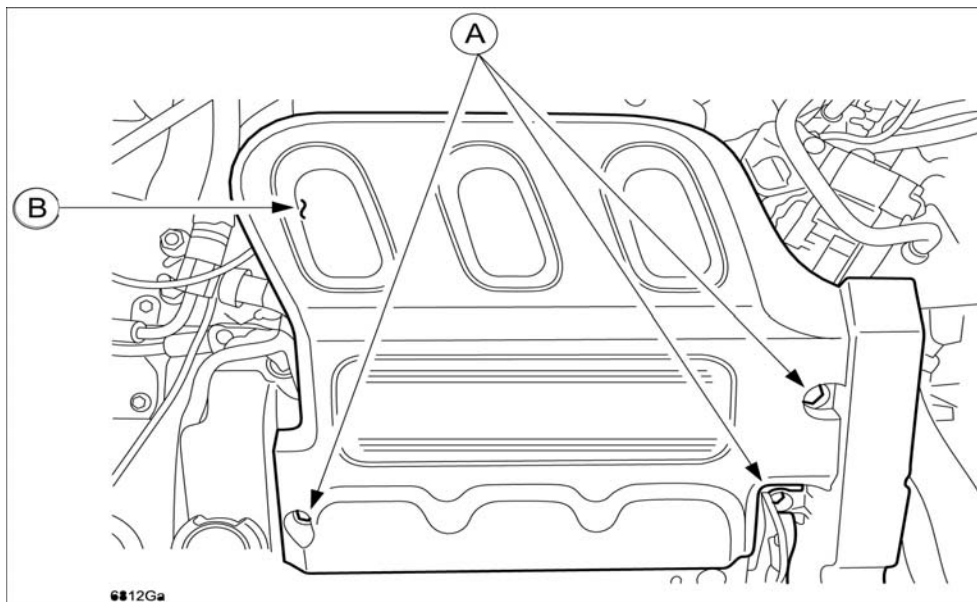
6. Reinstall the engine cover (B) and tighten the three nuts (A).  
Tighten the engine cover nuts to 53 in-lbf (6 Nm).
