TMS-NTC-12278
November 20, 2012

Re: Toyota Safety Recall 12V-373 – Supplemental Dealer Notification

**Subject: Safety Recall CLE-Remedy Parts Available
2010 Model Year HS 250h Vehicles
Rear Lower Suspension Arm No. 1**

**2010 Model Year HS250h Vehicles
Rear Lower Suspension Arm No. 1
SAFETY RECALL NOTICE (Remedy Now Available)**

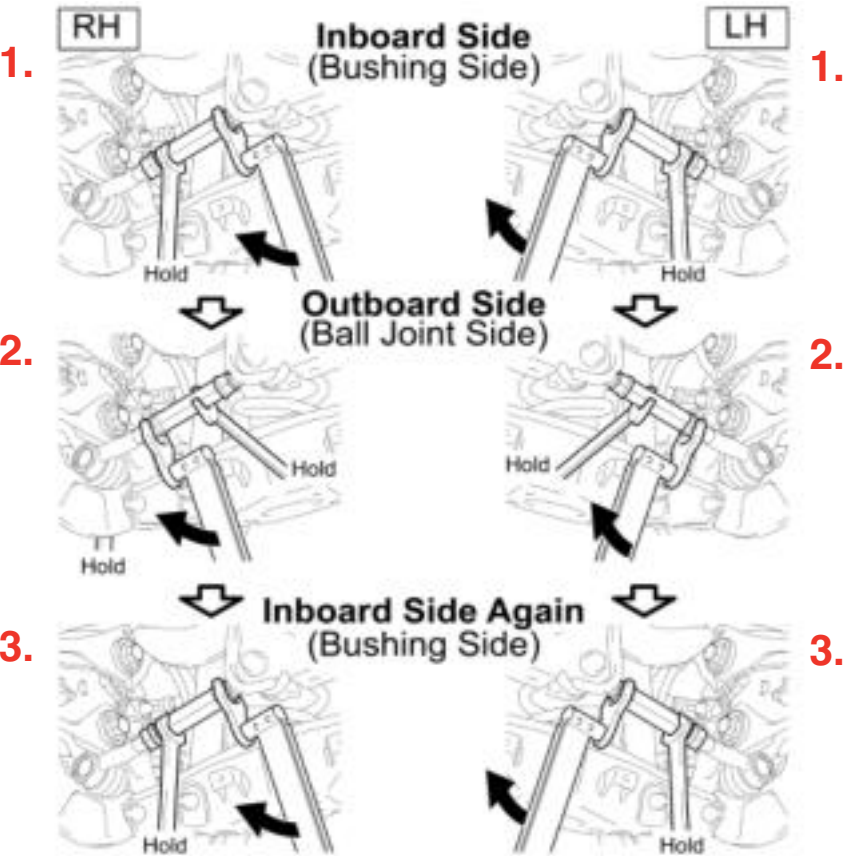
When making rear wheel alignment (toe) adjustments it is important to follow the proper procedure and torque specification. If the proper procedure is not followed, backlash may develop at the thread portion of the arm (shaft and turn-buckle), followed by formation of rust. If this occurs, threads may wear, causing the arm to separate, which could result in the loss of vehicle control.

The tightening procedure for these lock nuts is critical; failure to tighten them in the correct order could cause them to become loose.

Tightening Sequence:

1. Inboard 2. Outboard 3. Inboard Again

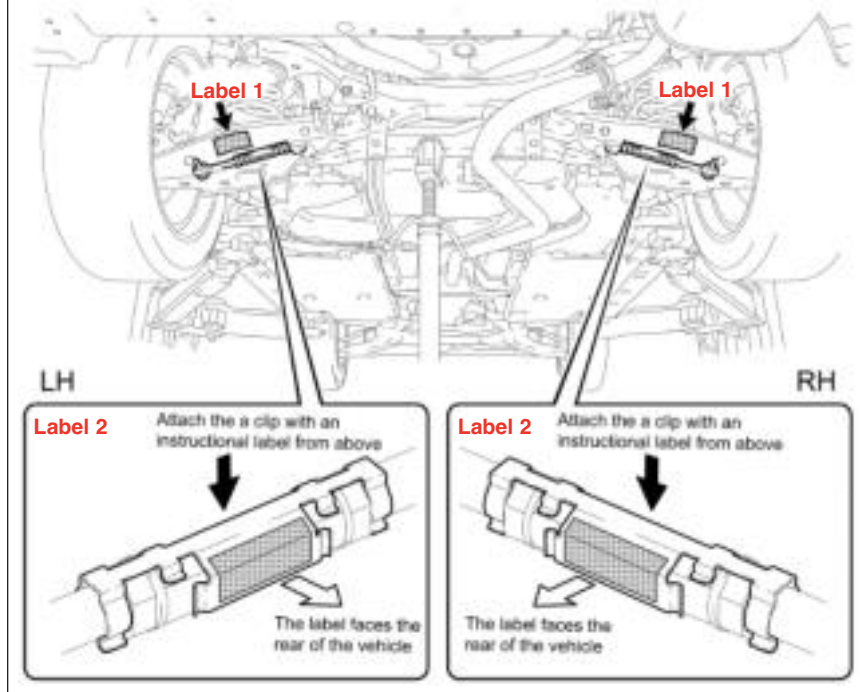
Lexus launched a Safety Recall (Lexus designation CLE) to remedy this condition. As part of the remedy, Caution Labels have been installed on the vehicle to help notify technicians performing a rear wheel alignment, of the importance of following the proper tightening sequence of the rear tie rod lock nuts.

Torque: 41ft-lbf (56N·m) Hold the turn buckle steady during nut tightening
For more information, see the repair manual or supplemental owner's manual insert in glove box.

1. Inboard 2. Outboard 3. Inboard again
Hold Turn Buckle Steady
Torque: 41ft-lbf (56N·m)

Two (2) labels per vehicle

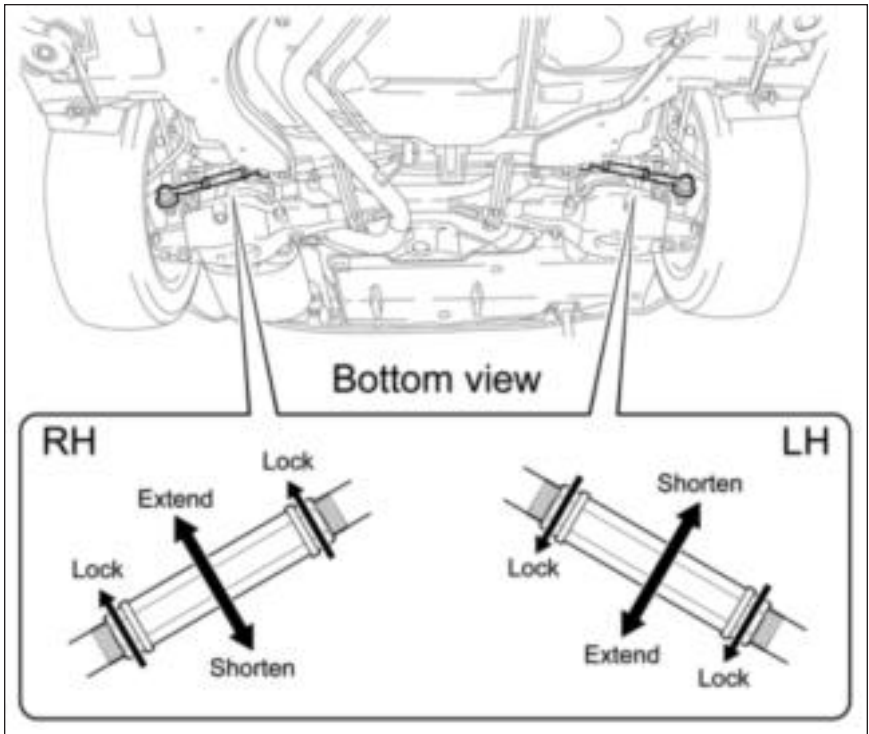
IV. STRUCTURE OF REAR No.1 SUSPENSION ARM ASSEMBLY

The arm can be extended or shortened by turning the adjusting tube located on the arm center area. A lock nut is provided on each end of the adjusting tube. One of the nuts, which are located at the ball joint side, has a left-hand thread (left-to-tighten, right-to-loosen). Understand the suspension arm structure properly to perform operations correctly.

- In order to prevent the center alignment of the adjusting tube from being displaced, do not disassemble the suspension arm.
- Rotate the replaced suspension arm's adjusting tube to adjust the rear wheel toe-in.

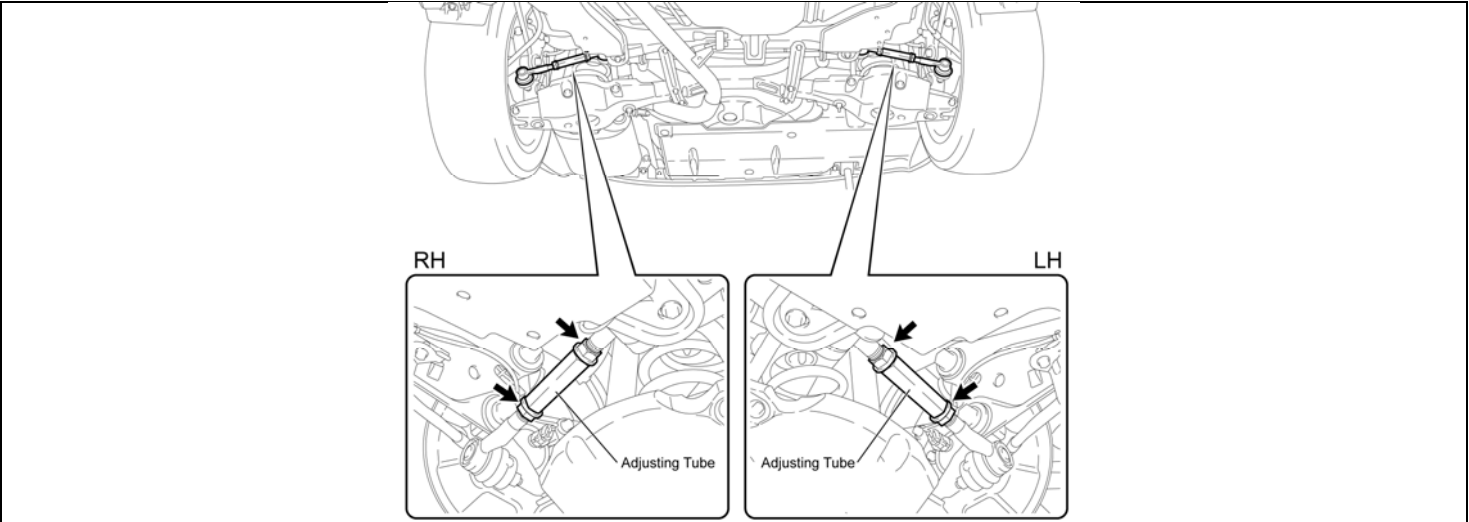
1. CHECK FOR LOOSENESS VISUALLY AND BY HAND

- a) Check visually and by hand to determine if any looseness is seen or felt in the suspension arm lock nuts or adjusting tube. Check the LH and RH arms.

- ONLY replace the suspension arm(s) if looseness is found.
- The arm(s) not found loose must also be checked using a torque wrench as described in steps 2-4.

| CONDITION | ACTION REQUIRED |
|---|---|
| Loose | Replace the suspension arm(s) with looseness. Refer to TIS for instructions on suspension arm replacement. NOTE: <ul style="list-style-type: none">To prevent stress on the new suspension arm bushing, apply a load to the suspension system to confirm the suspension arm bushing is aligned correctly when tightening by confirming that rear suspension arm No.1 is level with the ground.Suspension arm adjustment and tightening procedure is critical. After replacing the arm, refer to SECTION VII. in these instructions for this procedure. |

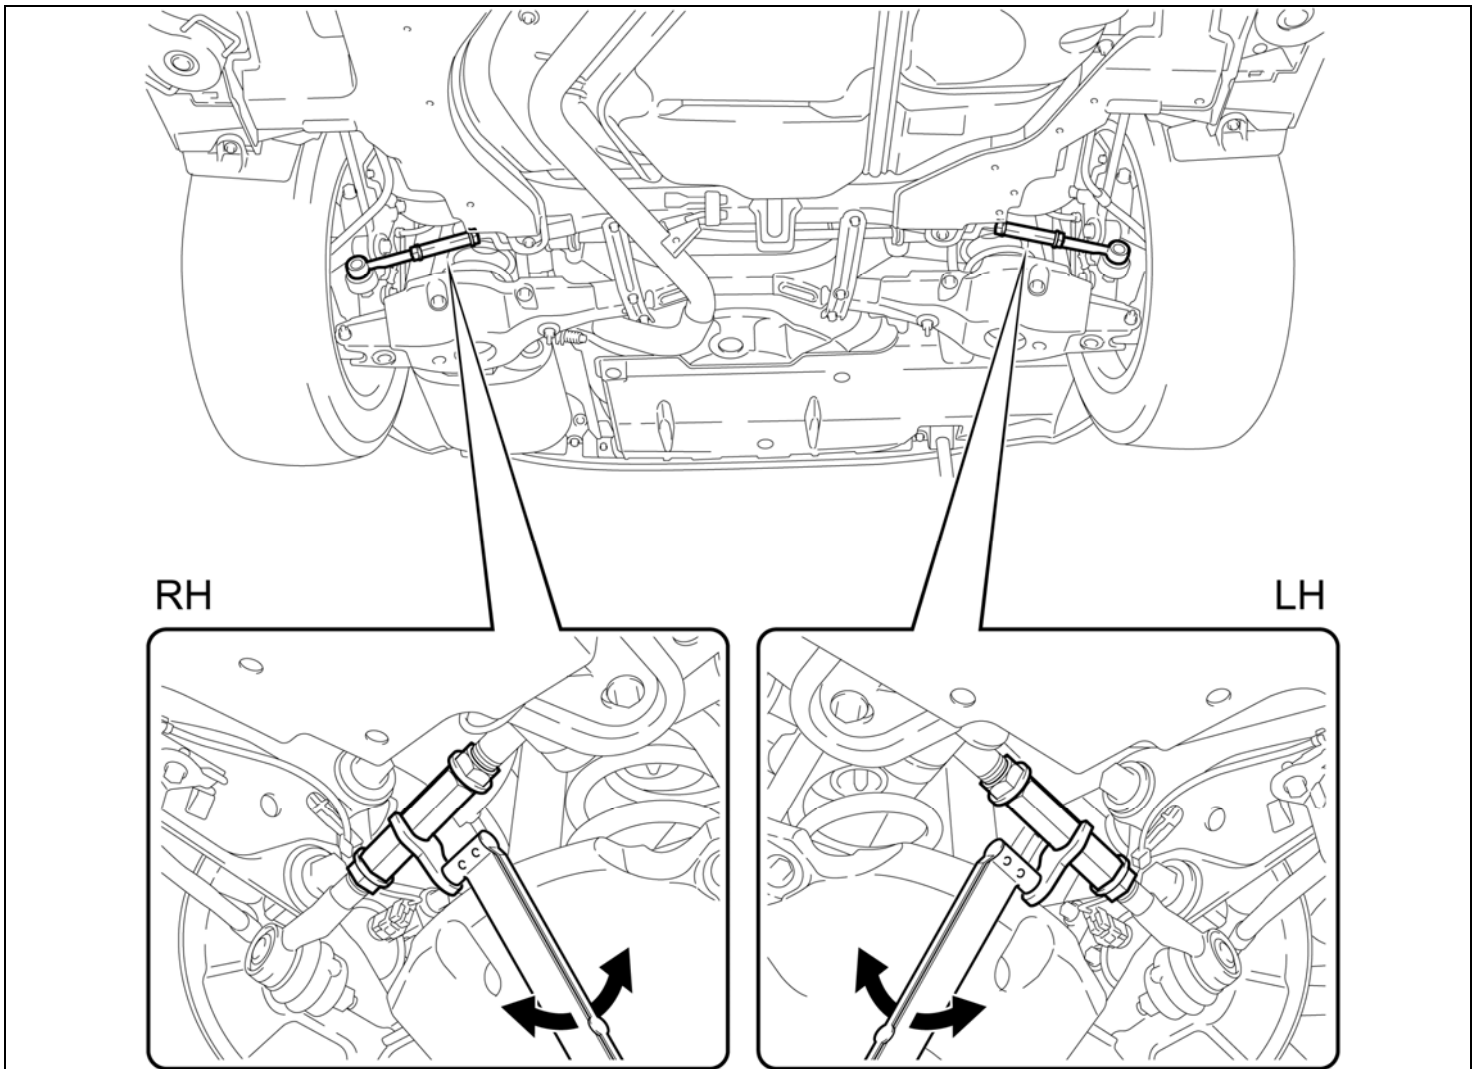
3. CHECK THE ADJUSTING TUBE FOR LOOSENESS WITH TORQUE WRENCH

(This checks inboard lock nut for looseness)

- Check for looseness in the adjusting tube using a torque wrench.
- Apply the specified torque to the adjusting tube in both directions. Check the arms that were not previously found loose during **STEP 1**. Inspect the match-marks to see if they become misaligned.

- Confirm the torque wrench is set correctly and that only the specified torque is being applied to the adjusting tube.
- ONLY** replace the suspension arm(s) if looseness is found.

| CONDITION | ACTION REQUIRED |
|---|--|
| Loose | <p>Replace the suspension arm(s) with looseness. Refer to TIS for instructions on suspension arm replacement.</p> <p>NOTE:</p> <ul style="list-style-type: none">To prevent stress on the new suspension arm bushing, apply a load to the suspension system to confirm the suspension arm bushing is aligned correctly when tightening by confirming that rear suspension arm No.1 is level with the ground.Suspension arm adjustment and tightening procedure is critical. After replacing the arm, refer to SECTION VII. in these instructions for this procedure. |

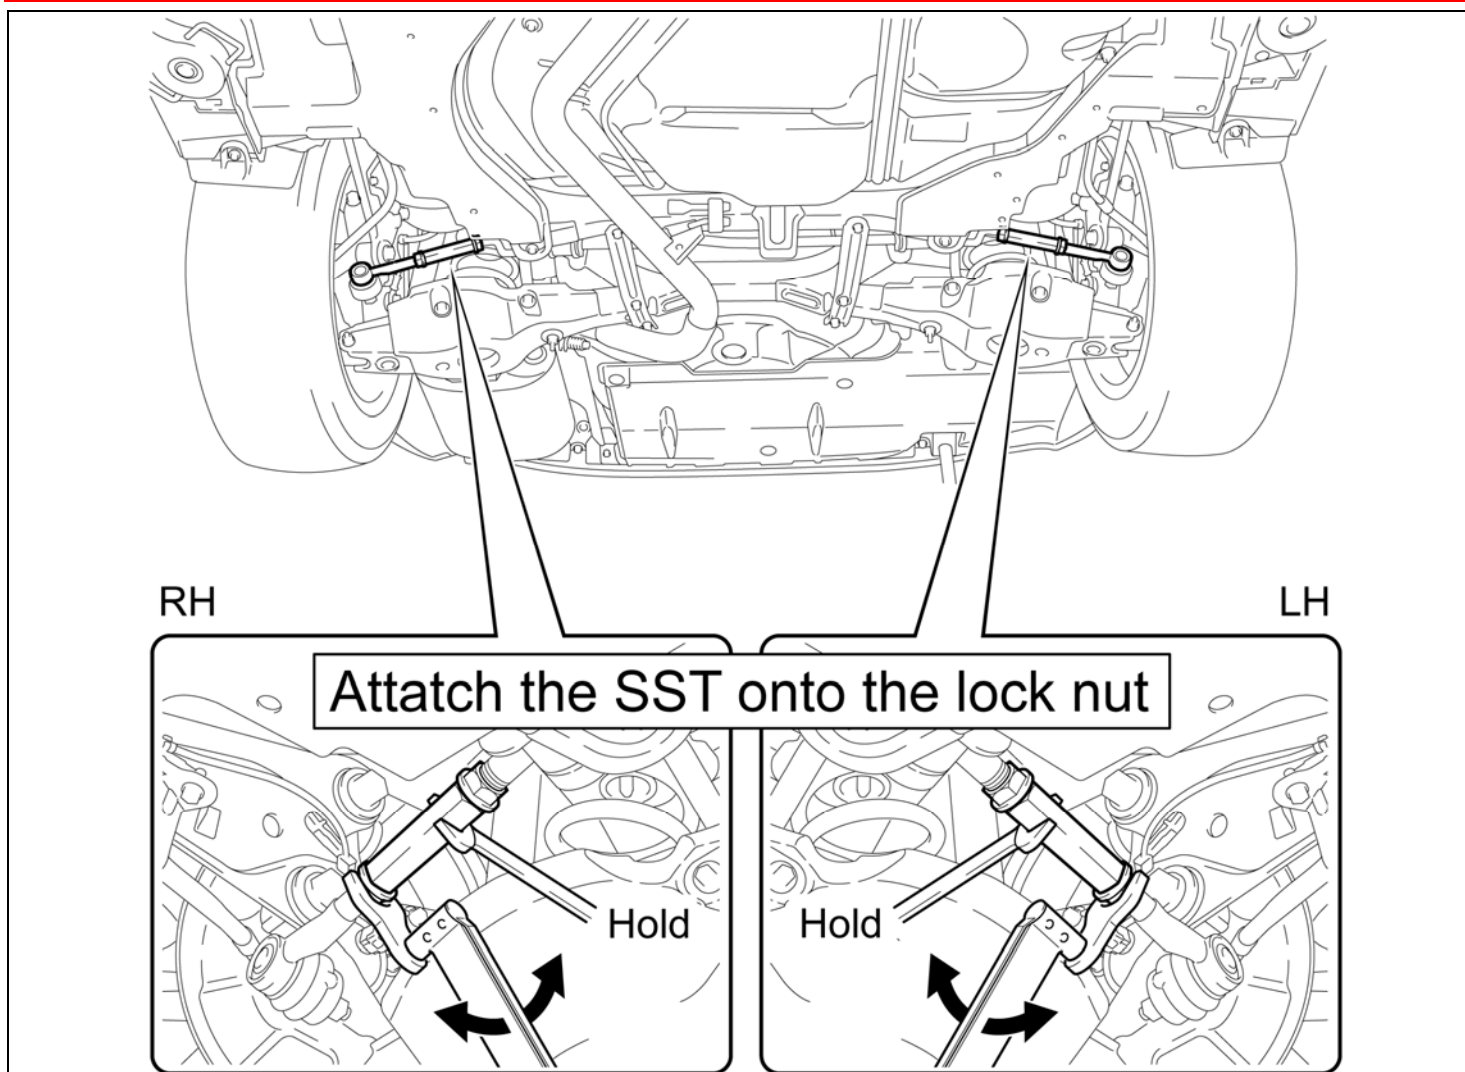
4. CHECK THE OUTBOARD LOCK NUT FOR LOOSENESS (lock nut closest to ball joint)

- While holding the adjusting tube with a wrench, check for looseness in the outboard lock nut using a torque wrench with a 22mm crowfoot attached.
- Apply the specified torque to the lock nut in both directions. Check the arms that were not previously found loose during **STEPS 1-3**. Inspect the match-marks to see if they become misaligned.

- Confirm the torque wrench is set correctly and that only the specified torque is being applied to the outboard lock nut.
- ONLY** replace the suspension arm(s) if looseness is found.

| CONDITION | ACTION REQUIRED |
|---|--|
| Loose | Replace the suspension arm(s) with looseness. Refer to TIS for instructions on suspension arm replacement. NOTE: <ul style="list-style-type: none"> To prevent stress on the new suspension arm bushing, apply a load to the suspension system to confirm the suspension arm bushing is aligned correctly when tightening by confirming that rear suspension arm No.1 is level with the ground. Suspension arm adjustment and tightening procedure is critical. After replacing the arm, refer to SECTION VII. in these instructions for this procedure. |

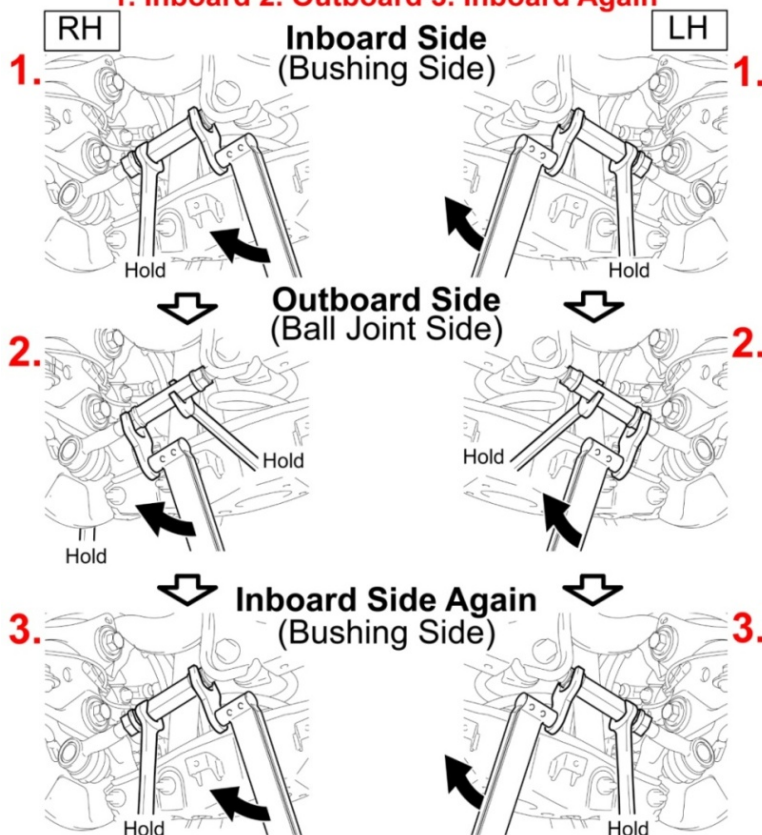
- The tightening procedure for these lock nuts is critical, failure to tighten them in the correct order could cause them to become loose.
- Confirm the alignment machine has been updated with the latest software.

Tightening Sequence:

1. Inboard 2. Outboard 3. Inboard Again
