Re: Toyota Safety Recall 12V-373 – Interim Dealer Notification

Subject: Safety Recall CLE (Interim C2E) -Interim Notification
2010 Model Year HS 250h Vehicles
Rear Lower Suspension Arm No. 1

INTERIM TECHNICAL INSTRUCTIONS
FOR
SAFETY RECALL CLE **INTERIM C2E**
REAR LOWER SUSPENSION ARM No.1
CERTAIN 2010 MODEL YEAR HS250h

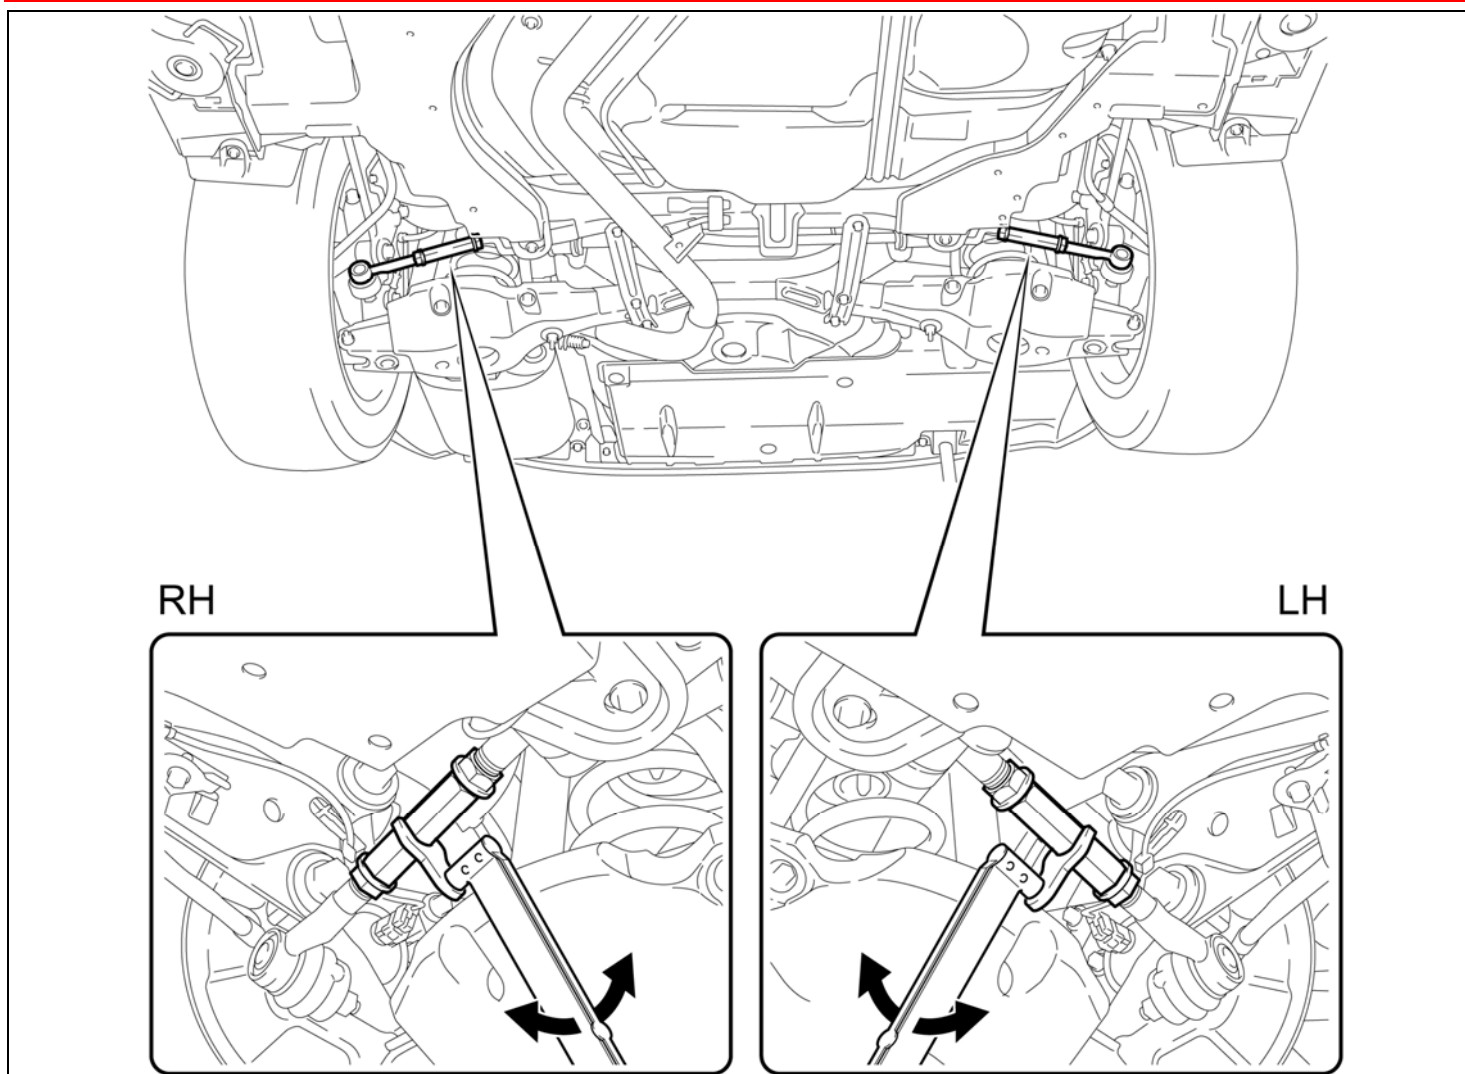
3. CHECK THE ADJUSTING TUBE FOR LOOSENESS WITH TORQUE WRENCH (This checks inboard lock nut for looseness)

- Check for looseness in the adjusting tube using a torque wrench.
- Apply the specified torque to the adjusting tube in both directions. Check the arms that were not previously found loose during **STEP 1**. Inspect the match-marks to see if they become misaligned.

Torque: 15ft. lbf (20N·m)

- Use a 22mm crowfoot attached to a 15 inch torque wrench. If a tool setup other than specified is used, refer to [TIS](#) for torque wrench calculation.

- Confirm the torque wrench is set correctly and that only the specified torque is being applied to the adjusting tube.
- ONLY** replace the suspension arm(s) if looseness is found.

CONDITION	ACTION REQUIRED
Loose	<p>Replace the suspension arm(s) with looseness. Refer to TIS for instructions on suspension arm replacement.</p> <p>NOTE:</p> <ul style="list-style-type: none"> To prevent stress on the new suspension arm bushing, apply a load to the suspension system to confirm the suspension arm bushing is aligned correctly when tightening by confirming that rear suspension arm No.1 is level with the ground. Suspension arm adjustment and tightening procedure is critical. After replacing the arm, refer to SECTION VII. in these instructions for this procedure.
NOT Loose	Proceed to STEP 5. CHECK THE OUTBOARD LOCK NUT FOR LOOSENESS

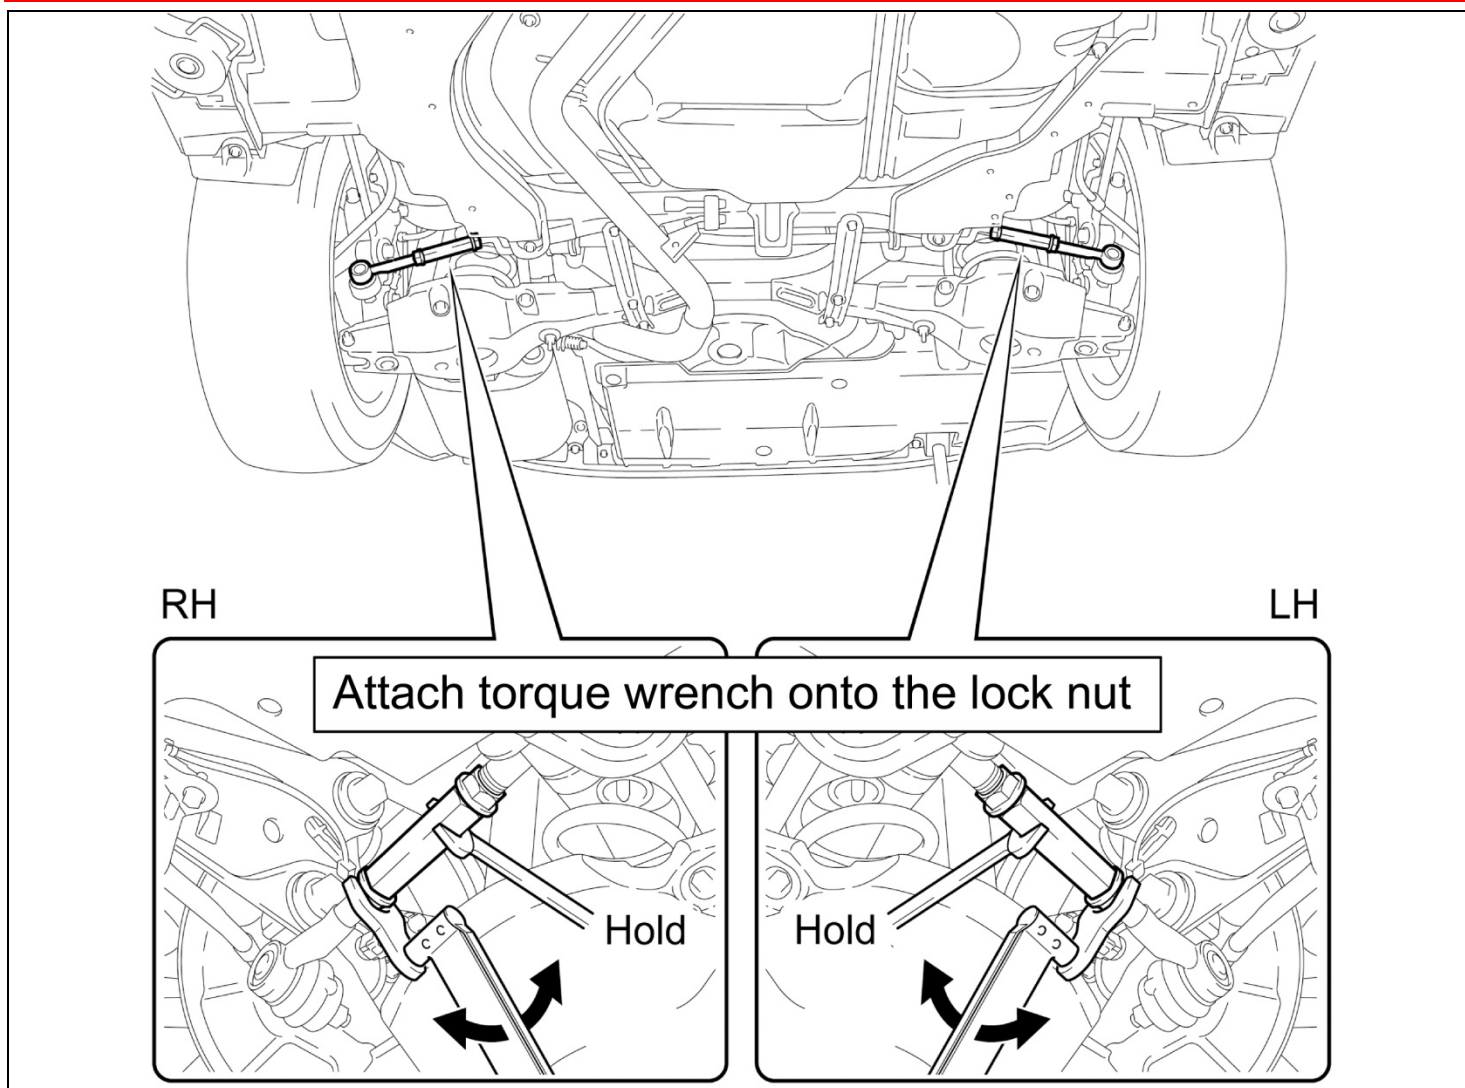
4. CHECK THE OUTBOARD LOCK NUT FOR LOOSENESS (lock nut closest to ball joint)

- While holding the adjusting tube with a wrench, check for looseness in the outboard lock nut using a torque wrench with a 22mm crowfoot attached.
- Apply the specified torque to the lock nut in both directions. Check the arms that were not previously found loose during **STEPS 1-3**. Inspect the match-marks to see if they become misaligned.

Torque: 15ft. lbf (20N·m)

- Confirm the torque wrench is set correctly and that only the specified torque is being applied to the outboard lock nut.
- ONLY** replace the suspension arm(s) if looseness is found.

CONDITION	ACTION REQUIRED
Loose	<p>Replace the suspension arm(s) with looseness. Refer to TIS for instructions on suspension arm replacement.</p> <p>NOTE:</p> <ul style="list-style-type: none"> To prevent stress on the new suspension arm bushing, apply a load to the suspension system to confirm the suspension arm bushing is aligned correctly when tightening by confirming that rear suspension arm No.1 is level with the ground. Suspension arm adjustment and tightening procedure is critical. After replacing the arm, refer to SECTION VII. in these instructions for this procedure.
NOT Loose	The interim portion of this campaign is complete. Return the vehicle to the customer

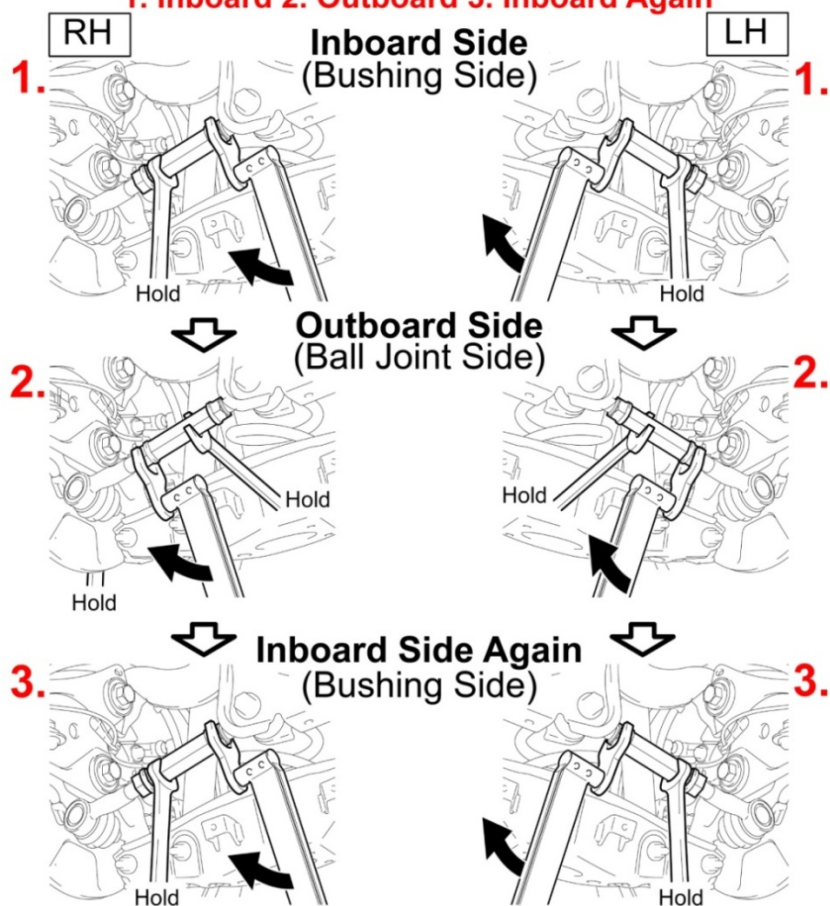
- The tightening procedure for these lock nuts is critical, failure to tighten them in the correct order could cause them to become loose.
- Confirm the alignment machine has been updated with the latest software.

Tightening Sequence:

1. Inboard 2. Outboard 3. Inboard Again
