Re: Toyota Safety Recall 12V-373 – Interim Dealer Notification

Subject: Safety Recall C0J – (C1J) *Interim Notification*

2006 to Early 2011 Model Year RAV4 Vehicles

Rear Lower Suspension Arm No.1

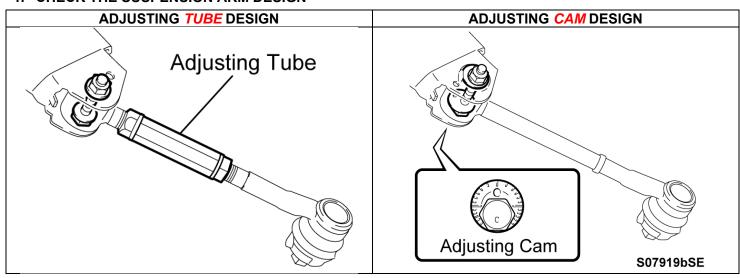
1. CHECK THE SUSPENSION ARM DESIGN

ARM DESIGN	ACTION REQUIRED
Adjusting Tube	Proceed to STEP 2. CHECK FOR LOOSENESS VISUALLY AND BY HAND
Adjusting Cam	No further action required. Campaign complete.

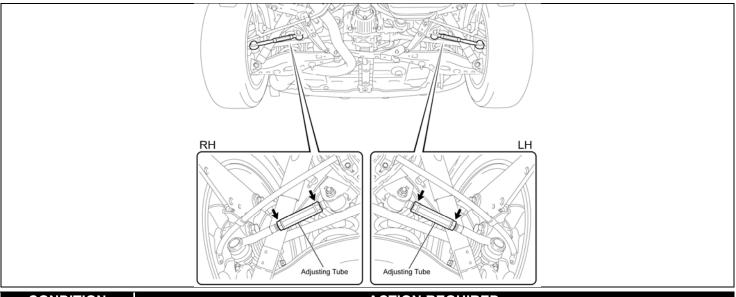
2. CHECK FOR LOOSENESS VISUALLY AND BY HAND

a) Check visually and by hand to determine if any looseness is seen or felt in the suspension arm lock nuts or adjusting tube. Check the LH and RH arms.

- ONLY replace the suspension arm(s) if looseness is found.
- The arm(s) not found loose must also be checked using a torque wrench as described in steps 3-5.

CONDITION	ACTION REQUIRED
Loose	 Replace the suspension arm(s) with looseness. Refer to TIS for instructions on suspension arm replacement. NOTE: To prevent stress on the new suspension arm bushing, apply a load to the suspension system to confirm the suspension arm bushing is aligned correctly when tightening by confirming that rear suspension arm No.1 is level with the ground. Suspension arm adjustment and tightening procedure is critical. After replacing the arm, refer to SECTION VII. in these instructions for this procedure.
NOT Loose	Proceed to STEP 3. PLACE MATCHMARKS ON SUSPENSION ARM

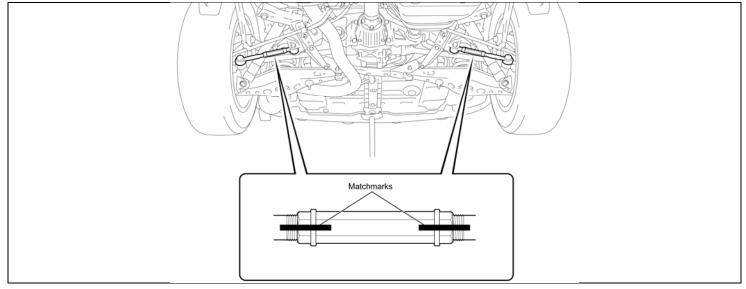
3. PLACE MATCH-MARKS ON SUSPENSION ARM

- a) Place match-marks across the suspension arms as shown. Mark the arms that were not found loose during **STEP 2.**
- b) Use these match-marks to determine if looseness is found in steps 4 and 5 when applying torque.

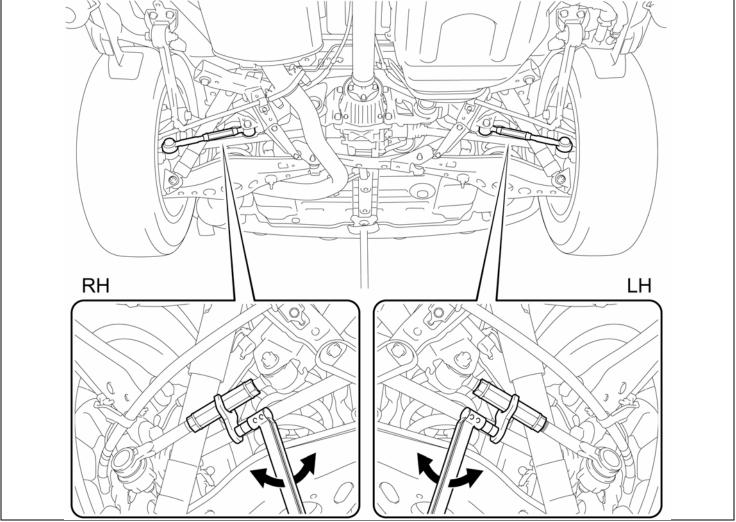
4. CHECK THE ADJUSTING TUBE FOR LOOSENESS WITH TORQUE WRENCH (This checks inboard lock nut for looseness)

- a) Check for looseness in the adjusting tube using a torque wrench.
- b) Apply the specified torque to the adjusting tube in both directions. Check the arms that were not previously found loose during **STEP 2.** Inspect the match-marks to see if they become misaligned.

- Confirm the torque wrench is set correctly and that only the specified torque is being applied to the adjusting tube.
- ONLY replace the suspension arm(s) if looseness is found.

CONDITION	ACTION REQUIRED
Loose	Replace the suspension arm(s) with looseness. Refer to TIS for instructions on suspension arm replacement. NOTE: • To prevent stress on the new suspension arm bushing, apply a load to the suspension system to confirm the suspension arm bushing is aligned correctly when tightening by confirming that rear suspension arm No.1 is level with the ground. • Suspension arm adjustment and tightening procedure is critical. After replacing the arm, refer to SECTION VII. in these instructions for this procedure.
NOT Loose	Proceed to STEP 5. CHECK THE OUTBOARD LOCK NUT FOR LOOSENESS

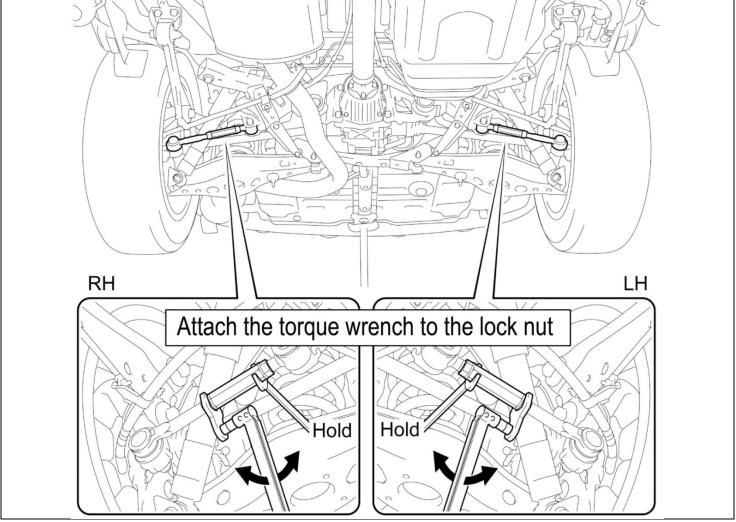
5. CHECK THE OUTBOARD LOCK NUT FOR LOOSENESS (lock nut closest to ball joint)

- a) While holding the adjusting tube with a wrench, check for looseness in the outboard lock nut using a torque wrench with a 22mm crowfoot attached.
- b) Apply the specified torque to the lock nut in both directions. Check the arms that were not previously found loose during **STEPS 2-4.** Inspect the match-marks to see if they become misaligned.

- Confirm the torque wrench is set correctly and that only the specified torque is being applied to the outboard lock nut.
- ONLY replace the suspension arm(s) if looseness is found.

CONDITION	ACTION REQUIRED
Loose	 Replace the suspension arm(s) with looseness. Refer to TIS for instructions on suspension arm replacement. NOTE: To prevent stress on the new suspension arm bushing, apply a load to the suspension system to confirm the suspension arm bushing is aligned correctly when tightening by confirming that rear suspension arm No.1 is level with the ground. Suspension arm adjustment and tightening procedure is critical. After replacing the arm, refer to SECTION VII. in these instructions for this procedure.
NOT Loose	The interim portion of this campaign is complete. Return the vehicle to the customer

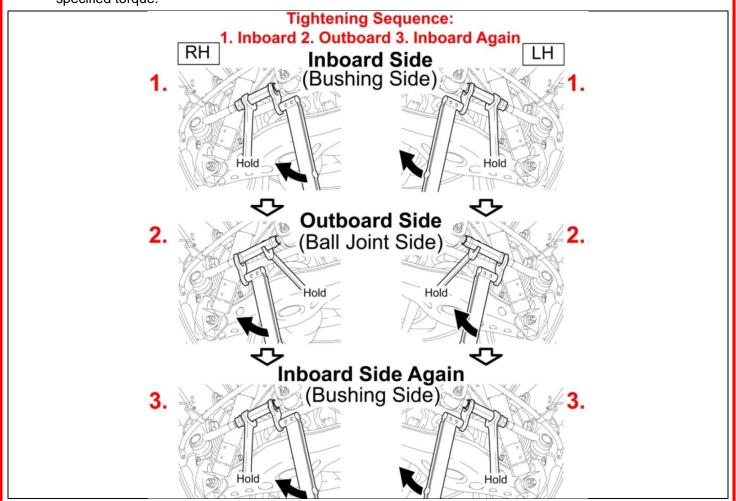
- The tightening procedure for these lock nuts is critical, failure to tighten them in the correct order could cause them to become loose.
- Confirm the alignment machine has been updated with the latest software.

Use a 22mm combination wrench and a 22mm crowfoot attached to a torque wrench Tightening Sequence: 1. Inboard 2. Outboard 3. Inboard Again Torque: 41ft. lbf (56N·m)

- a) Tighten the inboard lock nut. Hold the adjusting tube steady and tighten the inboard lock nut to the specified torque.
- b) Tighten the outboard lock nut. Hold the adjusting tube steady and tighten the outboard lock nut to the specified torque.
- c) Tighten the inboard lock nut again. Hold the adjusting tube steady and tighten the inboard lock nut to the specified torque.
