TMS-NTC-12218
September 27, 2012

Re: Toyota Safety Recall 12V-373 – Interim Dealer Notification

Subject: Safety Recall CLE (Interim C2E) -Interim Notification
2010 Model Year HS 250h Vehicles
Rear Lower Suspension Arm No. 1

INTERIM TECHNICAL INSTRUCTIONS
FOR
SAFETY RECALL CLE INTERIM C2E
REAR LOWER SUSPENSION ARM No.1
CERTAIN 2010 MODEL YEAR HS250h

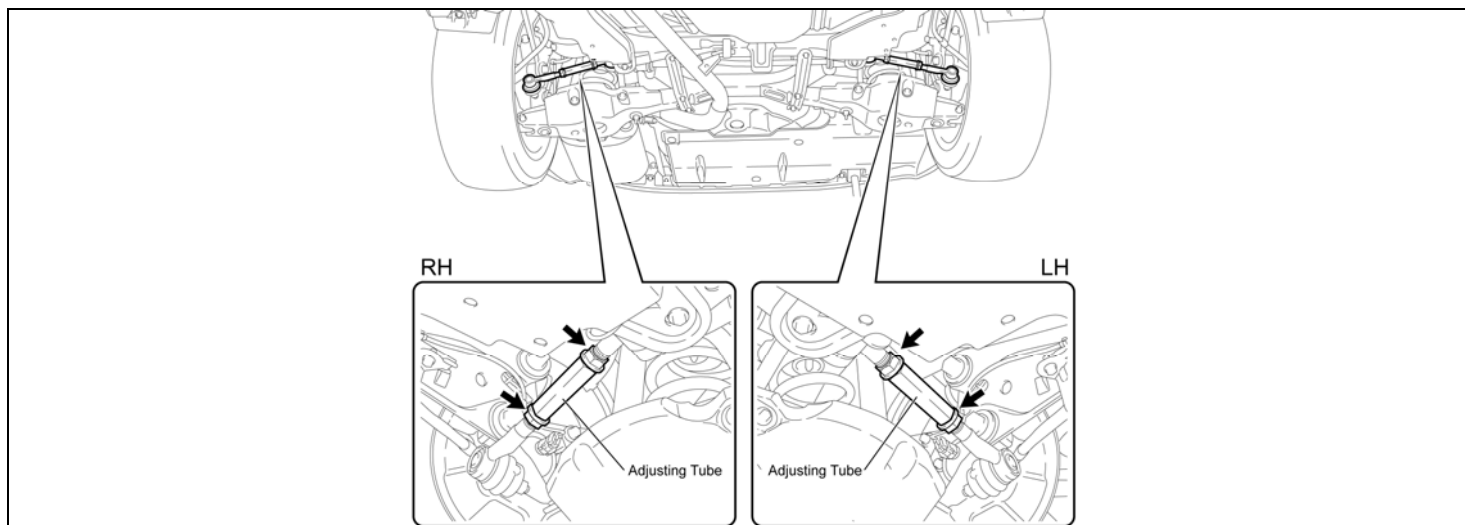
1. CHECK FOR LOOSENESS VISUALLY AND BY HAND

- a) Check visually and by hand to determine if any looseness is seen or felt in the suspension arm lock nuts or adjusting tube. Check the LH and RH arms.

- **ONLY** replace the suspension arm(s) if looseness is found.
- The arm(s) not found loose must also be checked using a torque wrench as described in steps 2-4.

CONDITION	ACTION REQUIRED
Loose	Replace the suspension arm(s) with looseness. Refer to TIS for instructions on suspension arm replacement. NOTE: <ul style="list-style-type: none">• To prevent stress on the new suspension arm bushing, apply a load to the suspension system to confirm the suspension arm bushing is aligned correctly when tightening by confirming that rear suspension arm No.1 is level with the ground.• Suspension arm adjustment and tightening procedure is critical. After replacing the arm, refer to SECTION VII. in these instructions for this procedure.
NOT Loose	Proceed to STEP 3. PLACE MATCHMARKS ON SUSPENSION ARM

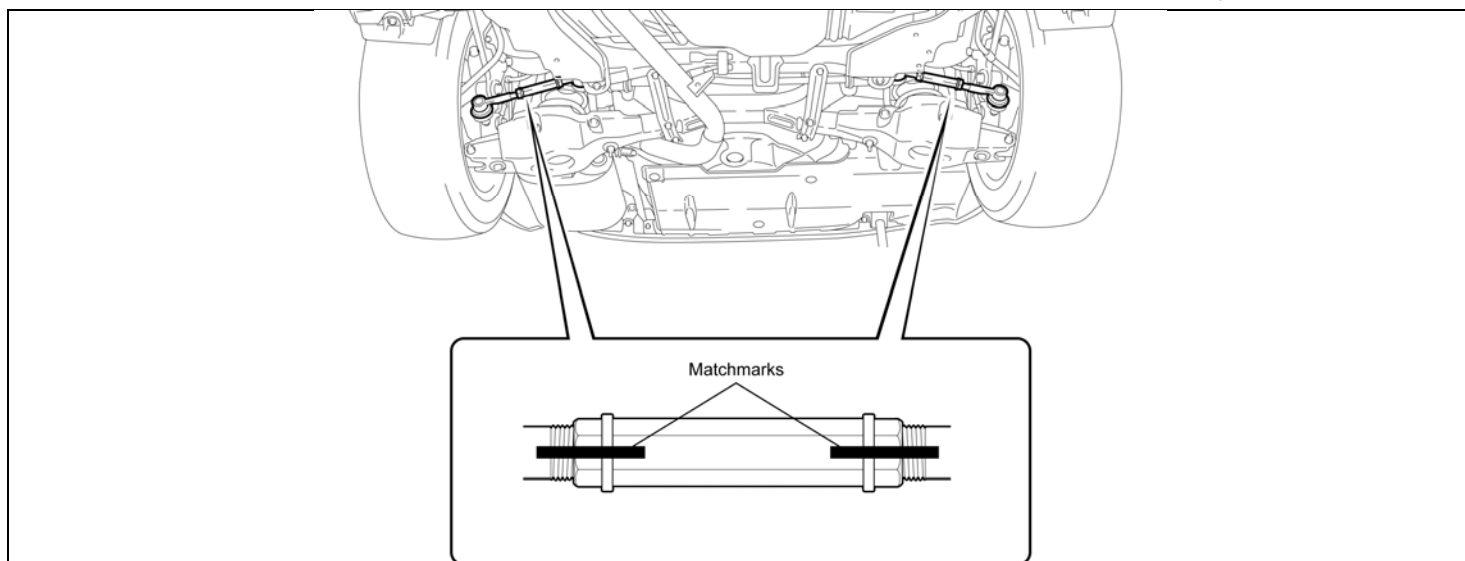
2. PLACE MATCH-MARKS ON SUSPENSION ARM

- a) Place match-marks across the suspension arms as shown. Mark the arms that were not found loose during **STEP 2**.
- b) Use these match-marks to determine if looseness is found in steps 3 and 4 when applying torque.

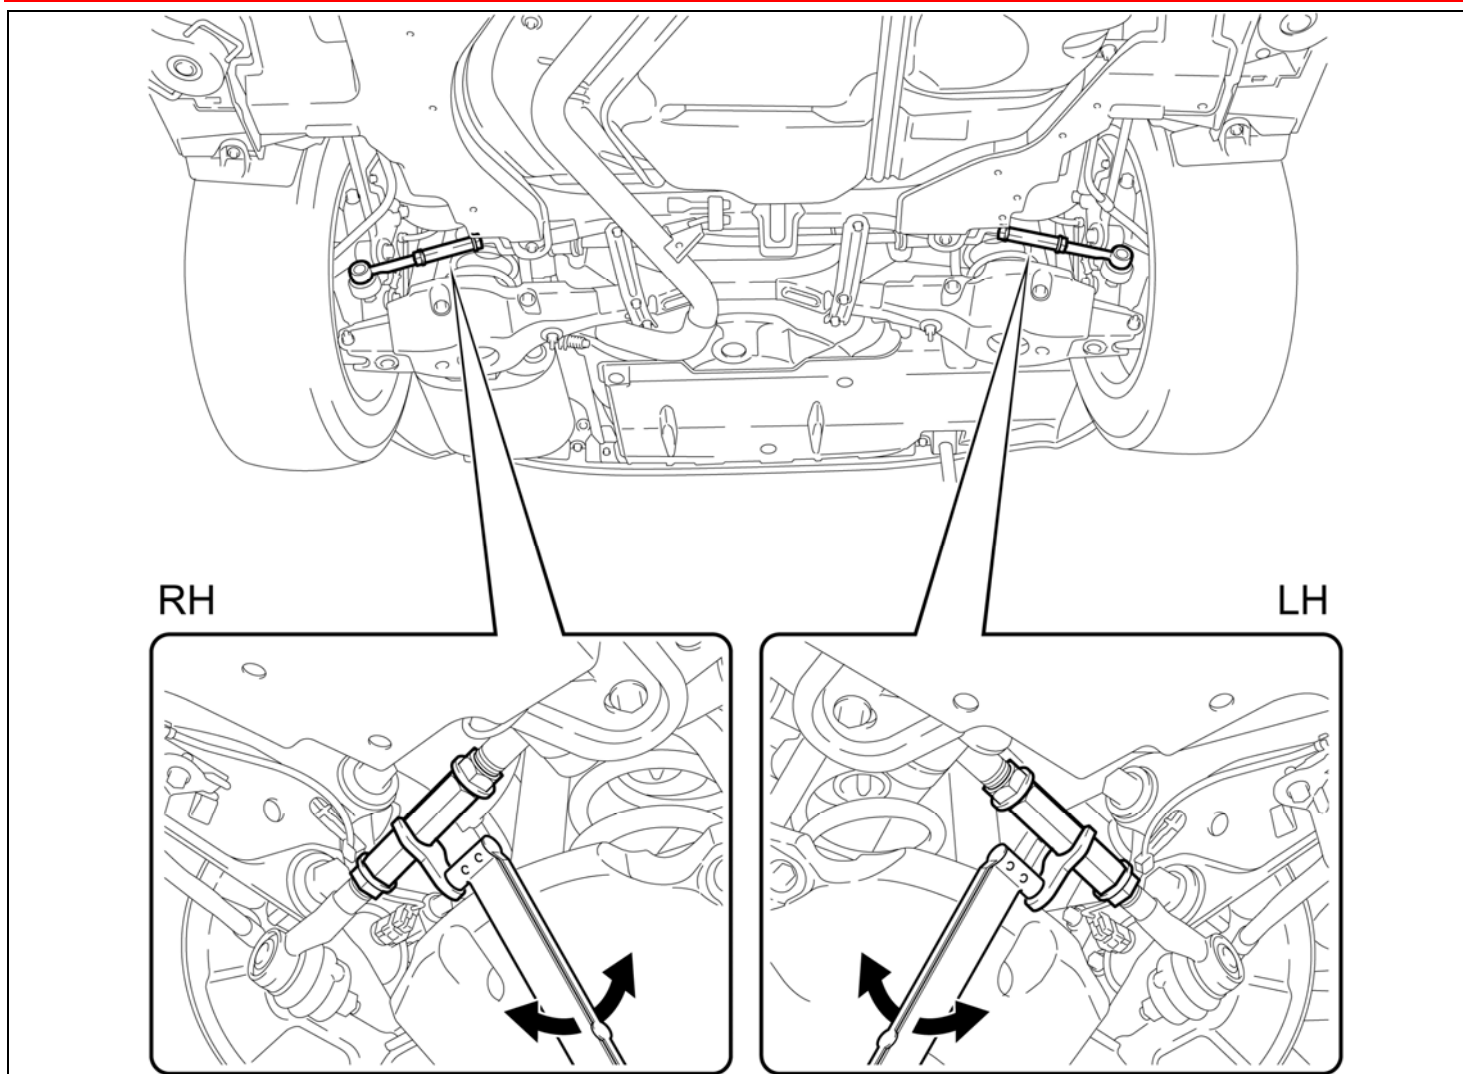
3. CHECK THE ADJUSTING TUBE FOR LOOSENESS WITH TORQUE WRENCH (This checks inboard lock nut for looseness)

- Check for looseness in the adjusting tube using a torque wrench.
- Apply the specified torque to the adjusting tube in both directions. Check the arms that were not previously found loose during **STEP 1**. Inspect the match-marks to see if they become misaligned.

Torque: 15ft. lbf (20N·m)

- Use a 22mm crowfoot attached to a 15 inch torque wrench. If a tool setup other than specified is used, refer to [TIS](#) for torque wrench calculation.

- Confirm the torque wrench is set correctly and that only the specified torque is being applied to the adjusting tube.
- ONLY** replace the suspension arm(s) if looseness is found.

CONDITION	ACTION REQUIRED
Loose	<p>Replace the suspension arm(s) with looseness. Refer to TIS for instructions on suspension arm replacement.</p> <p>NOTE:</p> <ul style="list-style-type: none"> To prevent stress on the new suspension arm bushing, apply a load to the suspension system to confirm the suspension arm bushing is aligned correctly when tightening by confirming that rear suspension arm No.1 is level with the ground. Suspension arm adjustment and tightening procedure is critical. After replacing the arm, refer to SECTION VII. in these instructions for this procedure.
NOT Loose	Proceed to STEP 5. CHECK THE OUTBOARD LOCK NUT FOR LOOSENESS

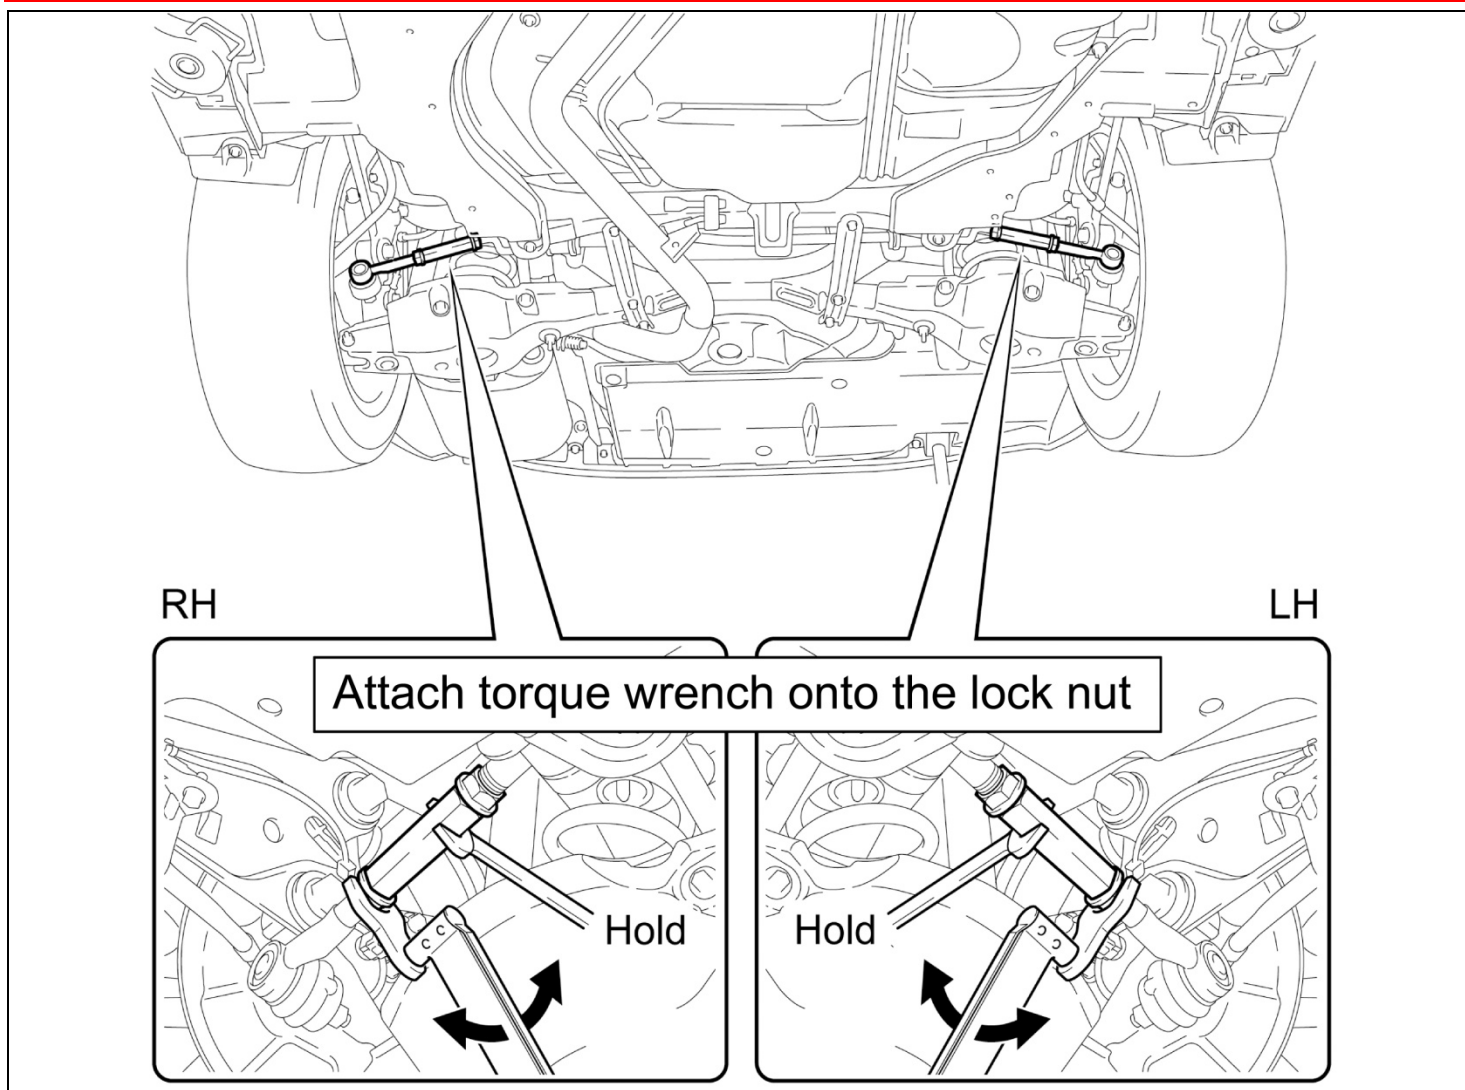
4. CHECK THE OUTBOARD LOCK NUT FOR LOOSENESS (lock nut closest to ball joint)

- While holding the adjusting tube with a wrench, check for looseness in the outboard lock nut using a torque wrench with a 22mm crowfoot attached.
- Apply the specified torque to the lock nut in both directions. Check the arms that were not previously found loose during **STEPS 1-3**. Inspect the match-marks to see if they become misaligned.

Torque: 15ft. lbf (20N·m)

- Confirm the torque wrench is set correctly and that only the specified torque is being applied to the outboard lock nut.
- ONLY** replace the suspension arm(s) if looseness is found.

CONDITION	ACTION REQUIRED
Loose	<p>Replace the suspension arm(s) with looseness. Refer to TIS for instructions on suspension arm replacement.</p> <p>NOTE:</p> <ul style="list-style-type: none"> To prevent stress on the new suspension arm bushing, apply a load to the suspension system to confirm the suspension arm bushing is aligned correctly when tightening by confirming that rear suspension arm No.1 is level with the ground. Suspension arm adjustment and tightening procedure is critical. After replacing the arm, refer to SECTION VII. in these instructions for this procedure.
NOT Loose	The interim portion of this campaign is complete. Return the vehicle to the customer

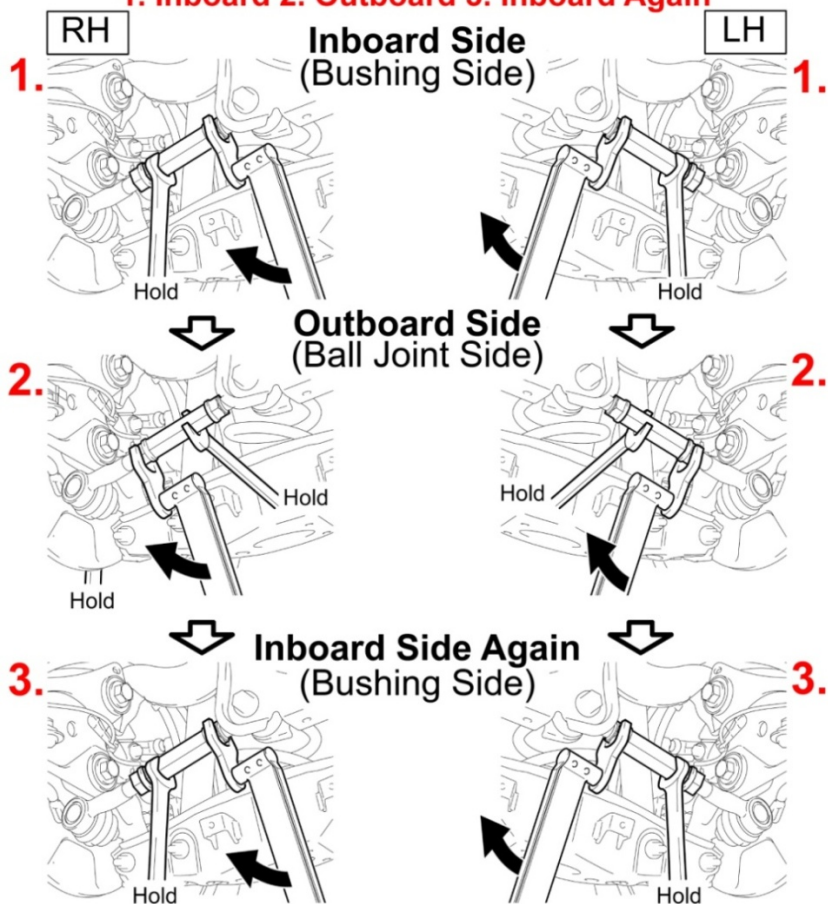
- The tightening procedure for these lock nuts is critical, failure to tighten them in the correct order could cause them to become loose.
- Confirm the alignment machine has been updated with the latest software.

Tightening Sequence:

1. Inboard 2. Outboard 3. Inboard Again
