**Re: Defect Information Report – Supplemental Report No. 3  
12V-405, FL-631, Perpendicular Air Tank Mounting Brackets  
Dealer Notification**

## **Subject: Perpendicular Aluminum Air Tank Mounting Brackets**

**Models Affected: Specific Freightliner 114SD, Business Class M2, Cascadia, and Coronado vehicles; Sterling 9500 vehicles; and Western Star 4700 vehicles manufactured July 29, 2008, through December 15, 2011.**

December 2012  
FL631AB  
NHTSA #12V-405  
Transport Canada #12-281

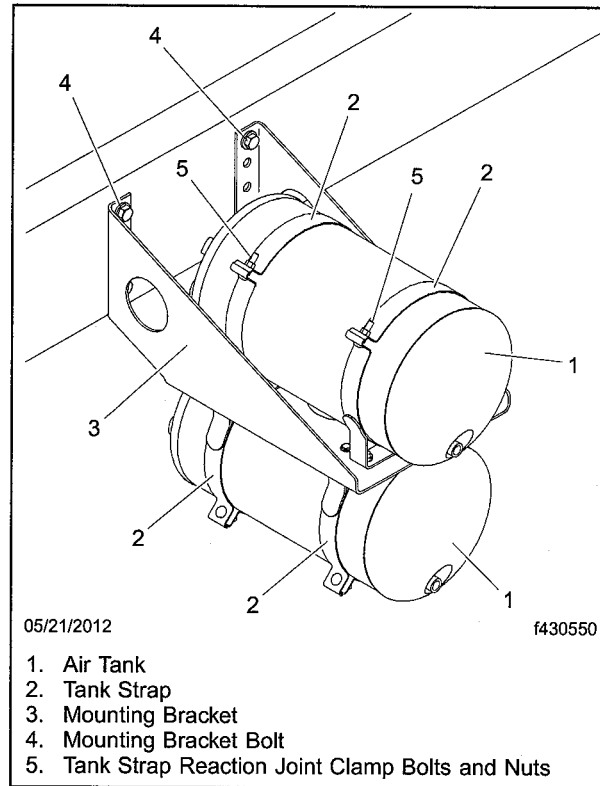
**Fig. 1, Perpendicular Air Tank Installation**

Certain perpendicular air tank mounting brackets may develop cracks under some conditions. Increasing size of the cracks may lead to air tank brackets separating from the frame rails which may lead to a loss of air in the air brake system, possibly leading to increased stopping distances. Air tanks that become separated from a moving vehicle may create a road debris hazard, increasing the risk of a crash.

Refer to Fig. 1 for this procedure.

7. Remove the aluminum air-tank mounting bracket from the frame rail.
8. Install the new steel air-tank mounting bracket on the frame rail. Tighten the mounting bolts and nuts 120 to 150 lbf-ft (163 to 203 N·m).

9. Lower the battery box, and install the fasteners. Tighten 120 to 150 lbf-ft (163 to 203 N·m).
10. Install the batteries and the battery box cover.
11. Remove the air tank cradles from the aluminum air tank mounting bracket and install them on the new steel bracket. Tighten the mounting bolts and nuts 25 to 31 lbf-ft (34 to 42 N·m).

12. Position the tanks in the cradles on the new mounting bracket and install the straps and fasteners. Tighten the reaction joint clamp bolts 26 lbf-ft (35 N·m).
