TMS-NTC-12251  
October 29, 2012

Re: Toyota Safety Recall 12V-491 – Dealer Notification (Remedy)

Subject: Safety Recall - C0M **Remedy Notification**  
Multiple Models and Model Years  
Power Window Master Switch (PWMS)

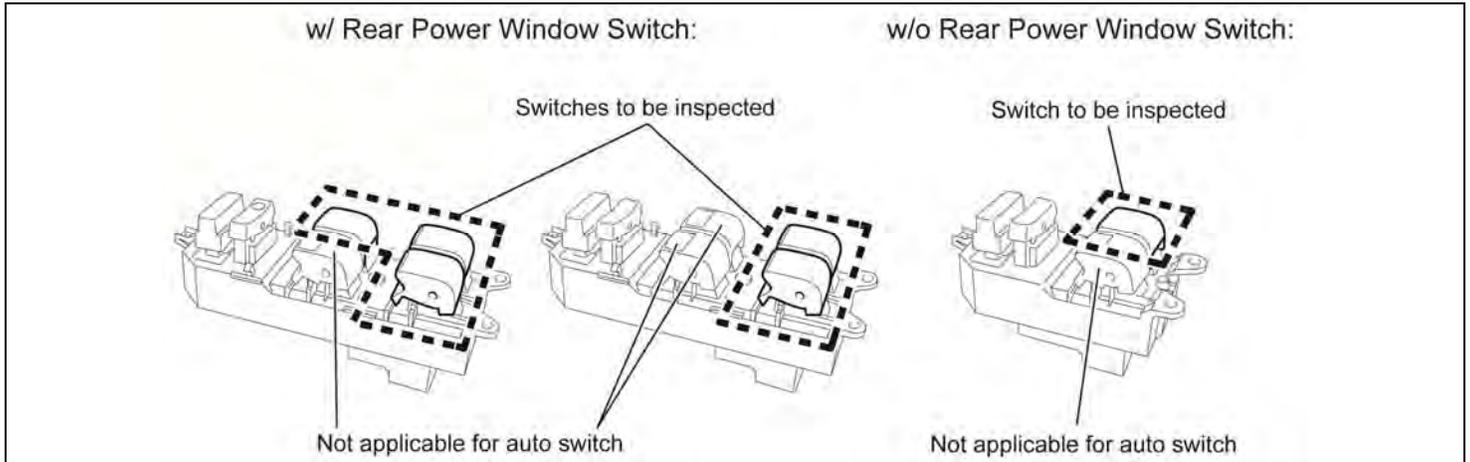
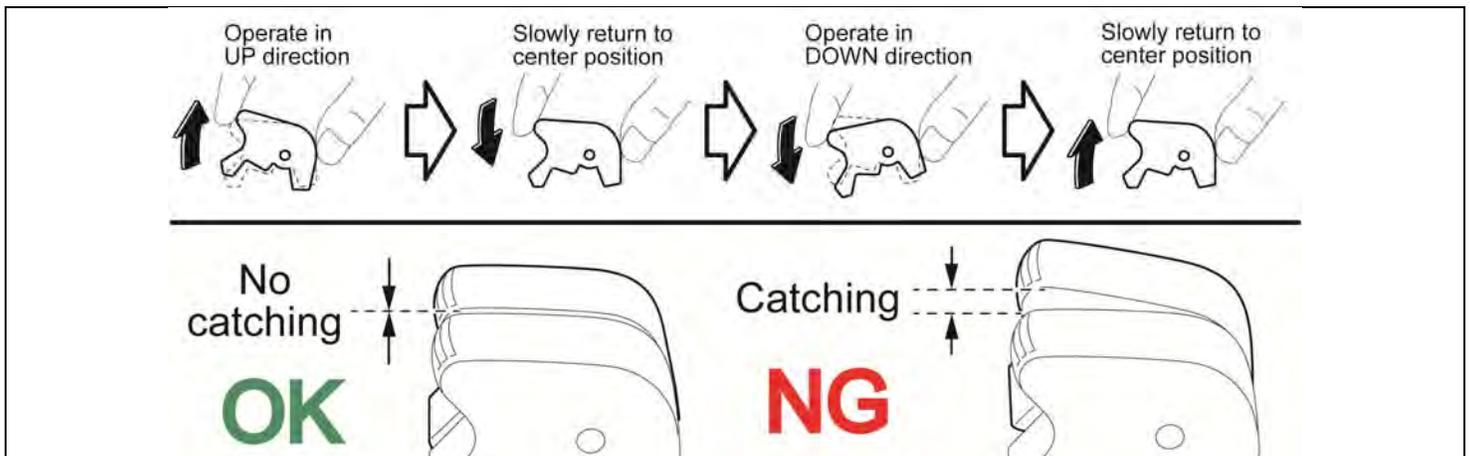
#### A. CHECK THE SWITCHES FOR CATCHING CONDITION

- **ALL** switches that **ARE NOT AUTO MUST** be inspected.
- The switches **MUST** be operated slowly, otherwise the catching cannot be noticed.
- The switches **MUST** be operated with two fingers, otherwise the catching cannot be noticed.
- The switches may feel unsmooth, this **DOES NOT** mean the switch is NG.
- Only a small number of vehicles (approximately less than 1%) will require the replacement of this part.

CONDITION	ACTION REQUIRED
<b>NONE</b> of the switches are catching.	Proceed to <b>STEP B. CHECK THE RESISTANCE OF THE SWITCHES</b>
One or more of the switches are catching.	Replace the power window master switch circuit board. Proceed to <b>STEP B, 1-2</b> for switch disassembly instructions. <b>NOTE:</b> <ul style="list-style-type: none"> <li>• <b>Mark the NG circuit board with an 'X' so that it is not reused.</b></li> <li>• <b>There is NO NEED to apply grease to the new circuit board.</b></li> </ul>

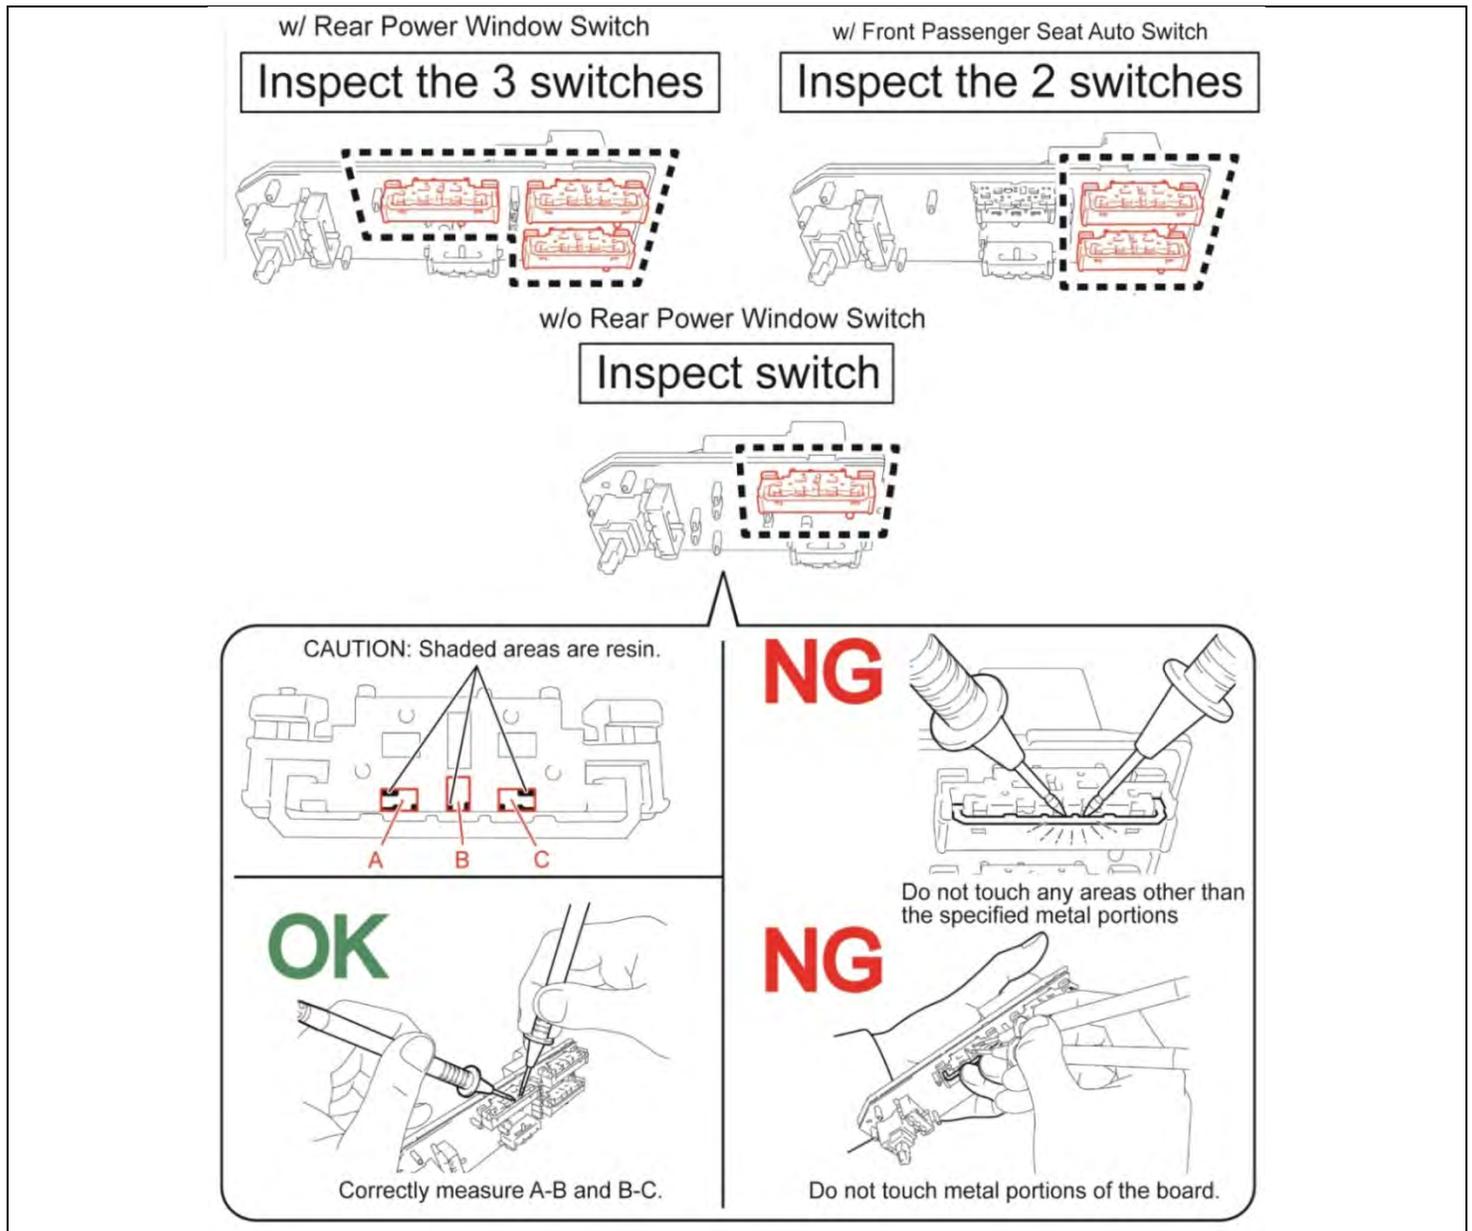
- If the the ZERO calibration function is not performed, the readings may be inaccurate.
- Set the DVOM to the maximum resistance range.
- DO NOT** touch any metal other than points A, B, C on the circuit board when checking resistance.
- The points being checked are small, confirm the probes are contacting the correct points.
- ALL** switches that **ARE NOT AUTO** **MUST** be checked.

CONDITION	ACTION REQUIRED
Resistance value for <b>ALL</b> switches is infinite.	Fill the switches with grease. Proceed to <b>SECTION IX. GREASE APPLICATION</b>
One or more resistance value <b>IS NOT</b> infinite.	Replace the power window master switch circuit board. Proceed to <b>SECTION X SWITCH REASSEMBLY</b> <b>NOTE:</b> <ul style="list-style-type: none"> <li>Mark the NG circuit board with an 'X' so that it is not reused.</li> <li>There is <b>NO NEED</b> to apply grease to the new circuit board.</li> </ul>

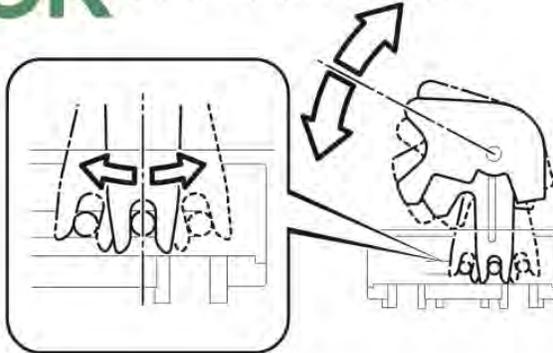
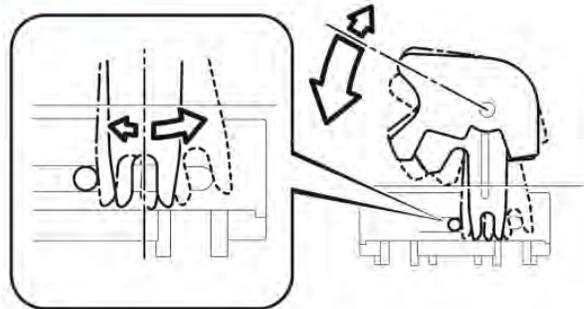
**OK** Same Movement Amount

**NG** Movement Amount is Different

CONDITION	ACTION REQUIRED
Movement is equal in <b>ALL</b> switches.	The circuit board is positioned correctly. Proceed to <b>STEP 4. INSTALL THE ONE-WAY SCREWS</b>
Movement in one or more switch <b>IS NOT</b> equal.	One or more switch pin is misaligned. Repeat <b>STEPS 1-3</b>

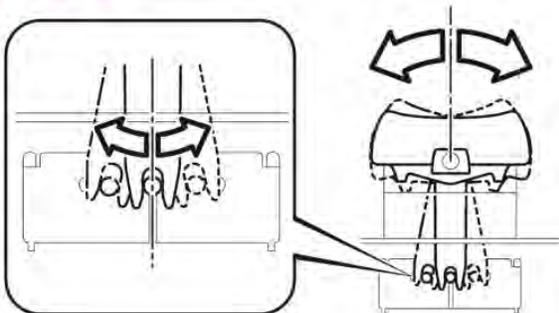
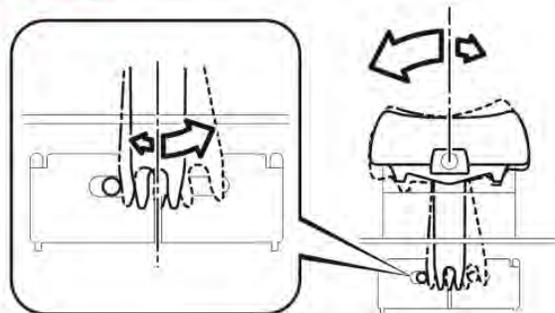
#### Door Control Switch

**OK** Same Movement Amount

**NG** Movement Amount is Different
