Re: Toyota Safety Recall 12V-491 – Preliminary Dealer Notification

Safety Recall - C0M (C1M) *Preliminary Notification*

Multiple Models and Model Years
 Power Window Master Switch (PWMS)

SAFETY RECALL C0M

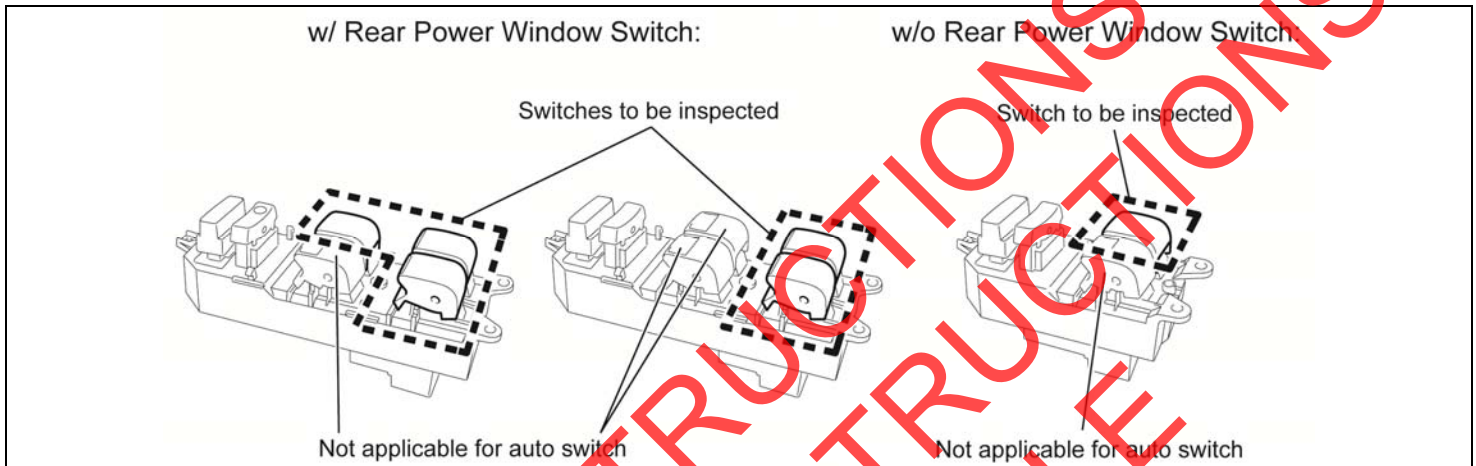
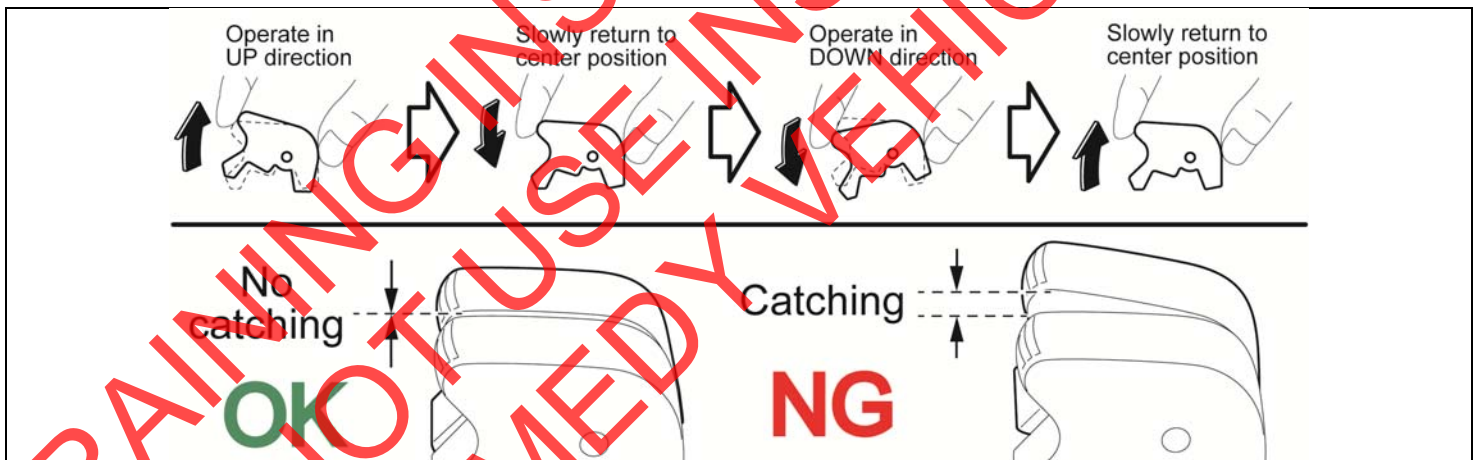
A. CHECK THE SWITCHES FOR CATCHING CONDITION

- **ALL** switches that **ARE NOT AUTO** **MUST** be inspected.
- The switches **MUST** be operated slowly, otherwise the catching cannot be noticed.
- The switches **MUST** be operated with two fingers, otherwise the catching cannot be noticed.
- The switches may feel unsmooth, this **DOES NOT** mean the switch is NG.
- Only a small number of vehicles (approximately less than 1%) will require the replacement of this part.

| CONDITION | ACTION REQUIRED |
|---|---|
| One or more of the switches are catching. | Replace the power window master switch circuit board. Proceed to STEP B, 1-2 for switch disassembly instructions. NOTE: <ul style="list-style-type: none">• Mark the NG circuit board with an 'X' so that it is not reused.• There is NO NEED to apply grease to the new circuit board. |

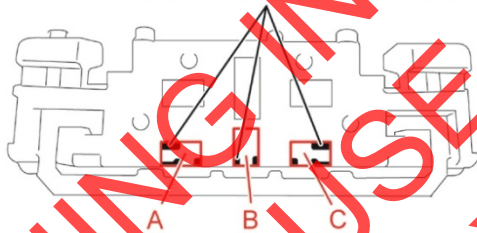
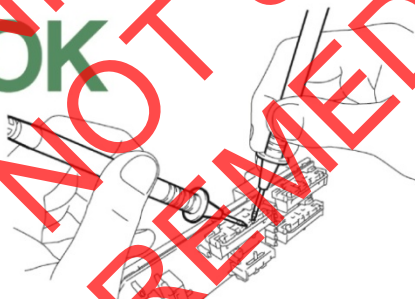
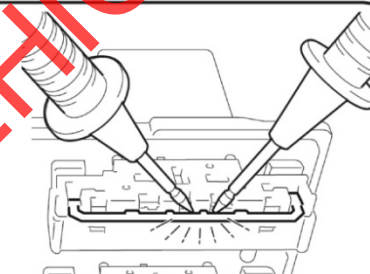
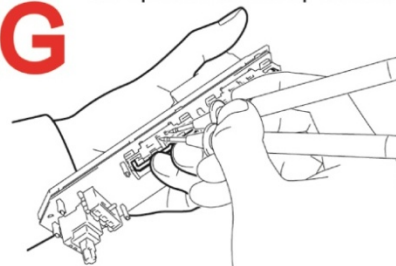
CAUTION: Shaded areas are resin.

Correctly measure A-B and B-C.

Do not touch any areas other than the specified metal portions

Do not touch metal portions of the board.

| CONDITION | ACTION REQUIRED |
|---|--|
| One or more resistance value IS NOT infinite. | Replace the power window master switch circuit board. Proceed to SECTION X SWITCH REASSEMBLY NOTE: <ul style="list-style-type: none">• Mark the NG circuit board with an 'X' so that it is not reused.• There is NO NEED to apply grease to the new circuit board. |

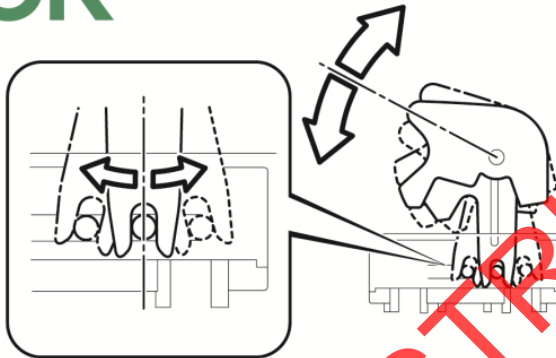
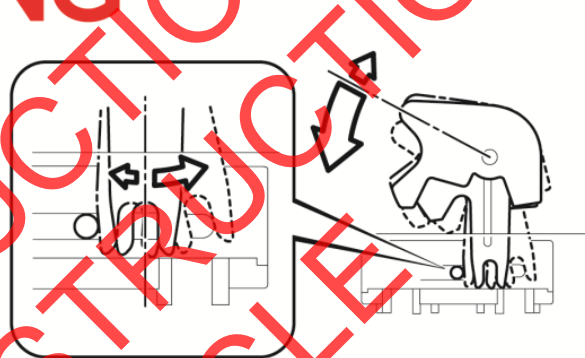
Same Movement Amount

Movement Amount is Different

| CONDITION | ACTION REQUIRED |
|---|--|
| Movement in one or more switch IS NOT equal. | One or more switch pin is misaligned. Repeat STEPS 1-3 |

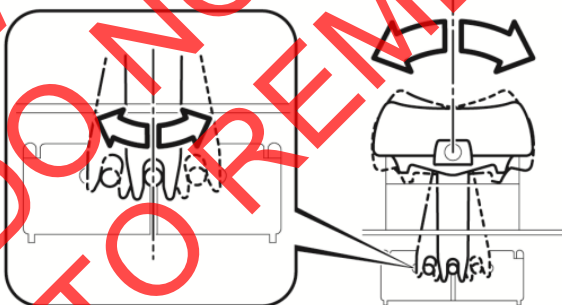
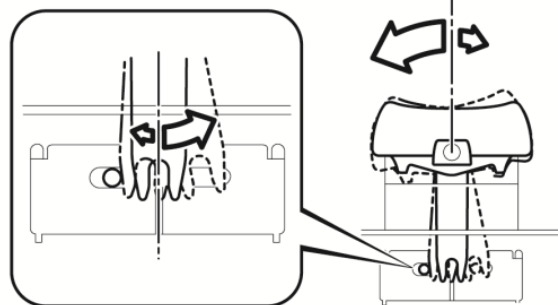
Same Movement Amount

Movement Amount is Different
