TMS-NTC-12277
November 20, 2012

Re: Toyota Safety Recall 12V-528 – Dealer Notification Remedy

Subject: Safety Recall - C0S **Remedy Notification**
2012 to early 2013 Model Scion iQ Vehicles
Occupant Classification System (OCS)

TECHNICAL INSTRUCTIONS
FOR
SAFETY RECALL C0S
OCCUPANT CLASSIFICATION SYSTEM (OCS)
2012 – EARLY 2013 MODEL YEAR SCION iQ

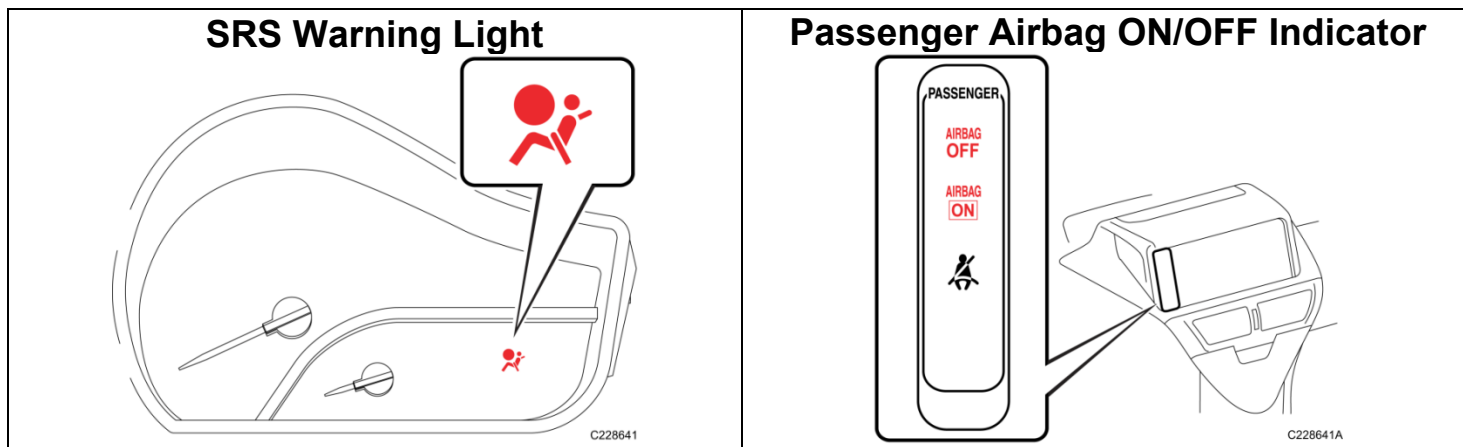
1. CHECK ILLUMINATION STATUS OF SRS WARNING LIGHT AND PASSENGER AIRBAG ON/OFF INDICATOR

CONDITION	ACTION REQUIRED
Indicator or Light NOT illuminated	Install the four OCS Protective Covers. Proceed to VII. INSTALL THE OCS PROTECTIVE COVERS
SRS Warning Light illuminated	Diagnose as outlined in the repair manual. NOTE: If diagnosis leads to seat adjuster assembly replacement, use the campaign part which already has the protective covers installed. If the seat adjuster assembly is not replaced, proceed to step VII. INSTALL THE OCS PROTECTIVE COVERS
Passenger Airbag ON/OFF Indicator illuminated	Replace the front seat adjuster assembly, then proceed to section VII. STEP 9. REINSTALL THE FRONT SEAT UNDER TRAY Refer to TIS for instructions on front seat adjuster assembly replacement
