Recall Campaign: Replace Hex Bolt with Internal Thread for Deflection Pulley

E70 with M57Y engine

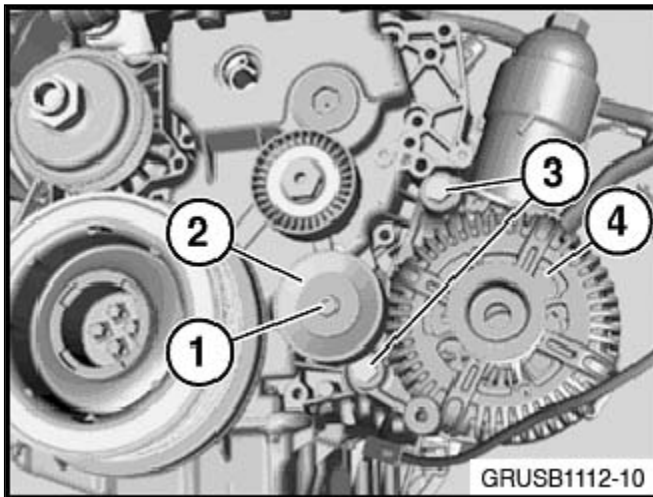
One of the alternator attaching bolts may fail. Subsequently the vehicle may lose power steering assist while driving. If power steering assistance is lost, the vehicle will remain controllable through the mechanical steering system, but with increased steering effort.

3. Remove cover (1) from Deflection pulley (2) to access the mounting bolt. Remove the deflection pulley (2).

4. Replace the alternator and deflection pulley mounting bolt with P/N 12 31 8 574 809.
5. Torque the bolt to 38 Nm initial torque and then angle torque the bolt an additional 180°.
6. Reassemble the vehicle.
