BLUE BIRD

R12TU

**Recall R12TU
Braun Lift Outer Rollstop Latch Recall
Recall Completion Reply Sheet**

Service Bulletin 37679

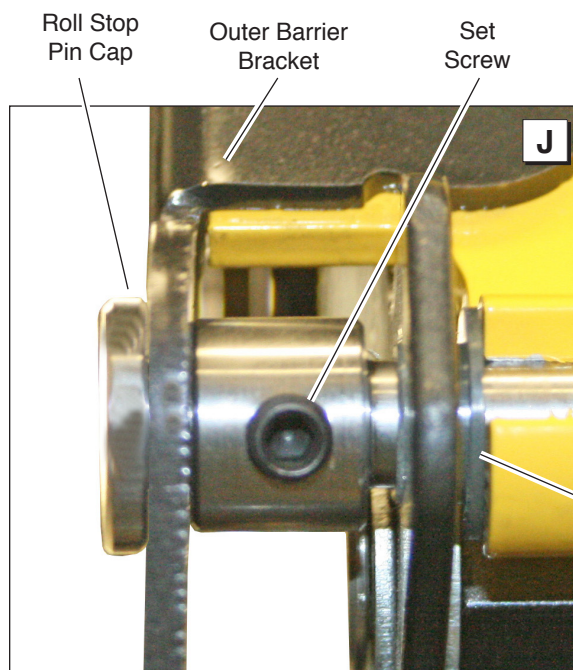
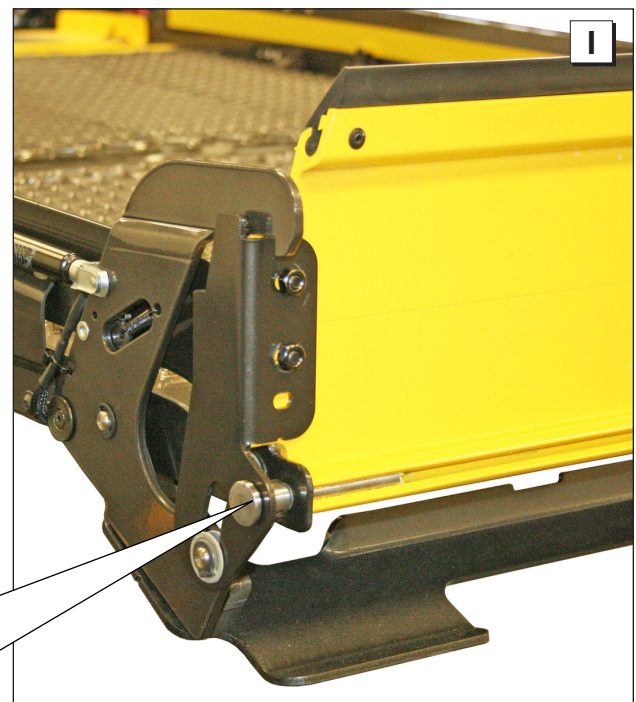
Ensure Plastic Flange
Bearing Remains in Position

10. Install roll stop pin cap. Apply Loctite® Threadlocker Blue 242™ or equivalent on threads. Secure with set screw. See Photos I and J.
