PREVOST SAFETY RECALL CAMPAIGN SR12-16 "ACCELERATOR PEDAL THROTTLE POSITION SENSOR REPLACEMENT"

**SAFETY
RECALL**

SR12-16

DATE : JULY 2012	SECTION : 03-FUEL
SUBJECT : ACCELERATOR PEDAL THROTTLE POSITION SENSOR REPLACEMENT

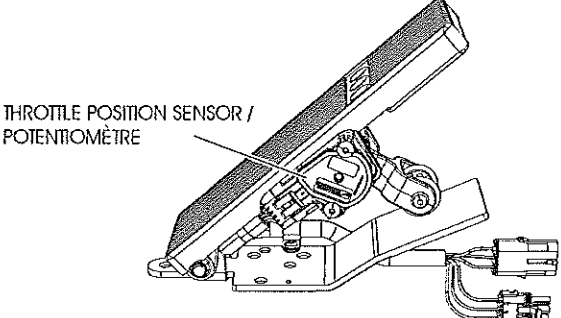
<p>1. Locate accelerator pedal throttle position sensor on the accelerator pedal assembly.</p>

<p>THROTTLE POSITION SENSOR / POTENTIOMÈTRE</p>
<p>2. Disconnect harness from sensor. 3. Unscrew sensor fasteners (2) and remove throttle position sensor. Return sensor to Prevost for reimbursement.</p>

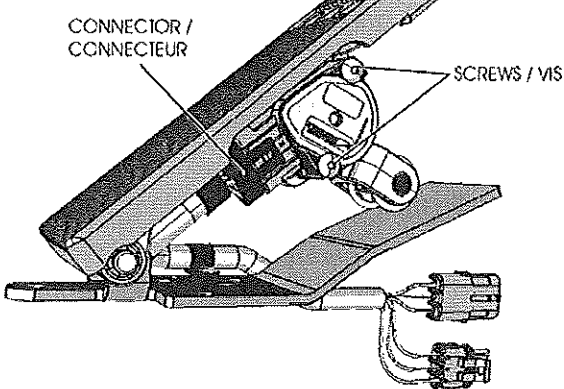
<p>CONNECTOR / CONNECTEUR</p> <p>SCREWS / VIS</p>
<p>4. Make sure the rotary piece at the center of the new throttle position sensor is completely turned counterclockwise prior installation, if not, stationary regenerations might be impossible to initiate.</p>
