SAFETY RECALL – OUTER ROLLSTOP BARRIER LATCH  
ON BRAUN CENTURY AND VISTA 2ND GENERATION PARALLEL ARM LIFTS

## Service Bulletin 37679

Applicable for NCL and NVL Series AA-DA

Installation Kit 945-12E002

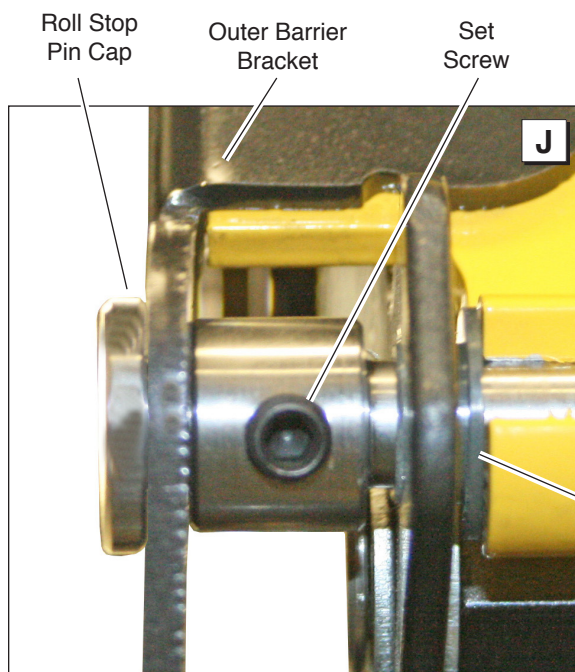
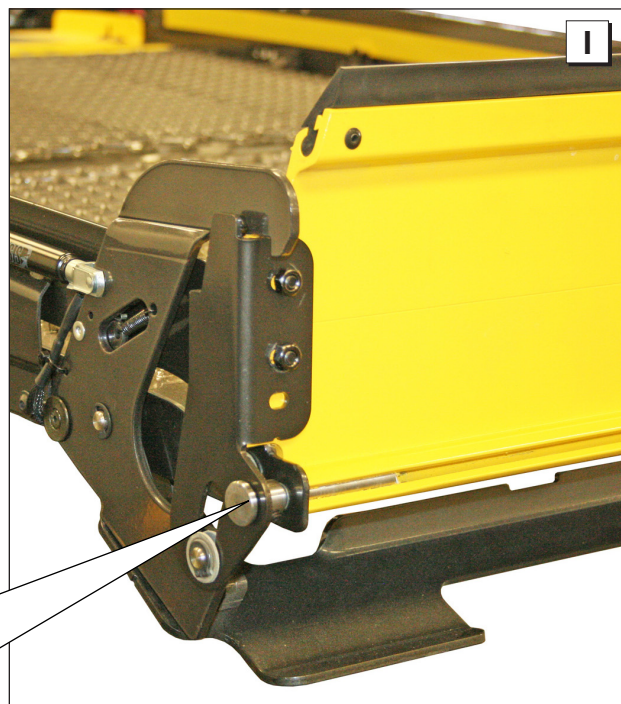
Ensure Plastic Flange  
Bearing Remains in Position

10. Install roll stop pin cap. Apply Loctite® Threadlocker Blue 242™ or equivalent on threads. Secure with set screw. See Photos I and J.
