MAB 563

MANDATORY ACTION BULLETIN

AH85/100 Main Pivot Pin Inspection

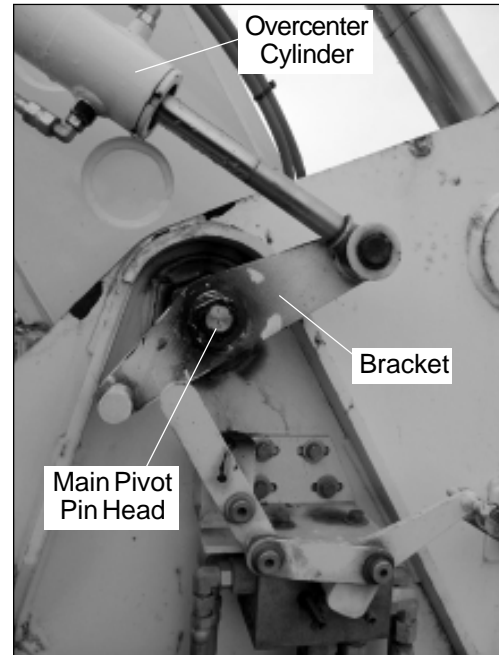
Figure 1 — Components

4. Remove the cover on the streetside of the turntable.
5. Remove the snap ring holding the overcenter cylinder on the pin attached to the main pivot pin head (refer to Figure 1). Remove the snap ring on the other end of the overcenter cylinder. Remove the overcenter cylinder.

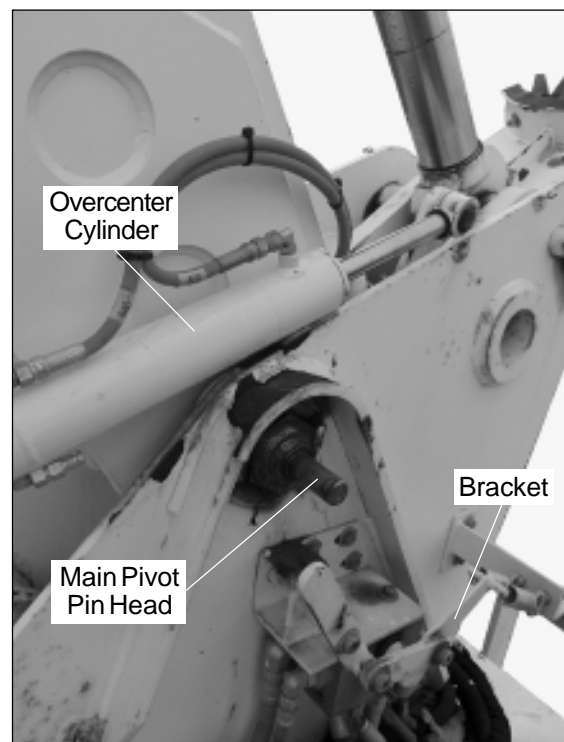
Figure 2 — Pipe Location

6. Remove the snap ring on end of the main pin on street side of unit.
7. Remove overcenter pivot on the end of main of the main pivot pin shaft.
8. Slide the 36" piece of pipe over end of main pivot pin where over center pivoting arm mounts (refer to Figure 2).

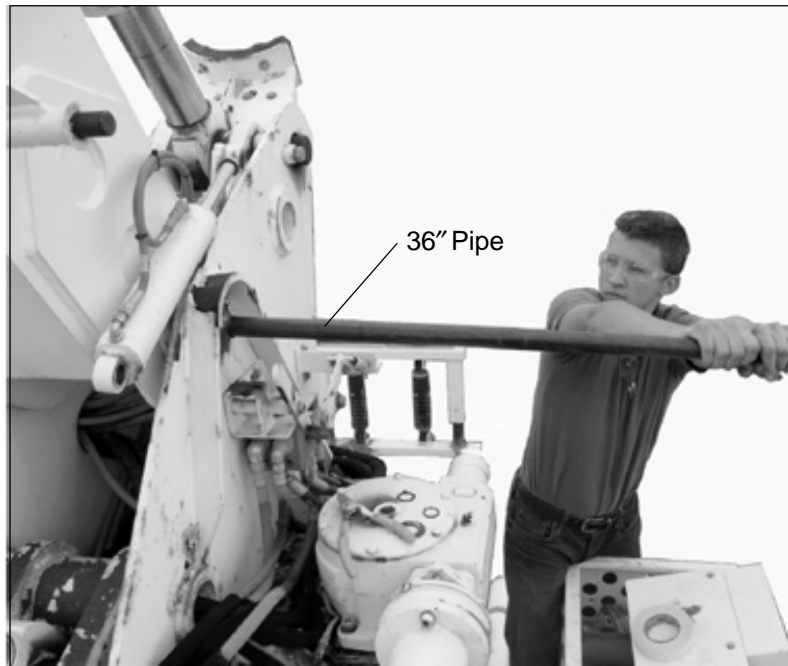
Figure 3 — Performing The Test

9. Grasp the pipe with both hands and cautiously move the pipe in various directions (up, down, front, and back) using approximately 100-150 pounds of force applied at far end of pipe (refer to Figure 3).

10. If the main pivot pin head fails and cracks or breaks off while using the pipe, remove the unit from service and replace the main pivot pin.

11. If the main pivot pin head does not fail or crack, reinstall the parts removed in Steps 4 through 8. The unit can continue to be used, but the main pivot pin must be replaced no later than 30 days from receipt of this MAB.
12. Stow the booms. Retract the outriggers. Disengage the unit's hydraulic system.
