# Customer Service Notice

Date: October 12, 2012

Units Affected: DL/DM Series (serial numbers starting with 0111 through 0812),  
DC Series (serial numbers starting with 0111 through 0712),  
D2000A/3000A/4000A Series (serial numbers starting with  
0111 through 0812),  
and D2000B/3000B/4000B Series Digger Derricks  
(serial numbers starting with 0412 through 0712),  
using 2 1/2" Auger Extension Shaft (Kelly Bar)

## Auger Extension Shaft Replacement

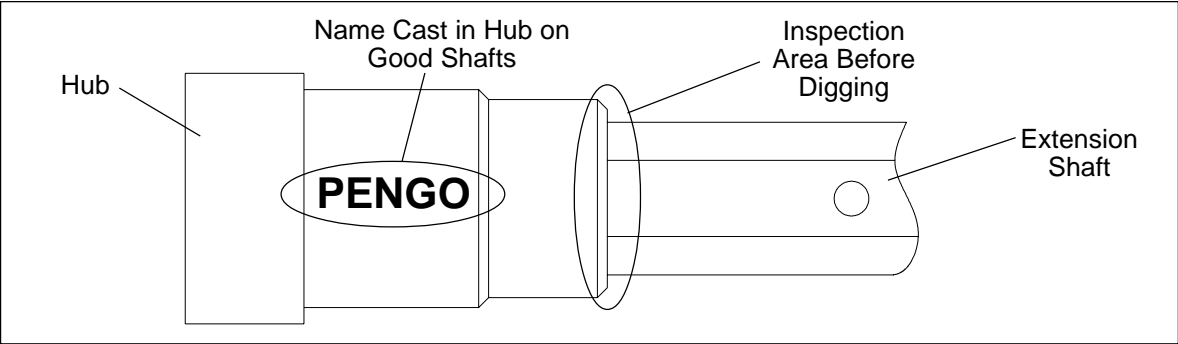
Figure 1 — Auger Extension Shaft Hub

Altec has been notified by our supplier that there is a possibility of a defective weld joint between the hub and the shaft on certain auger extension shafts, which could result in a stress fracture. The stress fracture could cause the extension shaft to separate from the drive hub when digging, increasing the risk of personal injury and/or property damage.

Altec requires an immediate inspection of the 2 1/2" auger extension shaft on the digger derrick and any 2 1/2" auger extension shaft that was ordered as replacement part. Inspect the extension shaft hub for the name "PENGO" cast in the side of the hub (refer to Figure 1). If "PENGO" is on the hub, the auger extension shaft does not require replacement.

If "PENGO" is not on the hub, the auger extension shaft must be replaced within 30 days of the inspection. The auger extension shaft can continue to be used until replacement, but a visual inspection for cracks must be done each time the digger is used (refer to Figure 1). *Visual evidence of cracks may not always be present on the external surface of the noted inspection area in Figure 1. Some cracks may originate from the inside surface.* Always follow safe work methods as described by OSHA and in the Altec Operator's manual that pertain to maintaining a safe working distance away from the auger.

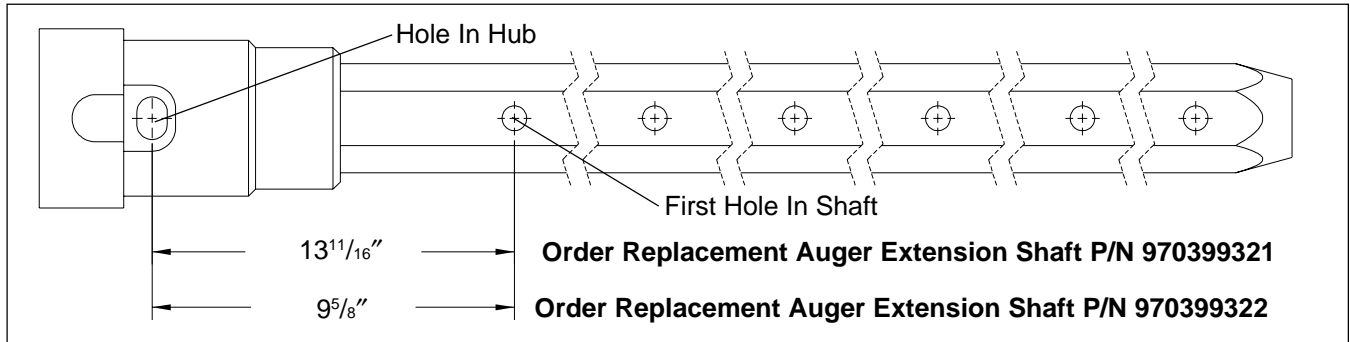
**Figure 2 — Auger Extension Shaft Identification**

The auger extension shafts affected by the CSN, part numbers 070000041 and 070000042, are the same diameter, but the distance from the hole in the hub and the first extension shaft hole is different (refer to Figure 2). Measure the distance and match that dimension with the ones shown on the Figure to order the correct part as shown on the Figure. Call 1-877-GO-ALTEC (1-877-462-5832) to order a replacement part.
