## SAFETY RECALL G-12529

NOVEMBER 2012

Navistar has decided that a defect which relates to motor vehicle safety exists in certain LoneStar®, ProStar®, and WorkStar® model trucks built 22 April 2012 thru 29 October 2012 with steering wheel feature codes 05CAW, 05CAX, 05CAZ, 05CBA or 05WBD.

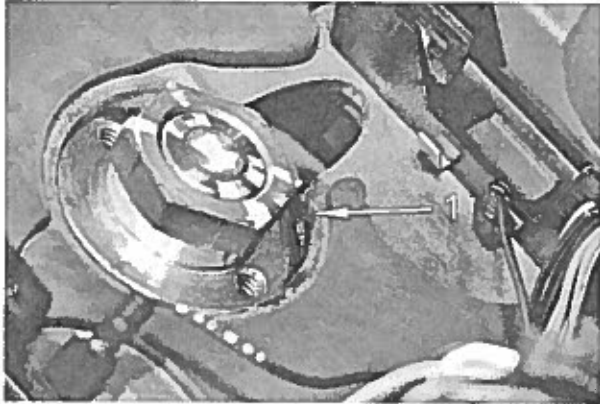
**Figure 3**  
1 Gap between center hub and outer ring.

5. If the steering wheel feels at all "flexible" (sensation the steering wheel may be lifting away from its attaching point), look closely at the center of the wheel assembly, where the center hub joins the outer ring of the wheel. Refer to figure 3.

6. If a small gap opens between the center hub and the outer ring on either side, immediately have the vehicle towed to the nearest authorized International Truck Dealership for further inspection and repair (Figure 3). If there is no movement as a result of step 3 (Figure 4), drive vehicle to the nearest International Truck Dealership, for a more detailed steering wheel inspection.

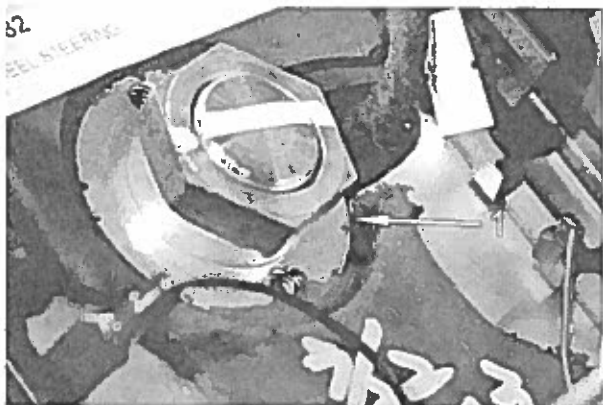
**Figure 4**  
1 No gap

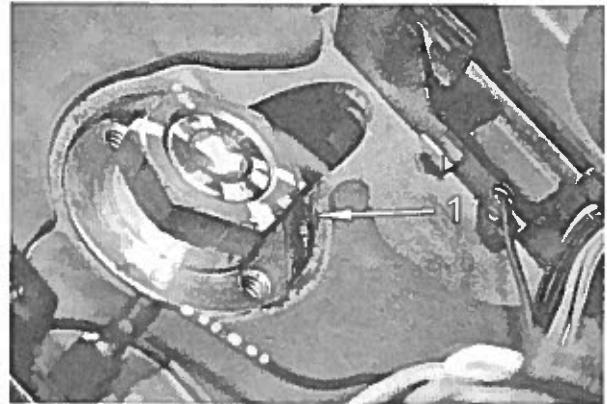
**Figure 3**  
1 Jeu entre le moyeu central et la bague extérieure.

5. Si vous décelez le moindre jeu (si vous avez la sensation que le volant se soulève de son point de fixation) examinez de près le centre du volant, à l'endroit où le moyeu central rejoint la bague extérieure du volant. Reportez-vous à la figure 3.

6. Si un petit jeu est présent entre le moyeu central et la bague extérieure, faites remorquer le véhicule immédiatement chez le concessionnaire Camion International le plus près pour qu'il soit examiné et réparé (figure 3). Si aucun jeu n'est décelé après avoir effectué l'étape trois (figure 4), rendez-vous chez un concessionnaire Camion International pour une inspection approfondie du volant.

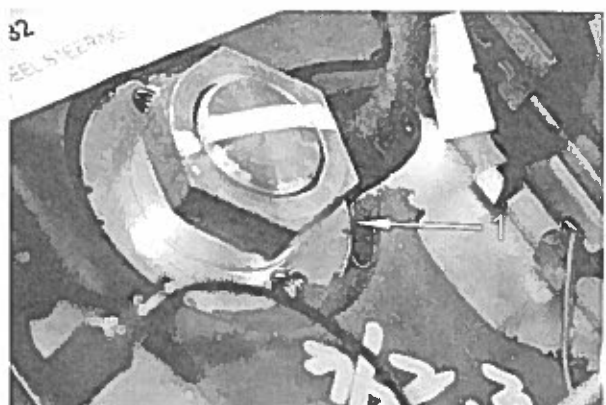
**Figure 4**  
1 Aucun jeu
