SAFETY DEFECT / NONCOMPLIANCE NOTICE

PREVOST SAFETY RECALL CAMPAIGN SR12-39 " POWER CABLE RUBBING ISSUE "

Sr12-39

DATE : OCTOBER 2012	SECTION : 06-ELECTRICAL
SUBJECT : POWER CABLE RUBBING ISSUE

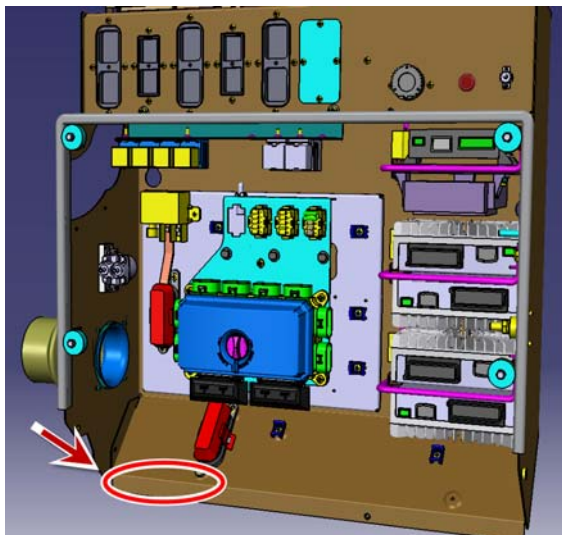
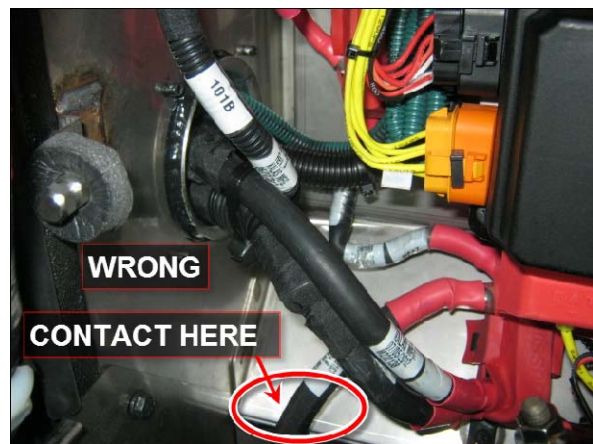
ITEM 2

Power cable 24EE1

Make sure that power cable 24EE1 doesn't come into contact with sheet metal edge as shown on the image at right.

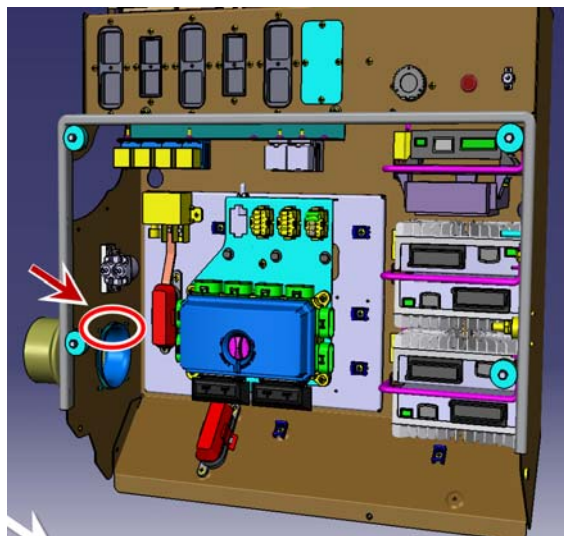
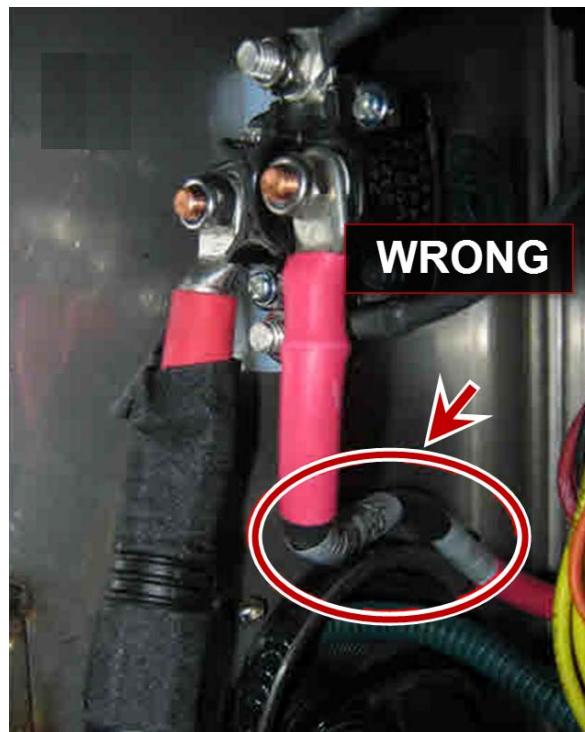
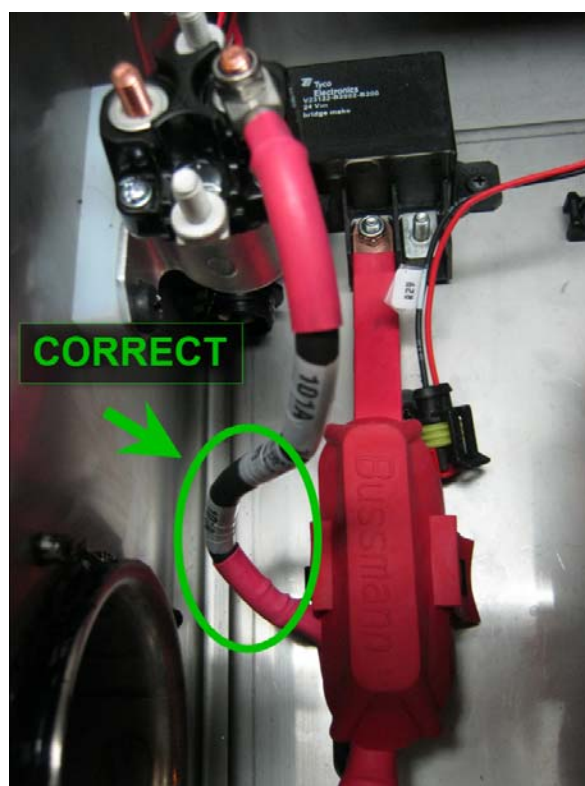
ITEM 3

Power cable 101A connected to starter relay

Eliminate any contact between power cable 101A and the cable grommet.

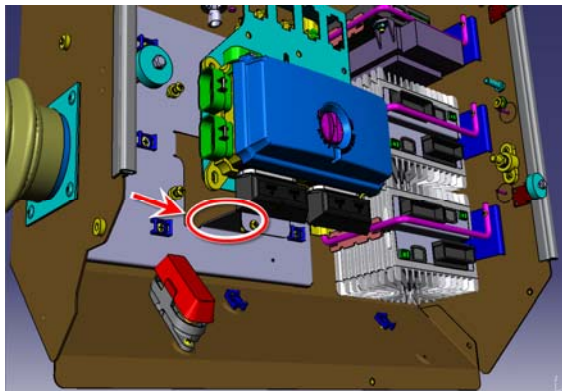
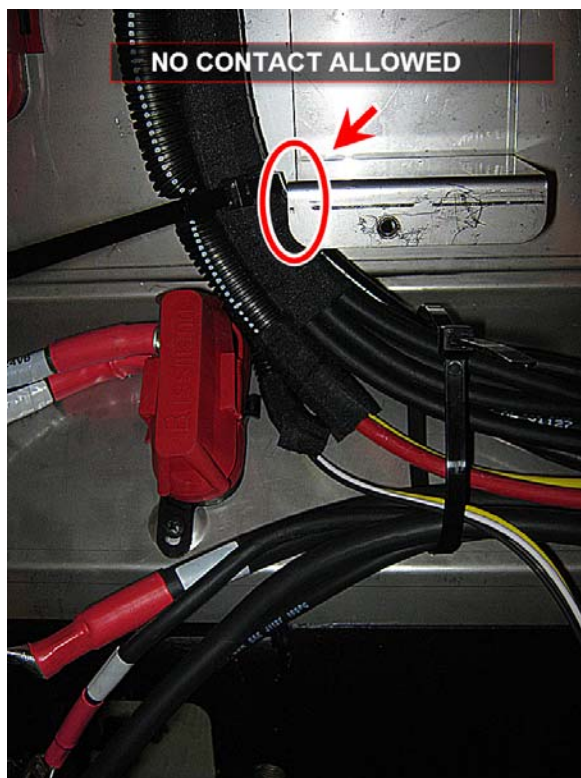
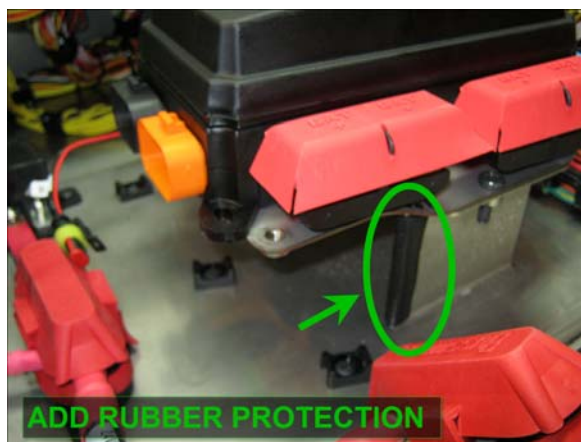
ITEM 4

Power cables under the VECR

Make sure that power cables do not come into contact with the metal edge of VECR support bracket. Add rubber protection 420584.

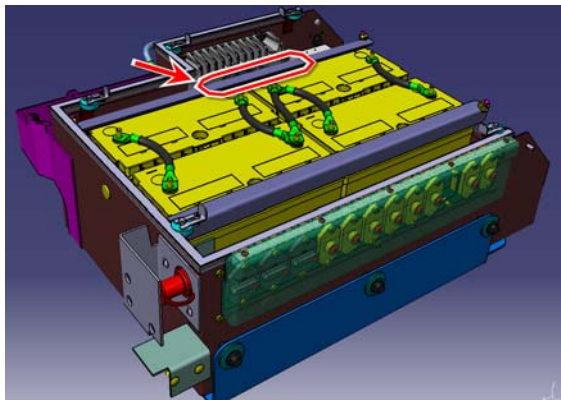
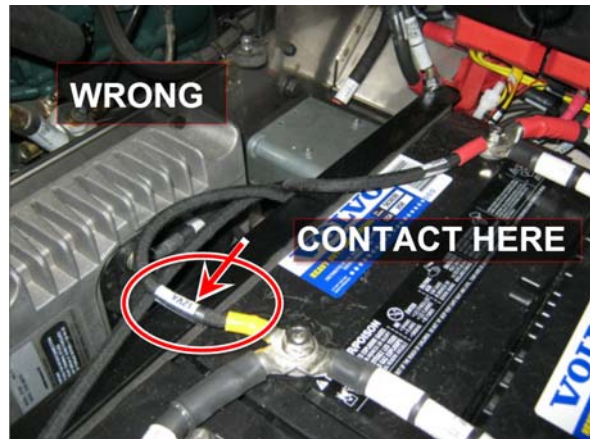
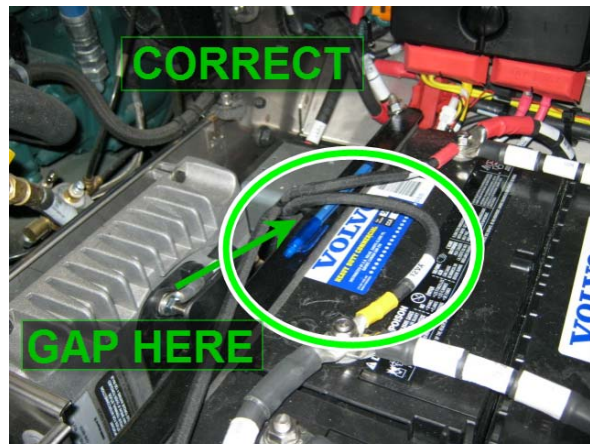
ITEM 1

Power cables 12VA, 24VA connected between battery terminals and battery equalizer

Loosen battery post nut and turn cable 12VA terminal to move the loop as shown on the image at right.

Arrange the cables in a different manner to avoid possible rubbing against the angle.

BATTERY POST NUT: 170 lbf-in

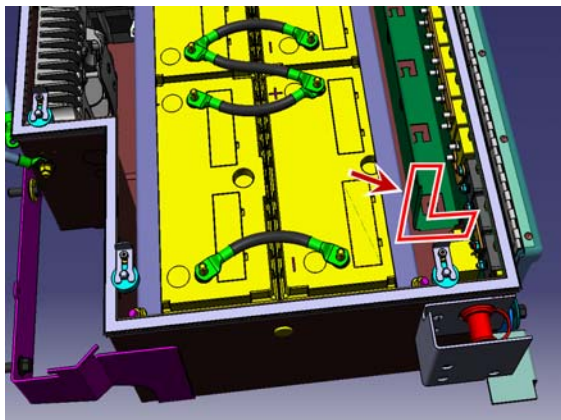
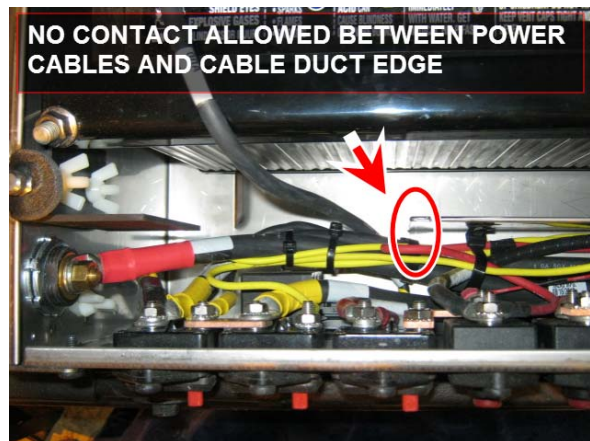
ITEM 2

Booster block cable and power cables

Check that the cables do not come into contact with the cable duct edge.

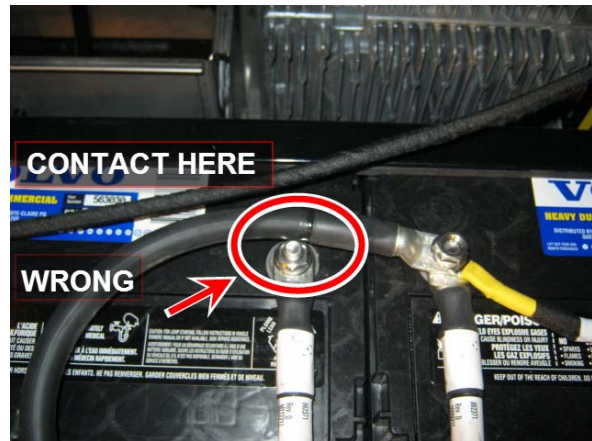
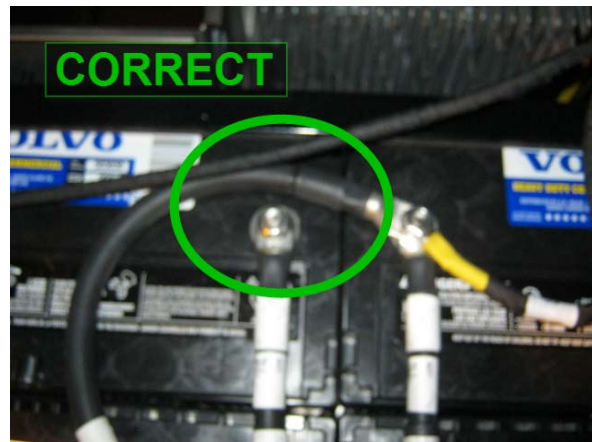
ITEM 3

Battery cable touching the battery post

Rearrange the battery cable to prevent rubbing against battery post.

BATTERY POST NUT: 170 lbf-in

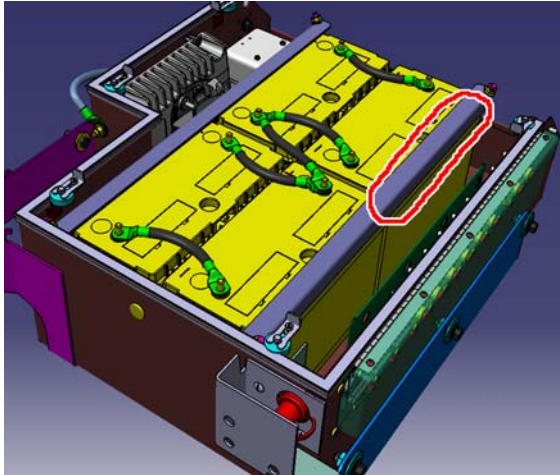
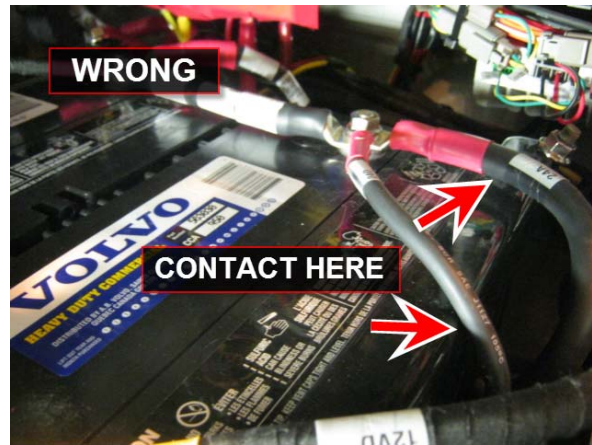
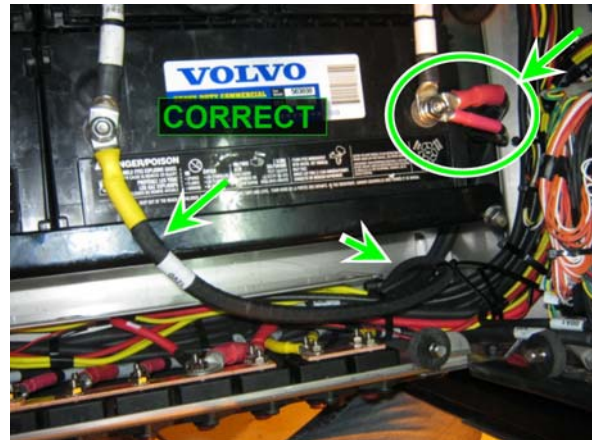
ITEM 4

Battery cables connected to circuit breakers

Rearrange the battery cables to prevent rubbing against the angle and other edges. Loosen battery post nut and rotate the battery cables as shown.

BATTERY POST NUT: 170 lbf-in

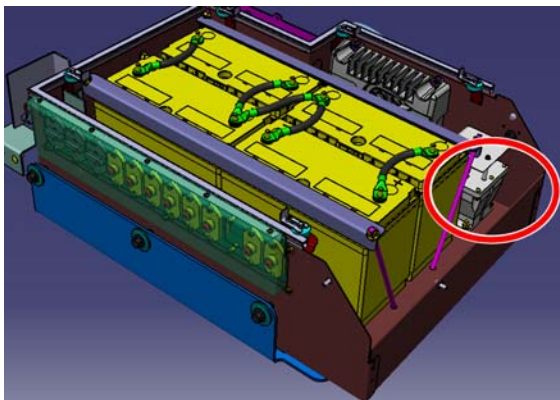
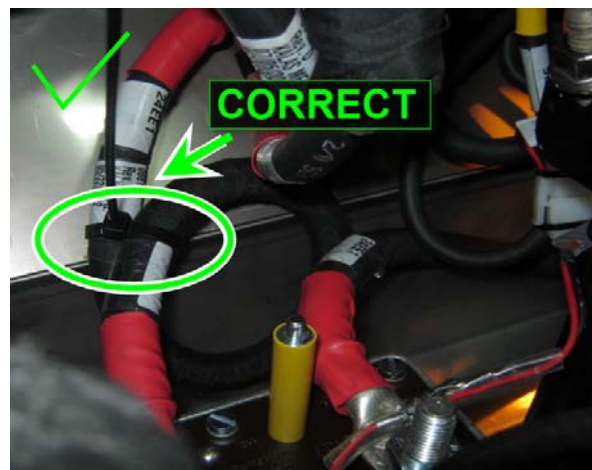
ITEM 5

Power cable 24EE1 connected to relay R1

Tie the cable 24EE1 loop to prevent it to come into contact with the sheet metal edge.
