**R12VT**

## Drag Link Castle Nut Torque

Models Affected: Certain 2013 Model Year Blue Bird Visions

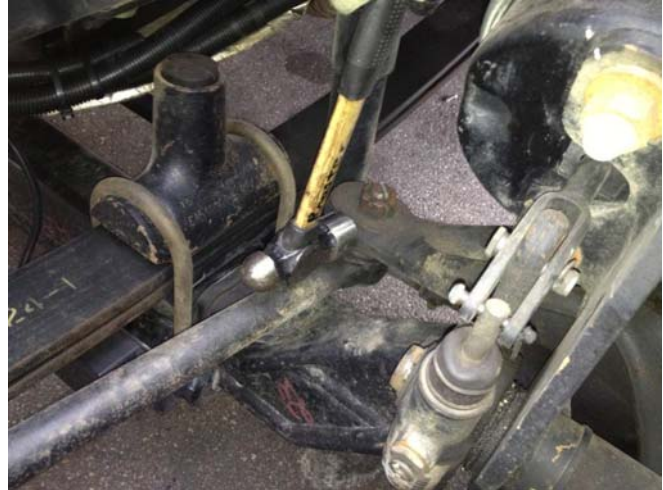
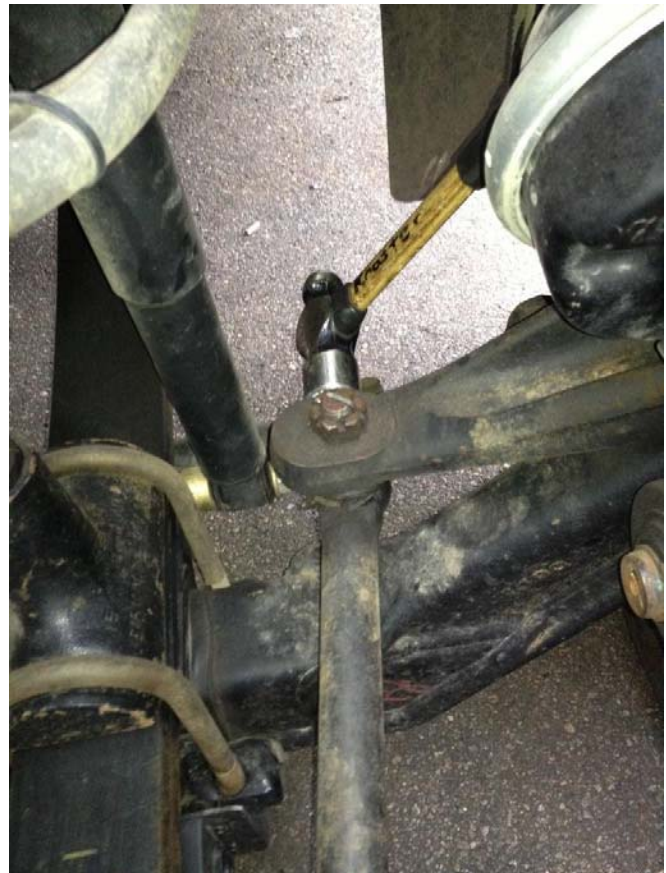
9. If ball stud taper drops out of steer arm after one or two blows, then steer arm tapered hole is damaged. Skip to step 13 and replace steer arm (upper steering knuckle).
10. If ball stud taper remains firmly seated in steer arm after two blows, joint is ok.
11. Torque castle nut on drag link ball stud to 160-170 ft-lbs.
12. Re-install cotter pin. If castle nut slot for cotter pin does not line up with through hole in ball stud, tighten castle nut until next slot aligns with through hole. Install cotter pin & bend-over pin tails. This completes the corrective action.

8. Using a 2 lb. ball peen hammer, strike sides of steer arm with two, firm, horizontal blows. Once in each direction.  
(Fig. 2 & 3)

**NOTE:** Castle nut on aft drag link ball stud *MUST* be torqued then loosened 6-8 turns before striking steer arm.
