### SAFETY RECALL NOTICE 12E-007

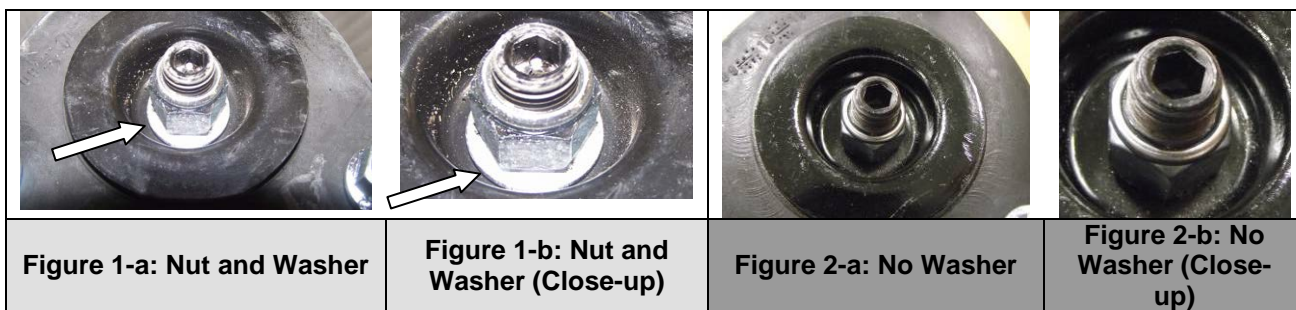
Ride Control, LLC has decided that a defect which relates to motor vehicle safety exists in front ReadyMount™ Assemblies. Certain of these assemblies were produced with a nut without a necessary washer. The absence of the washer can allow the ReadyMount Assembly to pull apart the top mount. If the assembly separates during installation, it could result in injury to the installer. If the Assembly is on the vehicle, the driver may notice a rattle or rubbing noise coming from the front suspension area. In addition, there may be higher than normal steering efforts, decreased ride performance, or some difficulty in maintaining vehicle directional control. If the assembly separated while the vehicle was moving, it could result in secondary damage to surrounding vehicle components, which may result in a crash.

- 3) If a nut and washer is present as shown in Figure 1-a and 1-b, then the ReadyMount Assembly is not affected by this Recall.
- 4) If only a nut is present (no washer) as shown in Figure 2-a and 2-b, then the ReadyMount Assembly is affected by this Recall.
- 5) **Please contact Gabriel Technical Services toll free at 1-800-999-3903** to receive repair kit consisting of one new flange nut per ReadyMount Assembly Maximum of 2 per vehicle. Repair kit with flanged nut and Service Bulletin will be overnight expressed.
