# SERVICE BULLETIN

No.: SRE12-01  
Section: Recall  
Date: 19 MAR 2012  
Model: 1995 - 1999MY Discovery (LJ),  
1999 - 2004MY Discovery II (LT),  
1995MY Range Rover (LH)  
Market: USA

*Subject:* Notification of Safety Recall P024 (NHTSA # 12E010)

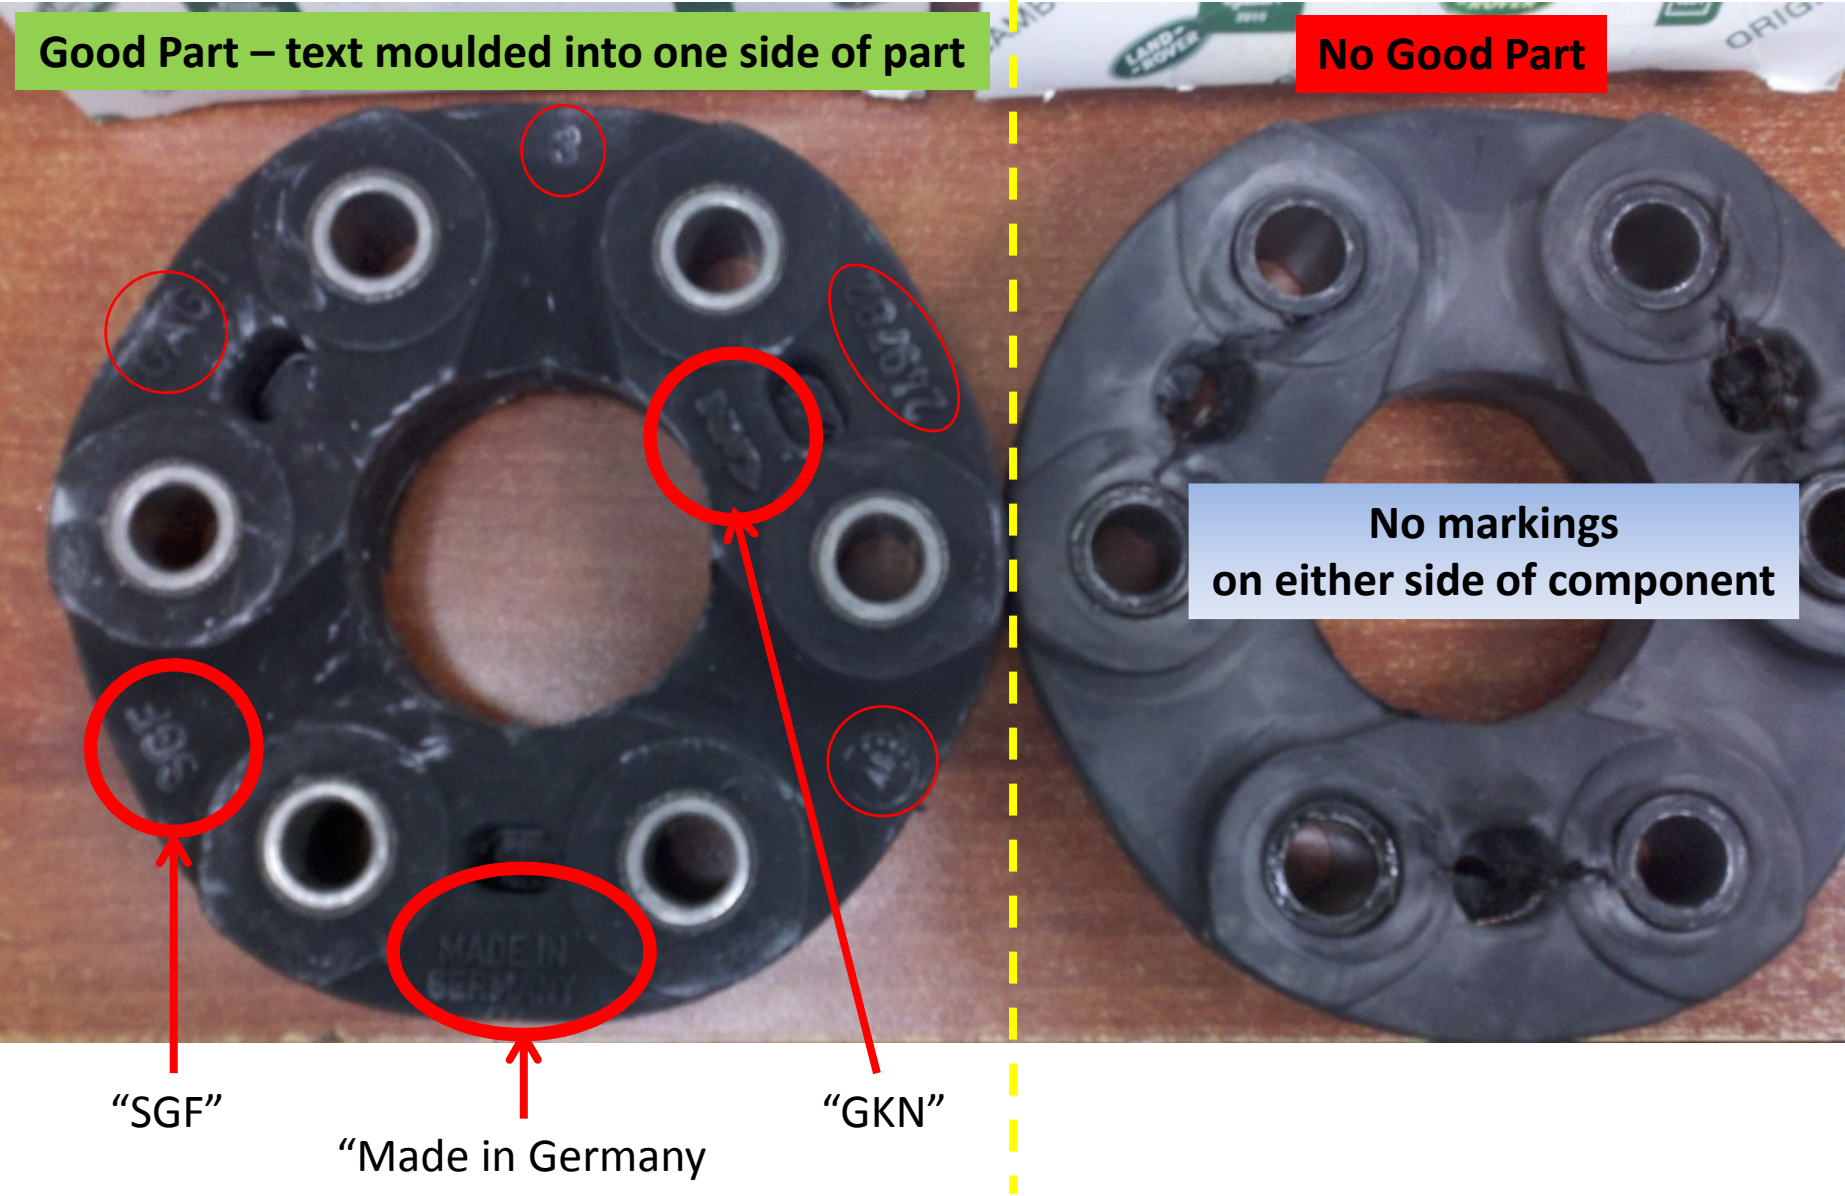
TVF100010 (1H2Z- 7123-AA)

A concern has been identified involving certain genuine Land Rover service parts rear driveshaft couplings (part number TVF100010) supplied to Land Rover retailers that did not meet engineering design specification.

Good Part – text moulded into one side of part

No Good Part

“SGF”

“Made in Germany”

“GKN”

No markings  
on either side of component

1. Check packaging label; if Vendor / Supplier Code is 'FA8FB', the component must be quarantined and must not be sold / utilized to affect vehicle repairs.
2. Check the component against the attached photo to further determine a 'good' / 'no good' condition, In the event of a 'no good' determination, the component must be quarantined and must not be sold / utilized to affect vehicle repairs.
3. In the event of a 'no good' determination in either step 1 or 2, the component must be immediately returned using return code 'ZRTN 020 – Faulty Material Number'.
