GROUP Campaign	MODEL 2007/08MY Rondo (UN), 2006/08 Optima (MG)
	NUMBER 094	DATE February 2012
<b>SAFETY RECALL CAMPAIGN</b>		
SUBJECT: RONDO & OPTIMA CLOCK SPRING ASSEMBLY REPLACEMENT (SC094)

Rondo & Optima Clock Spring Assembly

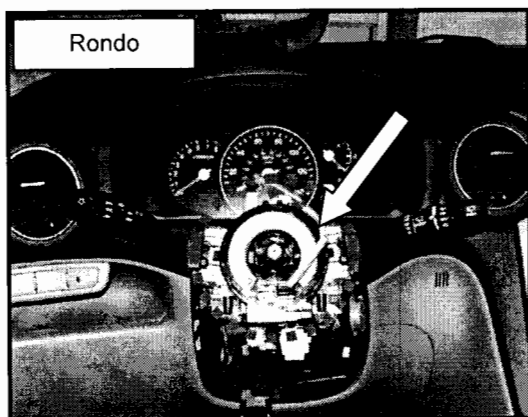
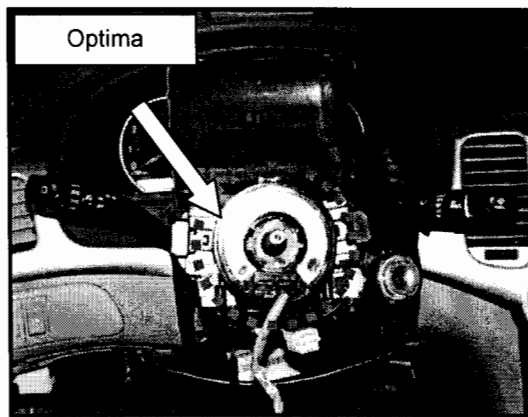
This bulletin provides information relating to the replacement of the clock spring assembly in Rondo vehicles produced from September 13, 2006 to March 21, 2008 and Optima vehicles produced from September 29, 2005 to January 29, 2008. There is a possibility that the clock spring contact assembly may become worn over time. If the clock spring contact assembly becomes damaged, it can cause high electrical resistance, which could prevent deployment of the driver's air bag in certain frontal collisions. If this condition occurs, the "AIR BAG" warning lamp will illuminate.
