**TO:** All Mazda Dealership General Managers, Service Managers, and Parts Managers  
**DATE:** June 2012  
**SUBJECT:** 2001-2002 Tribute - ABS Connector Voluntary Safety Recall 6712A

**2001-2002 TRIBUTE - ABS RELAY INSTALLATION AND MASTER CYLINDER RESERVOIR CAP REPLACEMENT [RECALL 6712A]**

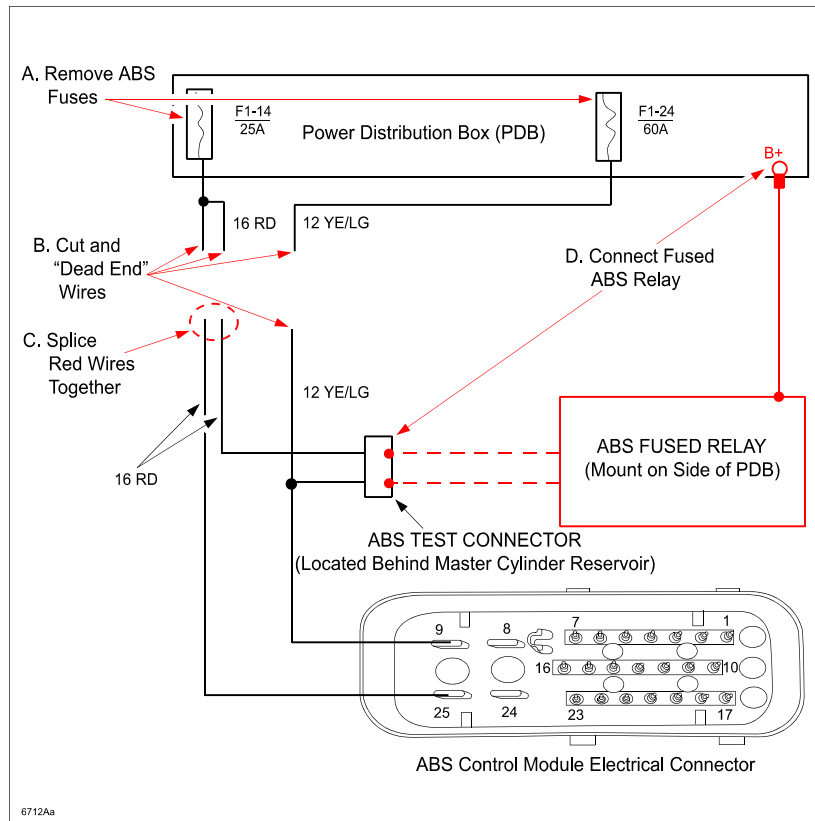
Some of the affected vehicles may have a master cylinder reservoir cap that could allow brake fluid to leak and potentially reach the ABS module connector. If the module connector is not sealed properly, brake fluid may enter the module connector, creating a potential for an electrical short. An electrical short might cause an ABS malfunction that would illuminate the ABS warning light, and in some cases, the module may overheat resulting in burning odor, smoke, and/or fire. This condition could occur either when the vehicle ignition switch is in the off position or while the vehicle is being operated.

- ensure Safety Recall 4507C 2001-2004 Tribute Anti-Lock Brake System is completed.
- install a revised brake master cylinder reservoir cap.
- disable the original ABS circuits which were powered at all times.
  - Remove and discard original fuses (reference "A" below).
  - Cut wires that lead to the fuses (reference "B" below).
  - Splice the two red wires together (reference "C" below).
- install a new fused ABS relay to provide "Key-On" power only (reference "D" below).

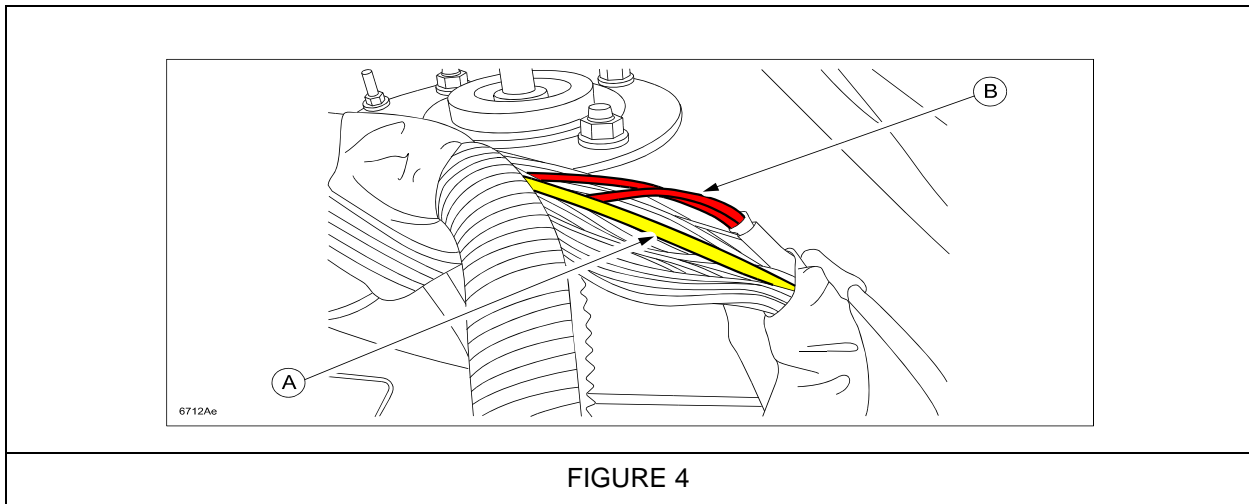
**NOTE:** In the absence of the 25A and 60A ABS fuses, the ABS fused relay will supply power to the ABS module and is only powered in the "Key-On" position. The circuit would be restored to "powered at all times" if an individual reinstalled the fuses. To prevent this, the original ABS wires that lead to the PDB must be cut and "dead ended".

1. Record radio presets.
2. Disconnect the negative battery cable. For additional information refer to MS3 online or Workshop Manual (section 01-17 BATTERY DISCONNECT).
3. Open the wire harness loom between the PDB and the tie down strap and locate the 12 gauge Y/LG wire (A). See Figure 4.

4. Locate the two 16 gauge R wires (B) that run next to each other and are factory spliced to a single Red wire near the PDB. See Figure 4.

5. Cut the 12 gauge Y/LG wire (A) and the two 16 gauge R wires (B).
