# Recall Campaign

**PRODUCT:** CE White 39" school bus seat

This document contains procedures to modify the seat frame on the standard CEW 39" seat which allows too much movement. This modification is necessary to meet the FMVSS 222 rearward push requirement.

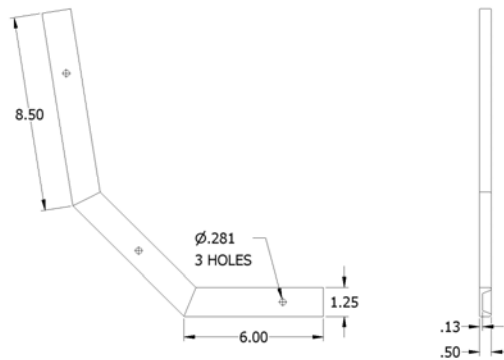
Figure 1:CEW Seat frame reinforcement bracket

| Part number | Description | Qty/seat |
|---|---|---|
| Left hand 700-125 and 700-128 or<br>Right hand 700-127 and 700-129 | Seat frame reinforcement bracket | 1 |

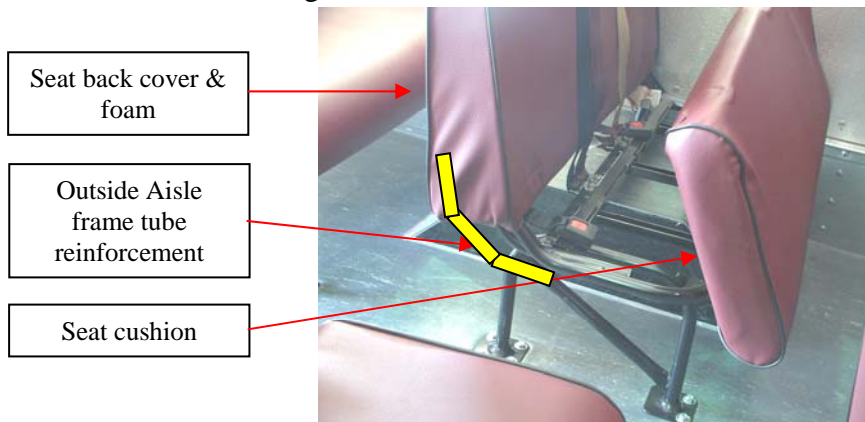
Figure 2: Side seat view

1. The reinforcement bracket shall be installed, as shown, on the outside aisle frame tube after removing the seat back cover and foam.

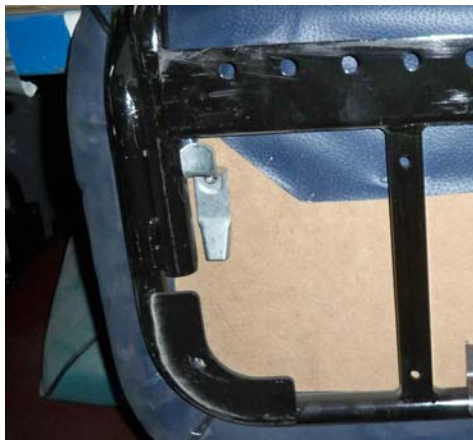
Figure 3: Quarter turn bracket – seat underneath view

2. Remove the seat cushion. Depending on the seat model year, the seat cushion could be secured with two quarter turn brackets or a self latching device.

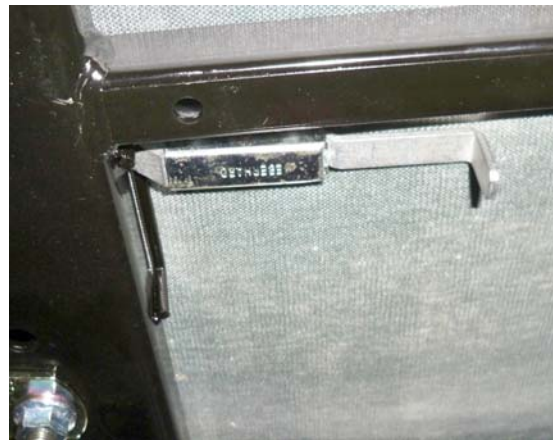
Figure 4: Self latching device – seat underneath view

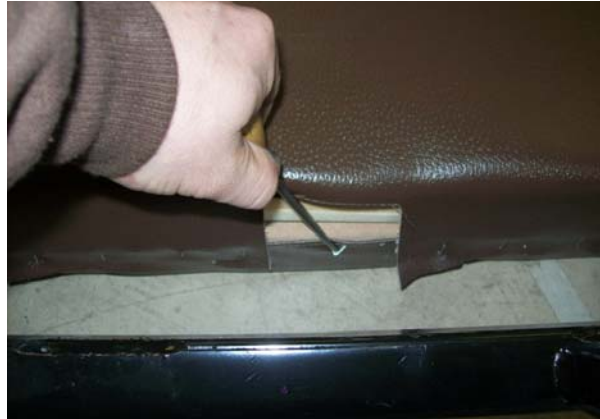
*Figure 5: Remove staple from the seat cover – seat back underneath view*

3. Remove staples from the bottom of the seat back cover. Once the staples are removed, grab the lower outside corner of the foam pack and pull up to release the foam from the frame. This will allow the foam and cover to slide up the frame as a single unit or the cover can be removed first and then the foam pack. If the foam pack sticks to the frame, “work” or twist the foam in the sticking area and pull up on the lower outside corners again.

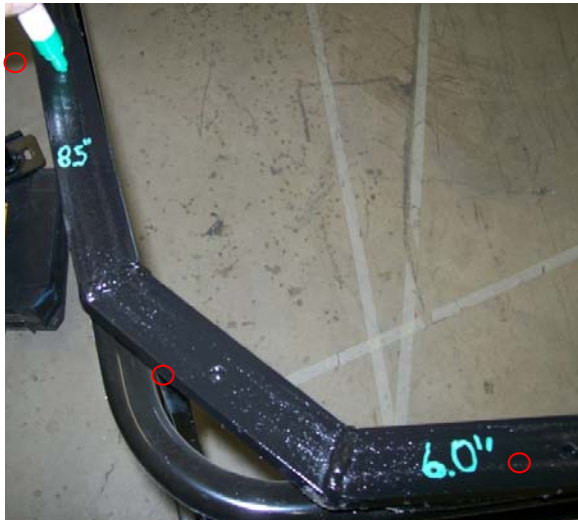
*Figure 6: Seat frame reinforcement bracket –seat frame side view  
The longer bracket side fits on the back of the seat (as shown)*

4. Place the reinforcement bracket on the outside seat frame tube, closest to the aisle, (two different brackets are provided, select the best fitting). While keeping the bracket centered on that tube, mark the 3 mounting holes or clamp the bracket to the tube. Note: reinforcement bracket is only needed on the aisle side of frame.

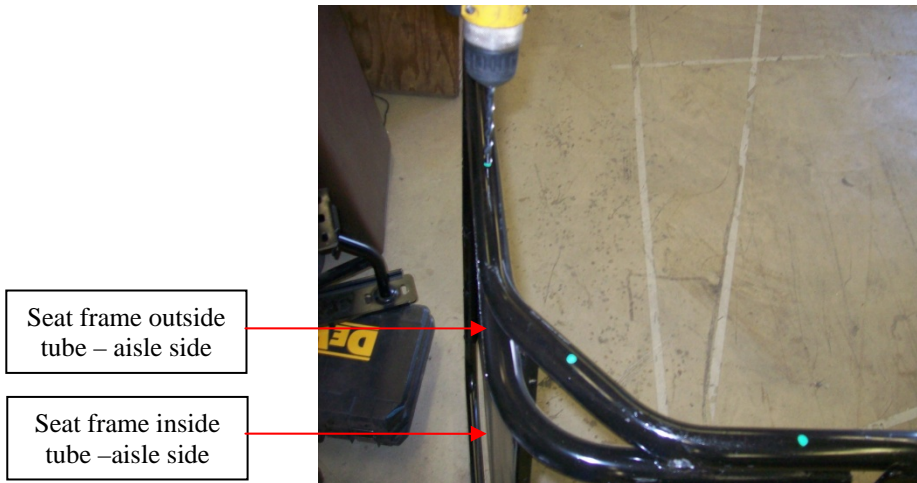
Figure 7: Frame drilling – seat frame side view

5. Drill the 3 mounting holes with a 9/32" drill bit. Drill completely through the outside and inside tubes for the upper and lower mounting locations. The center mounting location will only need a hole through the outside tube.
