Safety Recall Trucks

Date	Group.	No.	Page
04.12	SC0360		1(3)

Move Alternator Ground Cable, Compressed Natural Gas (CNG)

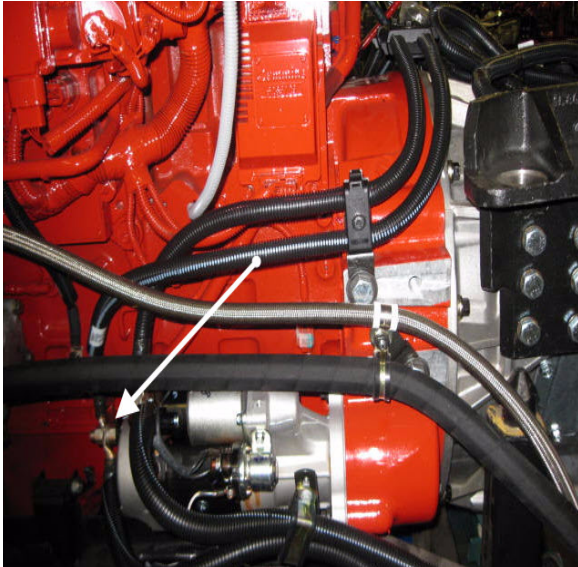
On these vehicles, the alternator ground cable runs directly to the starter and bypasses the fusible link. To correct the issue, remove the alternator ground cable from the starter and install the cable onto the engine ground stud.

1. Disconnect all cables from the negative (ground) battery terminals to prevent personal injury from electrical shock and damage to electrical equipment.
2. Raise the cab.
3. Locate the starter on the left side of the engine.
4. Remove the ground cable at the rear of the starter (routed from the alternator).

5. Torque starter ground stud to 26 +/- 1.5 Nm (19.2 +/- 1.1 ft-lb).
6. Loosen the engine ground stud.
7. Install the alternator ground cable onto the ground stud (located on the side of the engine block).
