## SIB 61 14 12

2021-04-26

### Recall Campaign 12V-126: Check the Battery Cable Connection

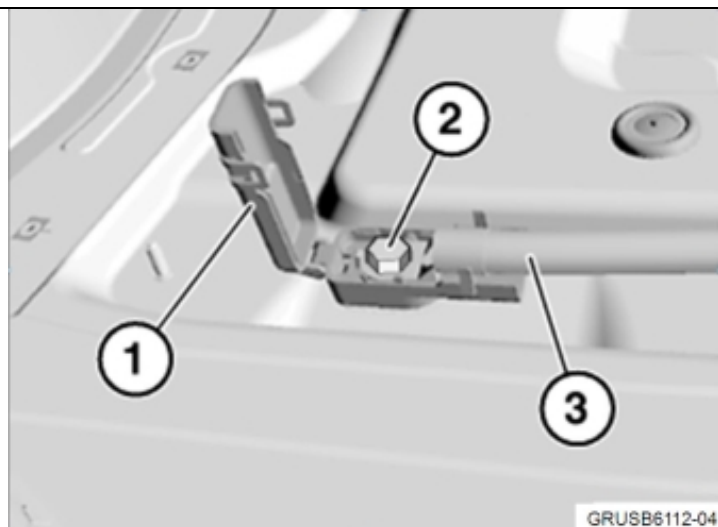
4. **E60, E63, and E64 only:** Prop up the trunk floor trim panel in order to gain access to the battery cable. For the E61, proceed to the next step.

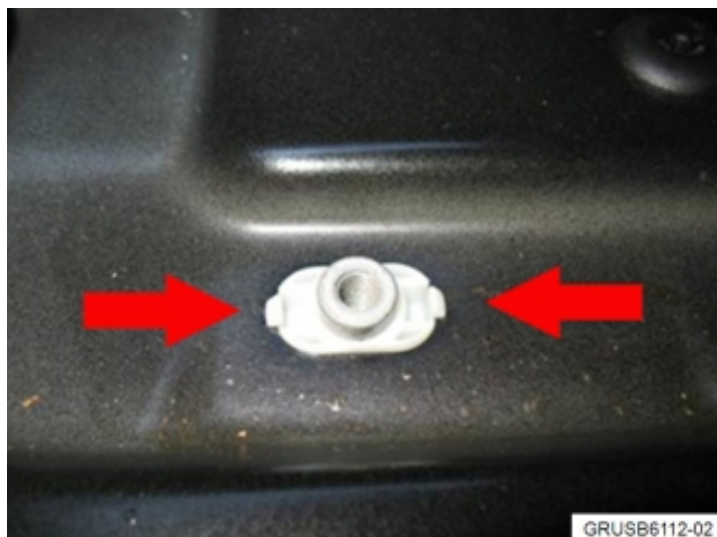
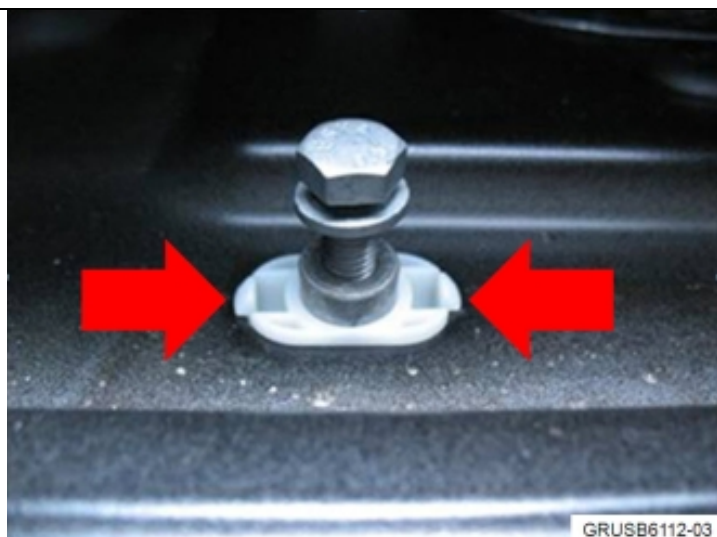
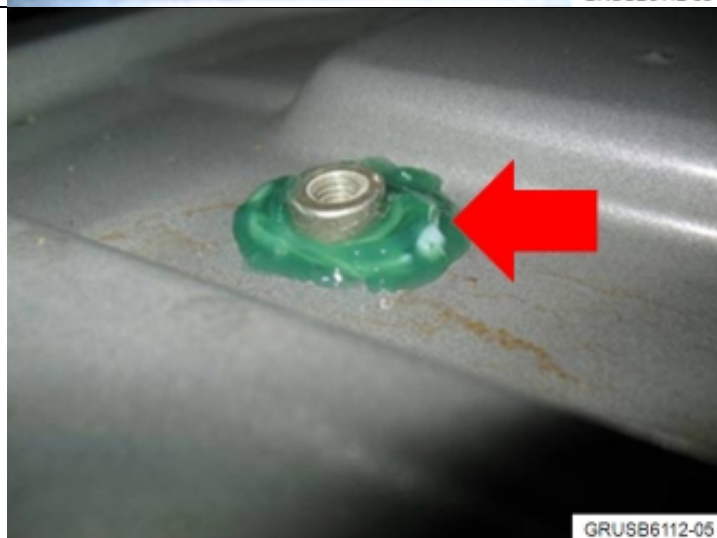
5. Open the cover (1) of the battery cable (3) connecting screw lug and remove the securing bolt (2).

6. Check that both clip-retaining tabs are locked into the luggage compartment sheet metal. If not, proceed to the next step.

7. Screw the previously removed securing bolt into the lug and pull up, so that both retainers on the clip are locked into the sheet metal.

8. Coat the area around the lug covering the retaining clip with contact protection grease.

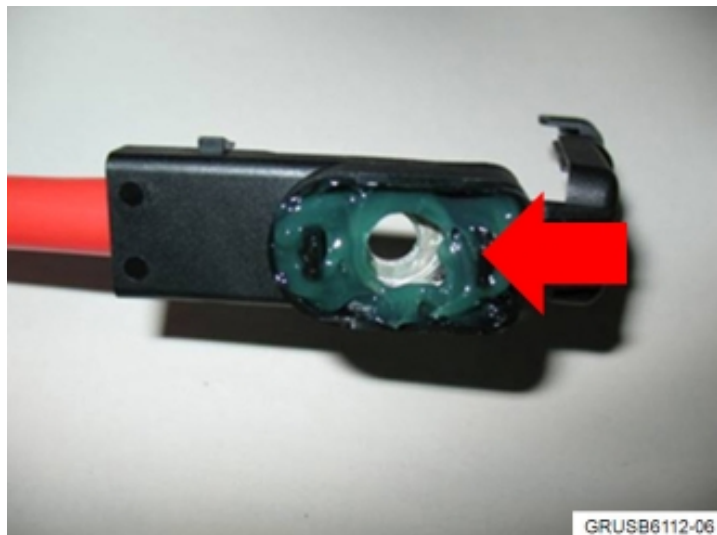
GRUSB6112-06

9. Ensure that the cable is clean before assembly. Install the new battery positive terminal cover (**the new cover is white in color**) and coat the bottom area, as shown, with contact protection grease.

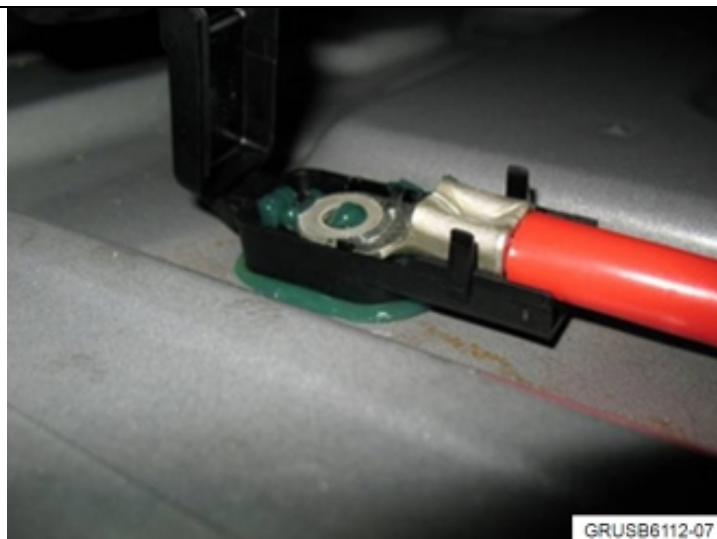
GRUSB6112-07

**See Important Note above.**

**10.** Ensure that the lug is clean before assembly. Install the battery positive cable on the lug.

**11.** Install the securing bolt and torque to 15 Nm. Be careful not to dislodge the lug retaining clip tabs under the cable during assembly.
