Service Information (US only)

11 04 12 (RR04)

Title: Recall Campaign 12V-166: Replace the Auxiliary Coolant Pump for Turbocharger (KIT- 05)

Affected cars: Rolls-Royce Ghost models produced between 07/04/2011 and 02/06/2011
According to VIN selection based on engine numbers.

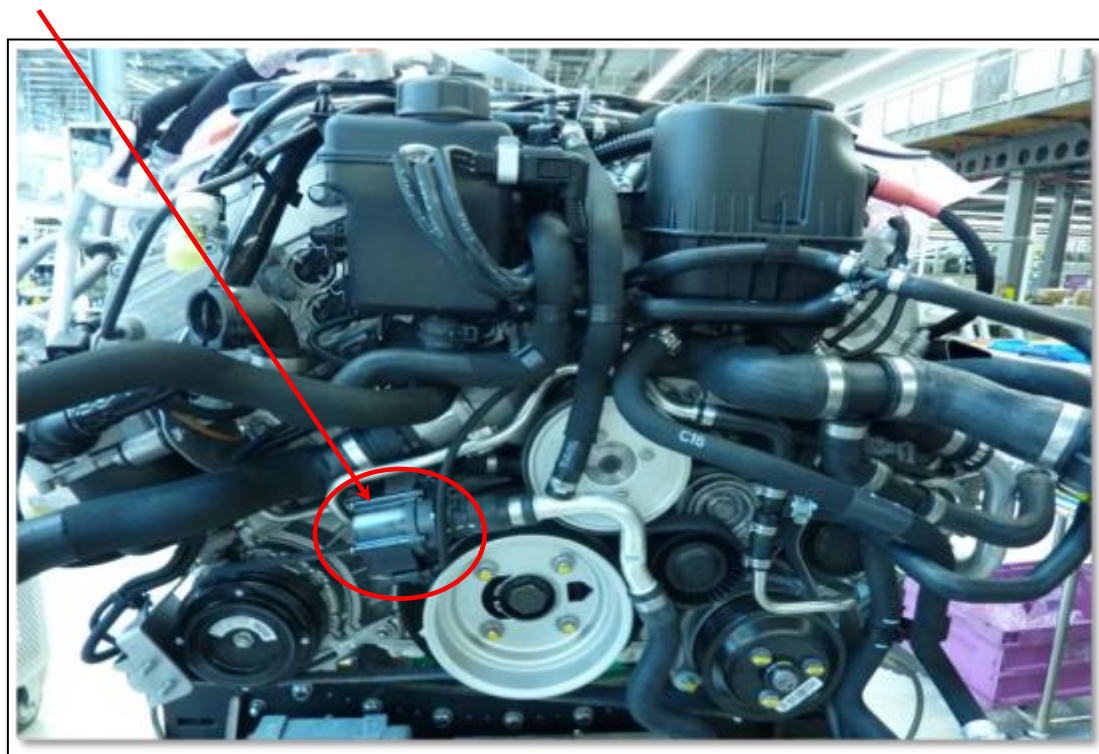
51 47 490	Removing and installing/replacing front underbody protection	No comments
51 75 051	Removing and installing/replacing distribution channel	No comments
17 11 035	Removing and installing/renewing fan cowl with electric fan (N74R)	No comments
11 53 000	Removing and installing/replacing auxiliary water pump for exhaust turbocharger (N74R)	Note: Do not remove charge air cooler expansion tank (17 13 020 Removing and installing/replacing charge air cooler expansion tank) Note: To gain access to the auxiliary water pump bracket fixings, the lower coolant hose needs to be removed as shown in Figure 2 and 3 below Note: Location of the auxiliary water pump on photo R11 5157 is incorrect. See correct location for N74R in Figure 4 below.

Figure 4, circled above, shows the location of the auxiliary water pump, fitted to the front of the N74R engine.
