SAFETY RECALL ACTION

To: All North America Dealers For the attention of: Service Manager/After Sales Manager Please copy to: Dealer Principal Sales Manager Warranty Administrator Aston Martin Technician(s) Parts Manager	Reference RA-03-0016V2 Issued: 23 October 2013
Model: All Models from 11 November 2007 thru 3 October 2013 but not New Vanquish or Cygnet	Page 1 of 13
VIN Range: Refer to the separately published list of VINs	
Subject: Throttle Pedal Lever - Incorrect Material Specification and Adjustment of the Footwell Scuff-Plate on Left Hand Steering Vehicles

Reason for Version 2 of this Safety Recall Action (RA-03-0016).

Subject: Throttle Pedal Lever - Incorrect Material Specification and Adjustment of the Footwell Scuff-Plate on Left Hand Steering Vehicles

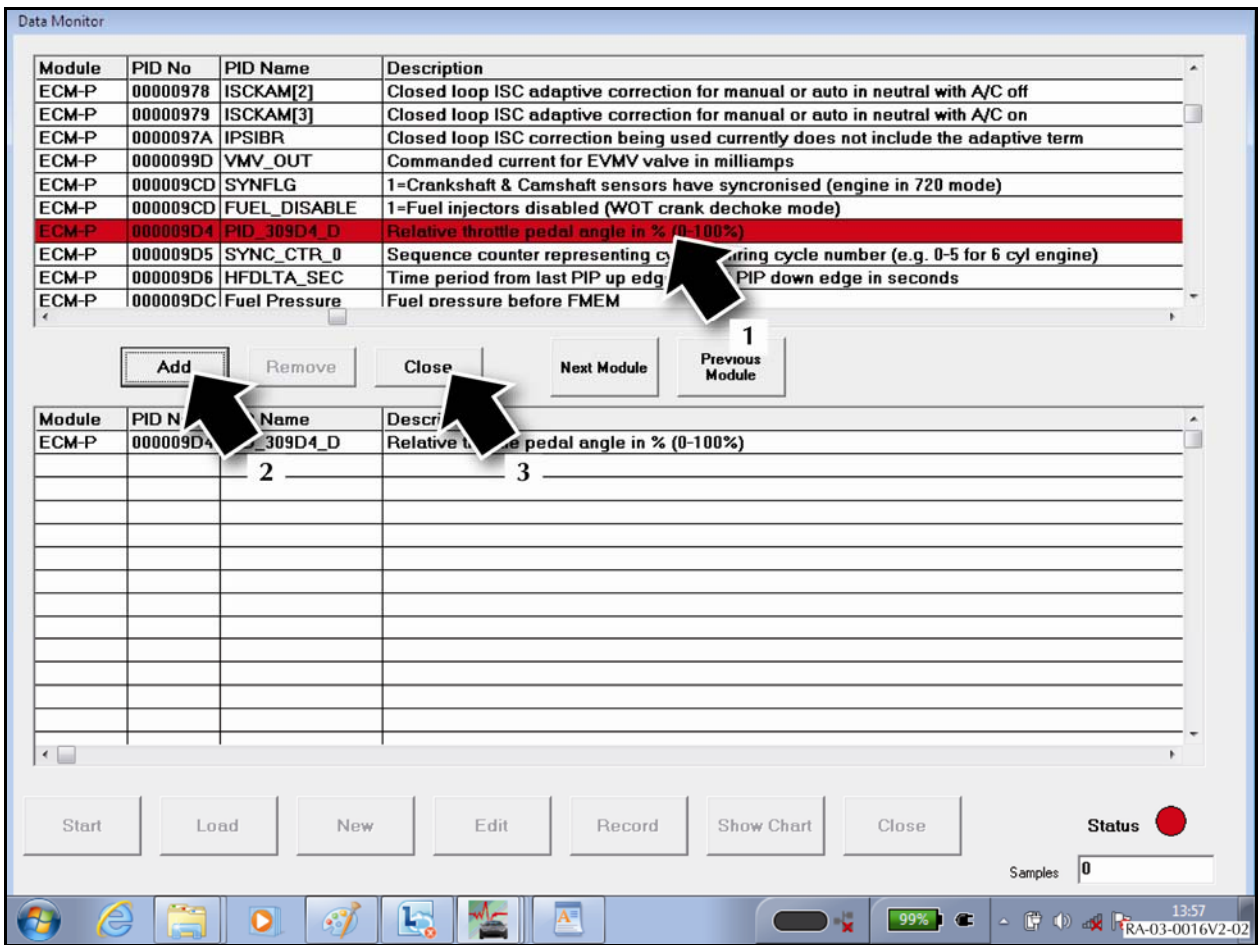
Figure 1

7. Connect the AMDS to the vehicle.
8. Go to data monitor on AMDS and select PID_309D4: "Relative throttle pedal angle in % (0-100%)" (1) (refer to Figure 1). The PID will be added to the bottom table.
9. Click on "Add" (2).
10. Click on "Close" (3).

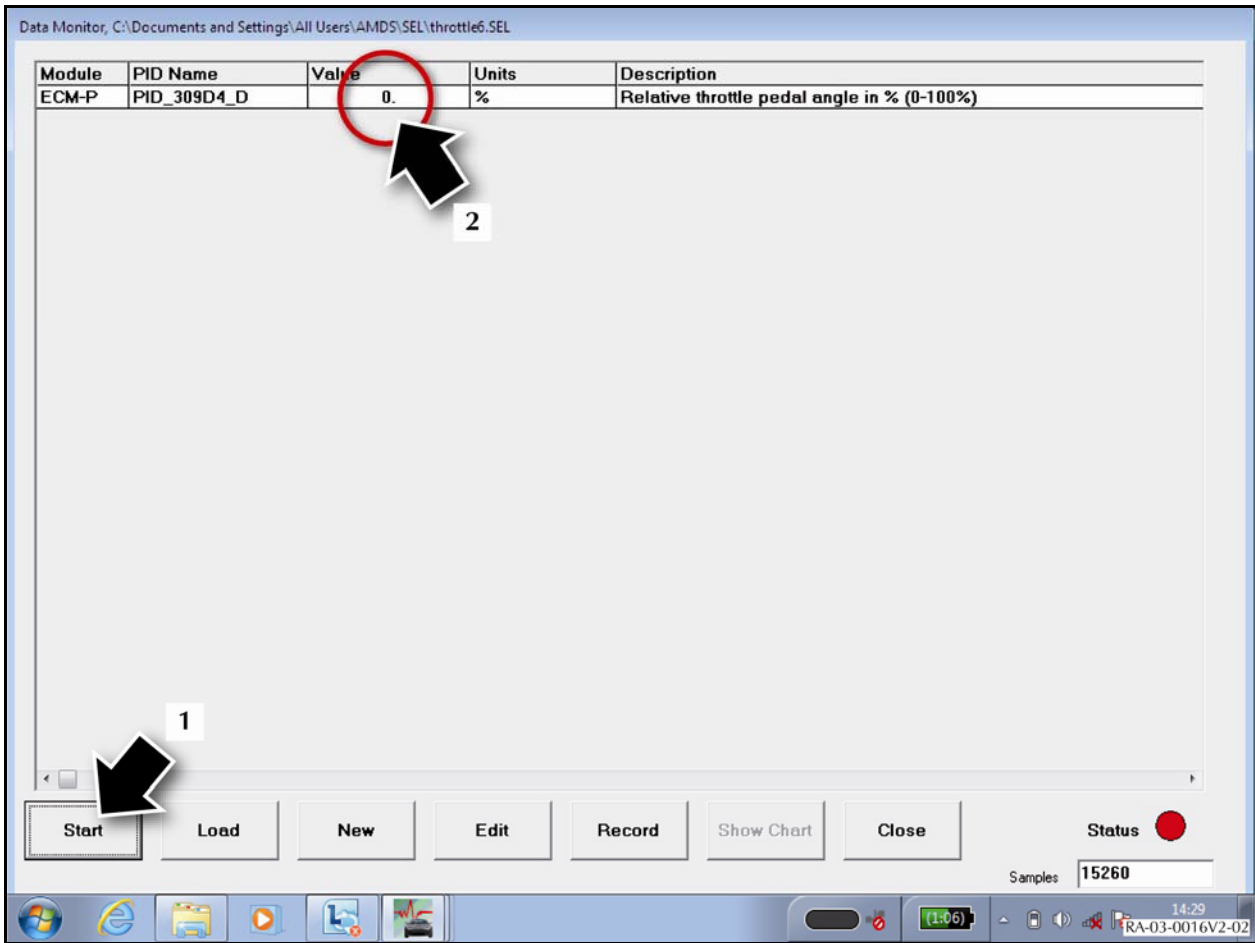
Figure 2

11. The throttle pedal angle screen will be shown (refer to Figure 2).
12. Click on "Start" (1). When you move the throttle pedal, the percentage of the angle of movement will be shown in the "value" cell (2).
